VOLUME 6 - APPENDIX SECTION 6.9 – GREVET-CHAPAIS RAILWAY BRIDGE INSPECTION

Consultant Reference: LGA-1-GN-F-FRN-RT-0006_00_Appendix6.9
2023-04-14

91.0 Chapais O'Sullivan River
LAT. N 49.24208 Long. W 76.27592
Type 3 DPG (Length 186 feet height 22 feet)

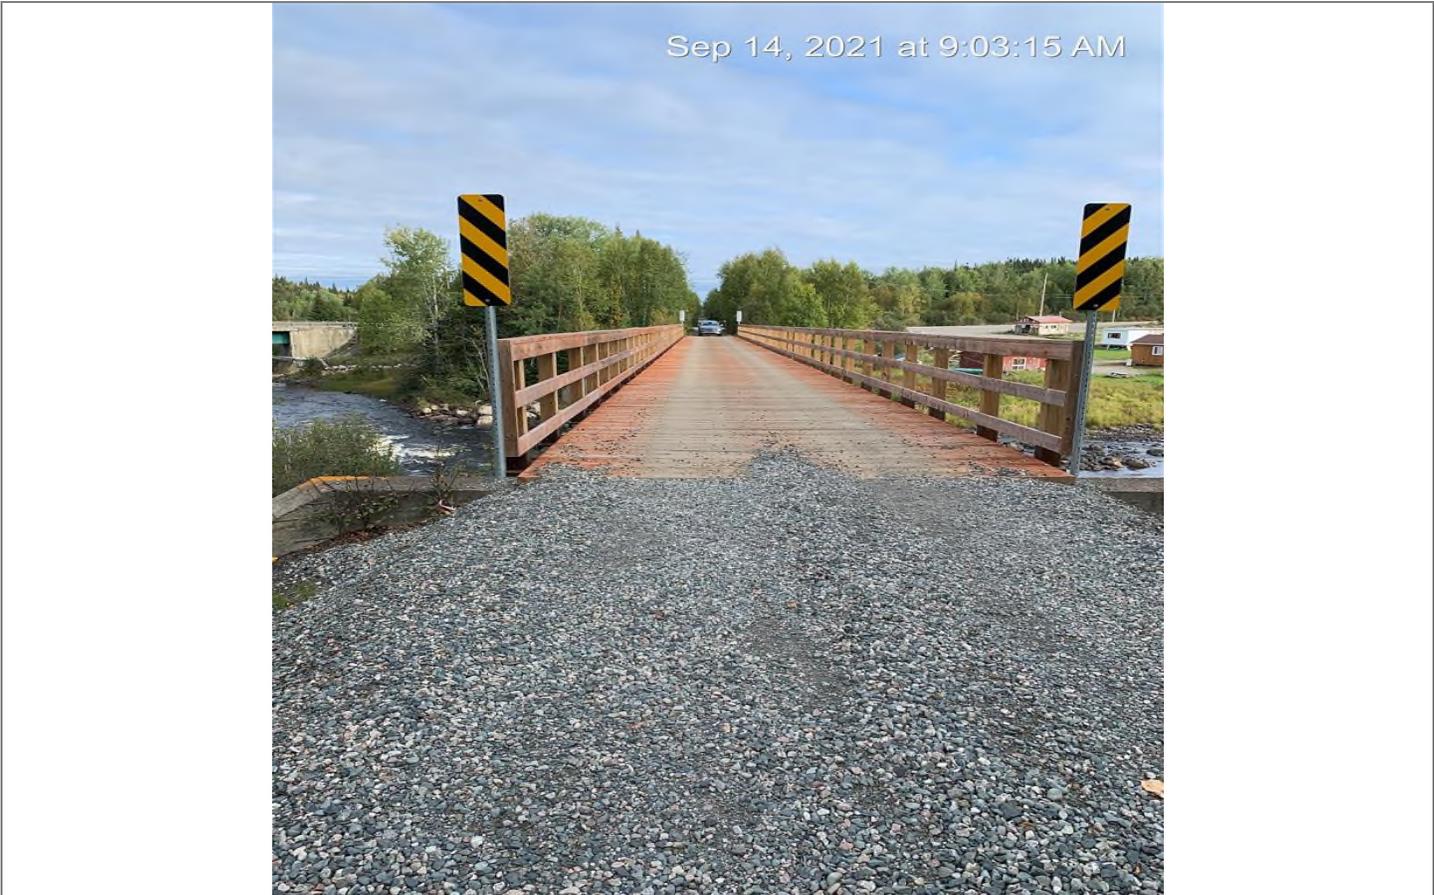
Number	P-158100425-14/09/21-641-YR	Date (AAAA-MM-JJ)	14/09/2021
Location	91.0 Chapais		
Remarks	Deck view toward the North. Level crossing 100 meters North end.

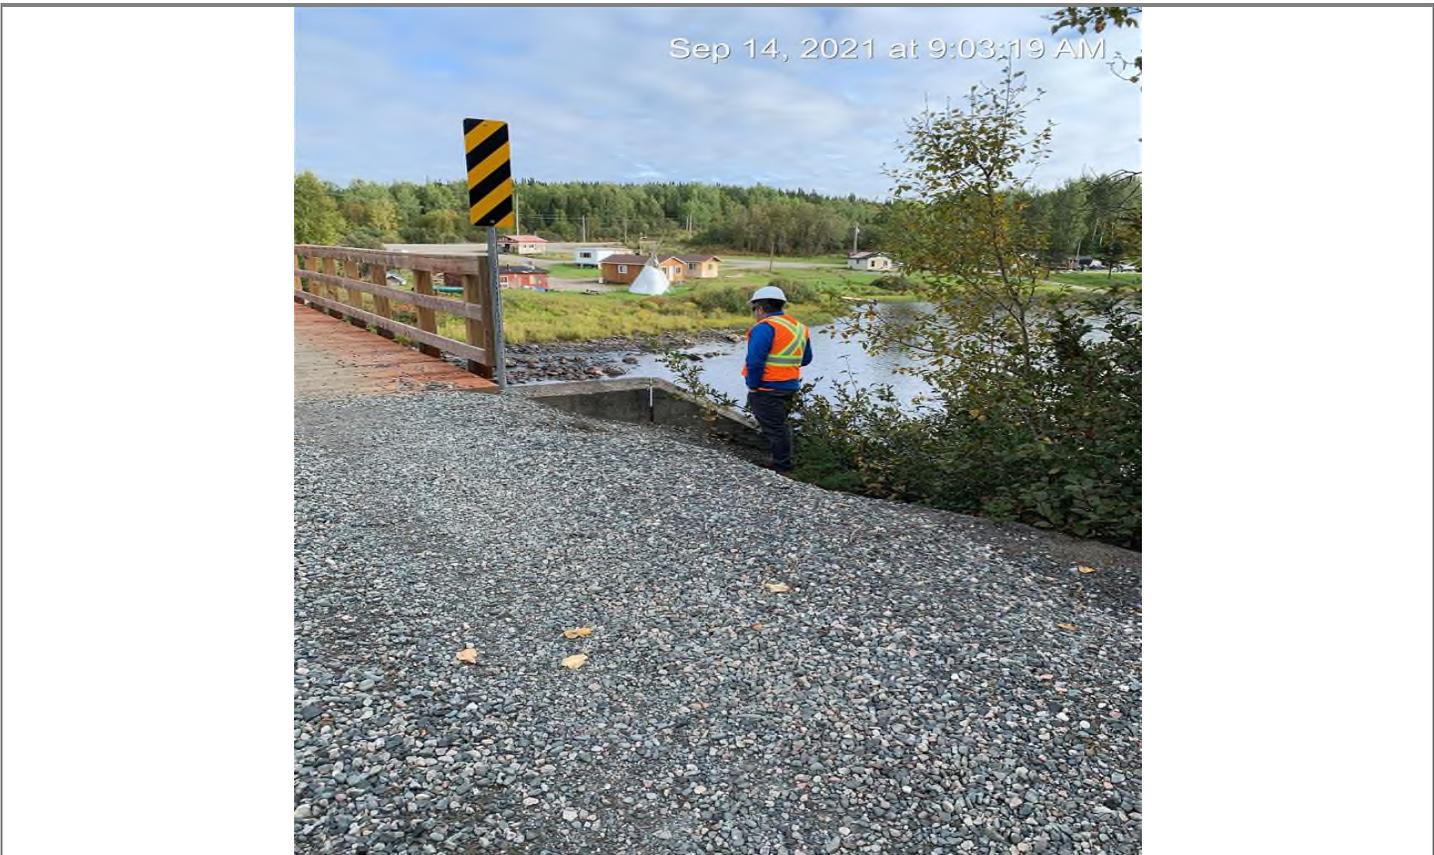
Number	P-158100425-14/09/21-642-YR	Date (AAAA-MM-JJ)	14/09/2021
Location	Southeast corner.		
Remarques	Wingwalls to be installed on both sides each abutment

Wingwalls required on both abutments both sides of bridge for bank stability.

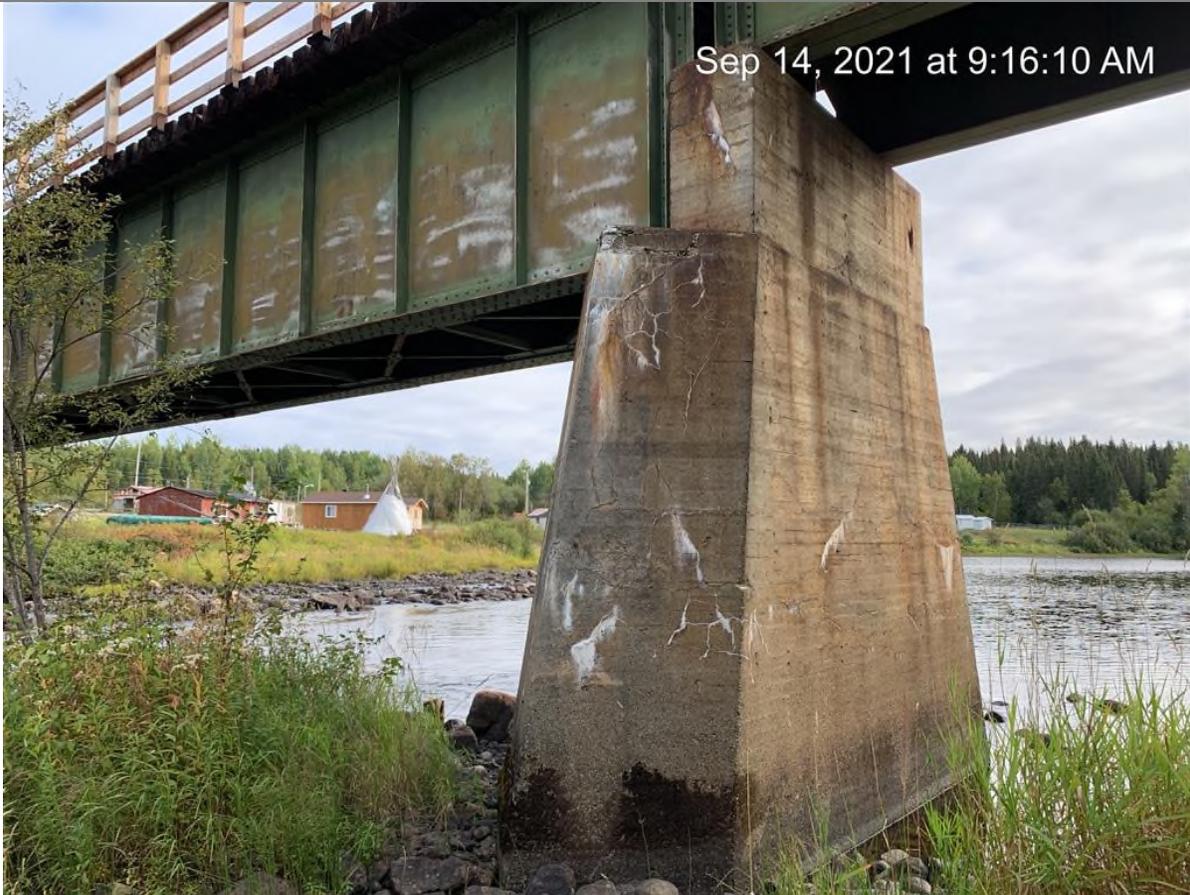
Number	P-158100425-14/09/21-649-YR	Date (AAAA-MM-JJ)	14/09/2021
Location	Pier # 1 West side		
Remark	Minor repairs to be completed on the nose of both piers

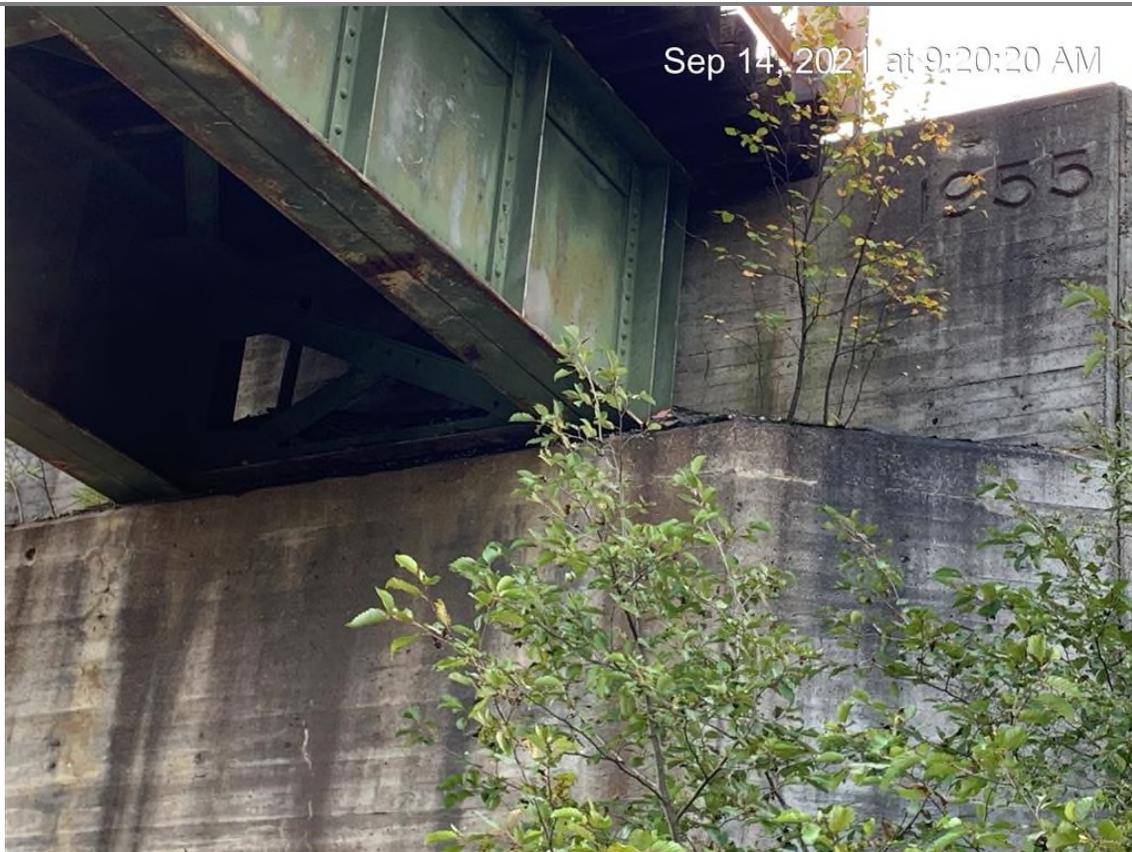
Number	P-158100425-14/09/21-651-YR	Date (AAAA-MM-JJ)	14/09/2021
Location	North abutment.		
Remark	Cleaning and minor repairs on bridge seats on both abutments and piers

All bridge seats require minor repairs and cleaning.

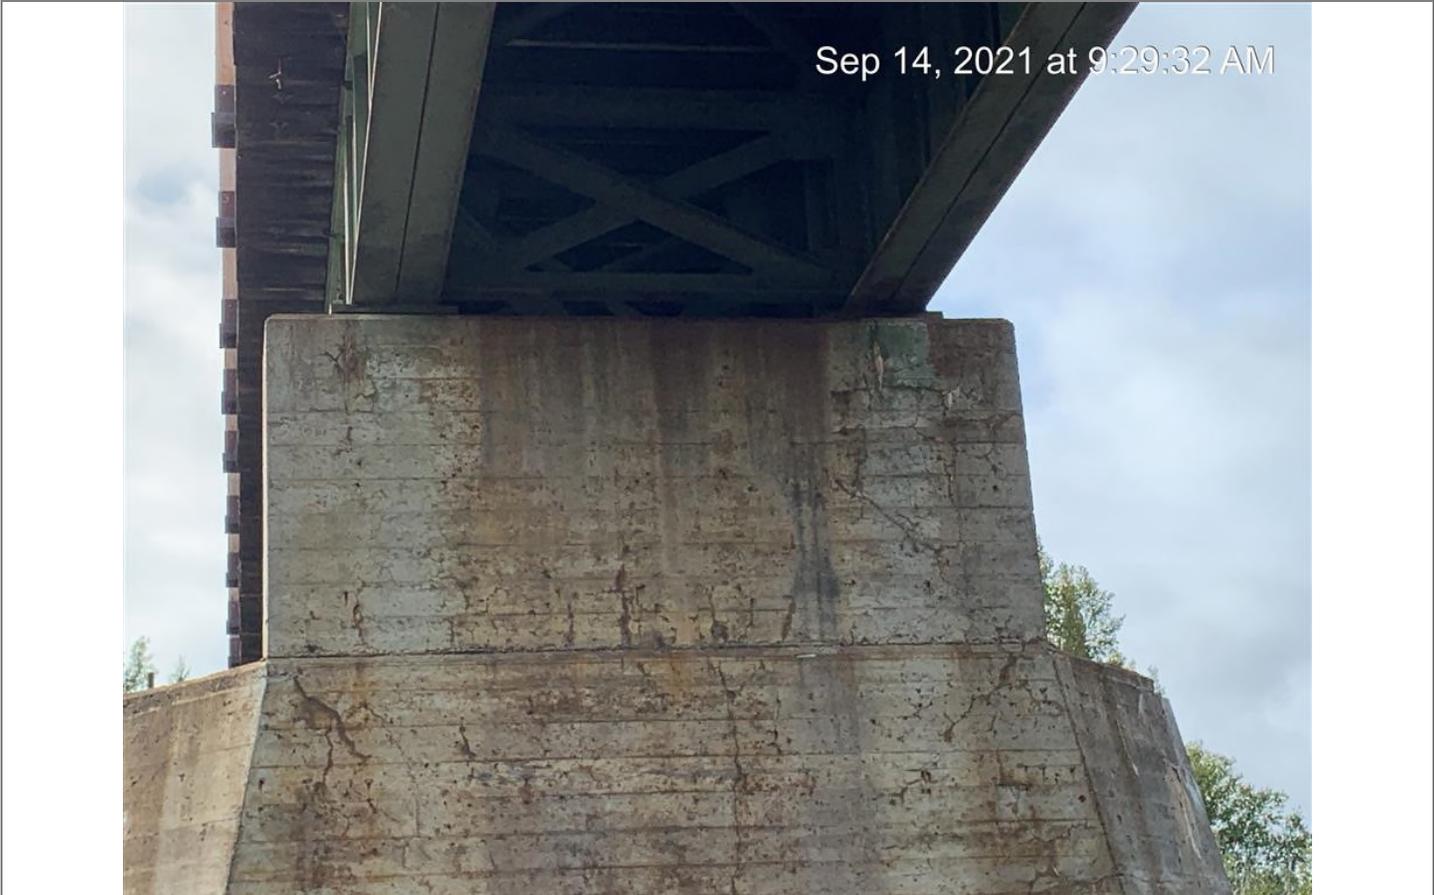
Number	P-158100425-14/09/21-660-YR	Date (AAAA-MM-JJ)	14/09/2021
Location	Back Wall Pier # 2		
Remark	Load capacity to be analyzed on back walls on both piers

Rating of both abutments and piers and backwall on both piers to be evaluated for capacity.

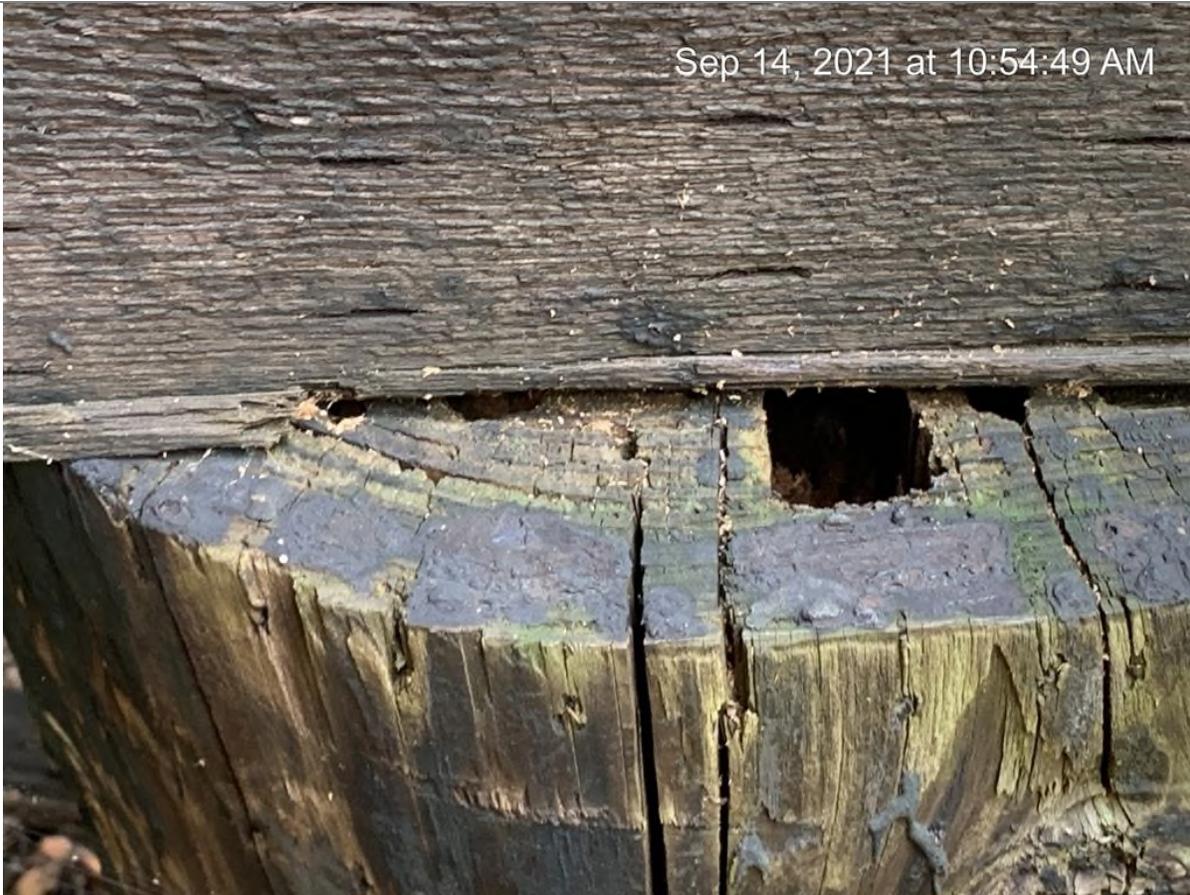
Number	P-158100425-14/09/21-667-YR	Date (AAAA-MM-JJ)	14/09/2021
Location	101.8 Chapais Bent # 6		
Remark	Note the rotted pile in the center. Typical in many locations on all the bents.

Timber spans 1 and 2 including spans 6, 7 and 8 to be replaced due to their poor condition.
Stingers are 10 inches X 18 inches don't meet loading capacity for proposed railroad classification.

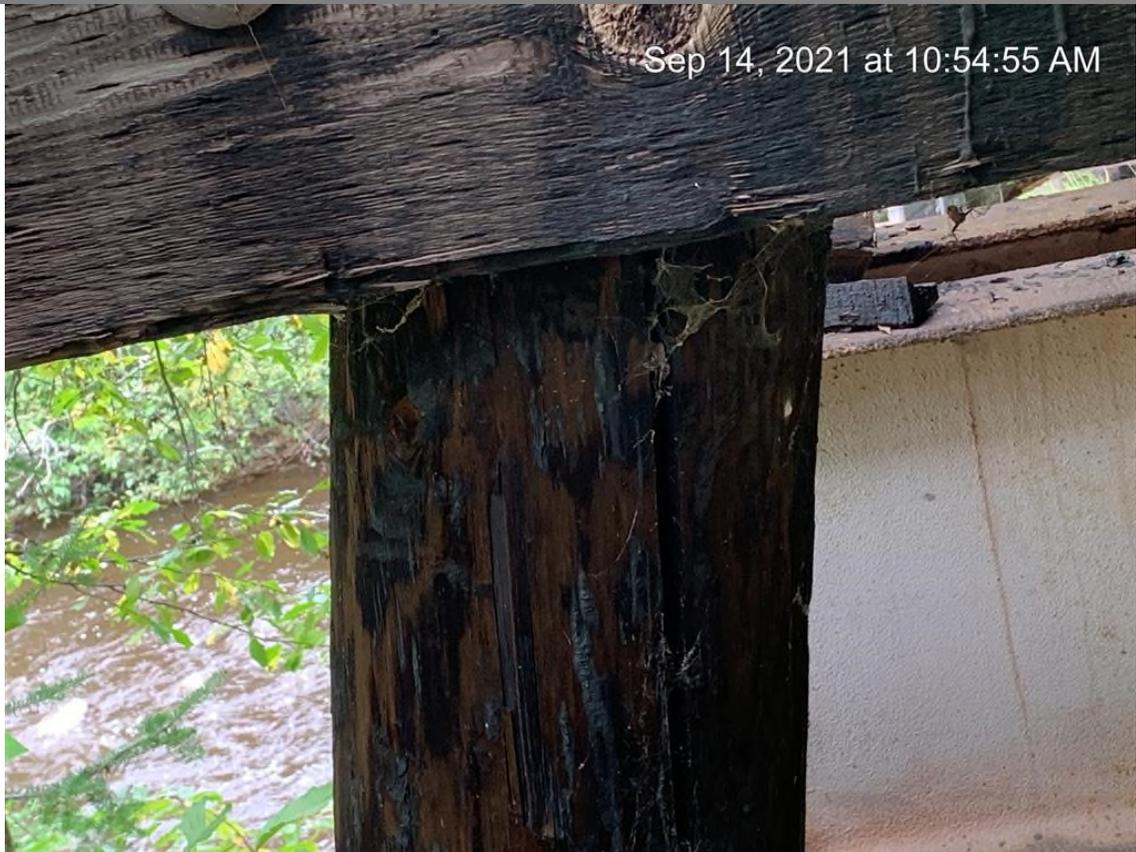
Number	P-158100425-14/09/21-668-YR	Date (AAAA-MM-JJ)	14/09/2021
Location	Span # 6		
Remarques	Cap beam not centered on piles

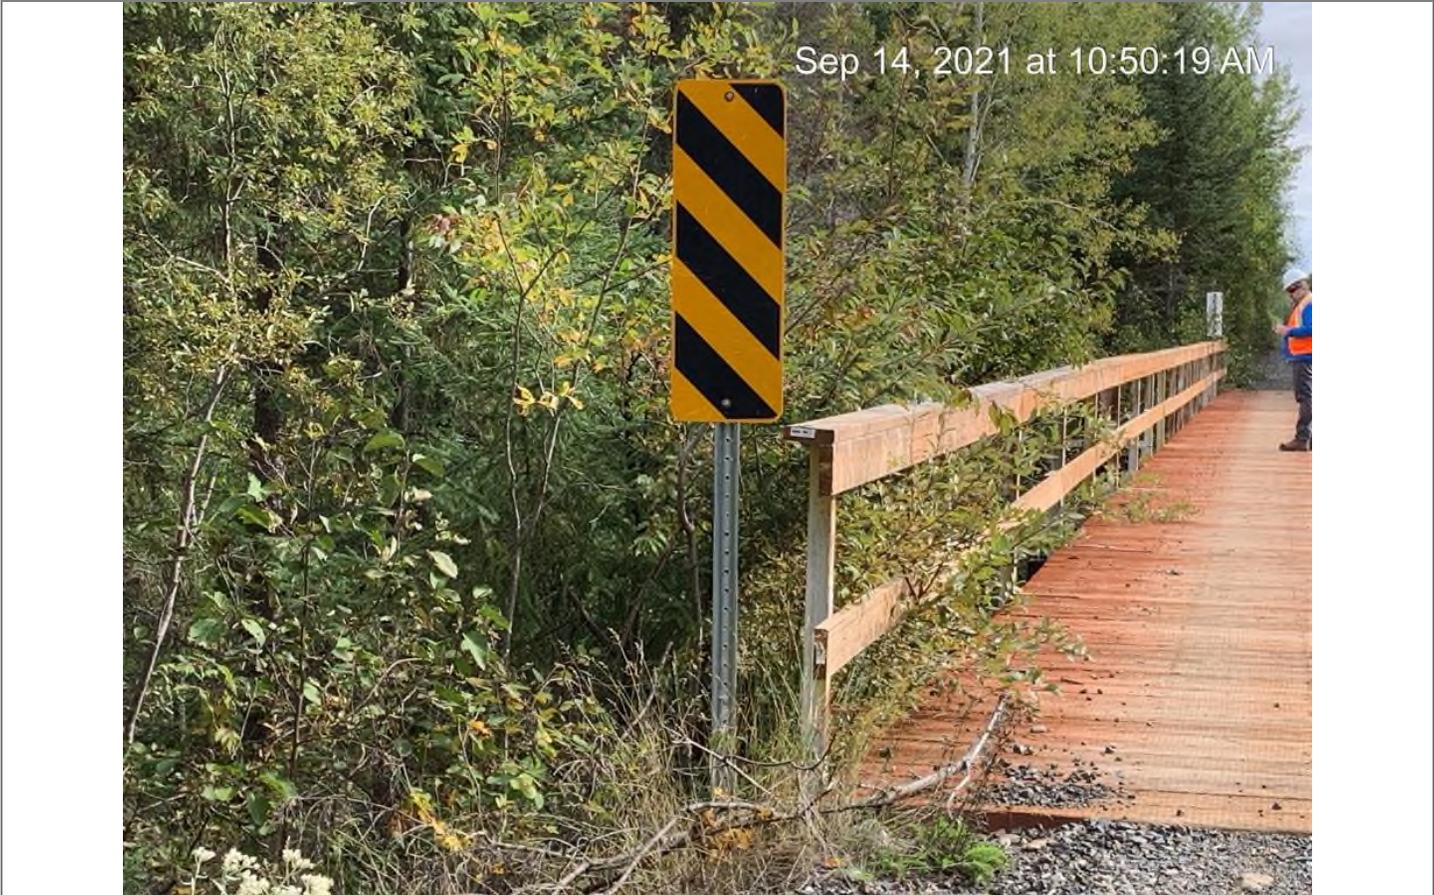
Number	P-158100425-14/09/21-662-YR	Date (AAAA-MM-JJ)	14/09/2021
Location	West side looking North		
Remark	Trees and brush cutting required. Also bridge clean on steel spans

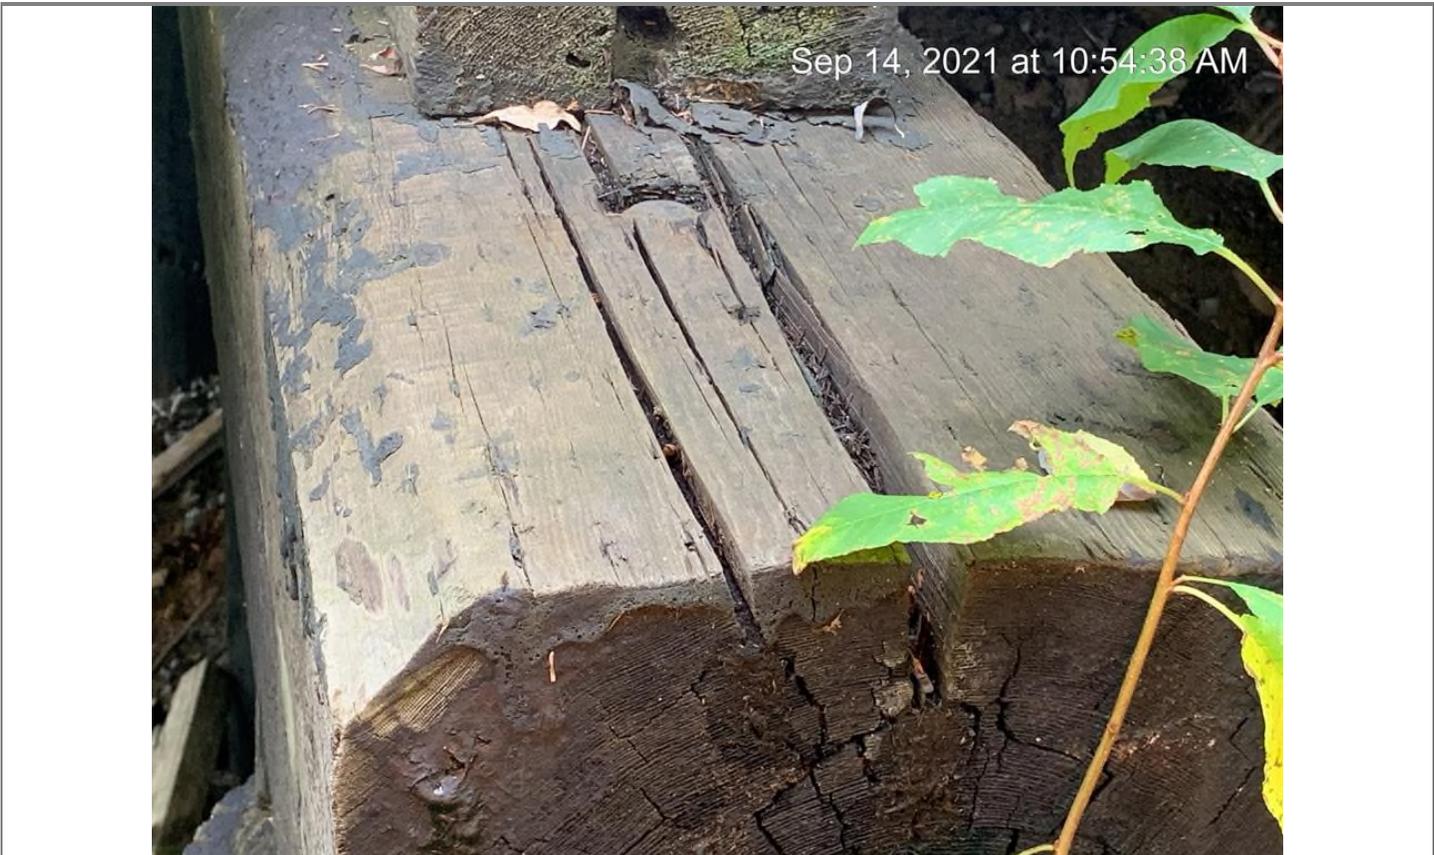
Number	P-158100425-14/09/21-665-YR	Date (AAAA-MM-JJ)	14/09/2021
Location	101.8 Chapais cap beam bent # 6		
Remark	Cap beam rotten and squashing down.

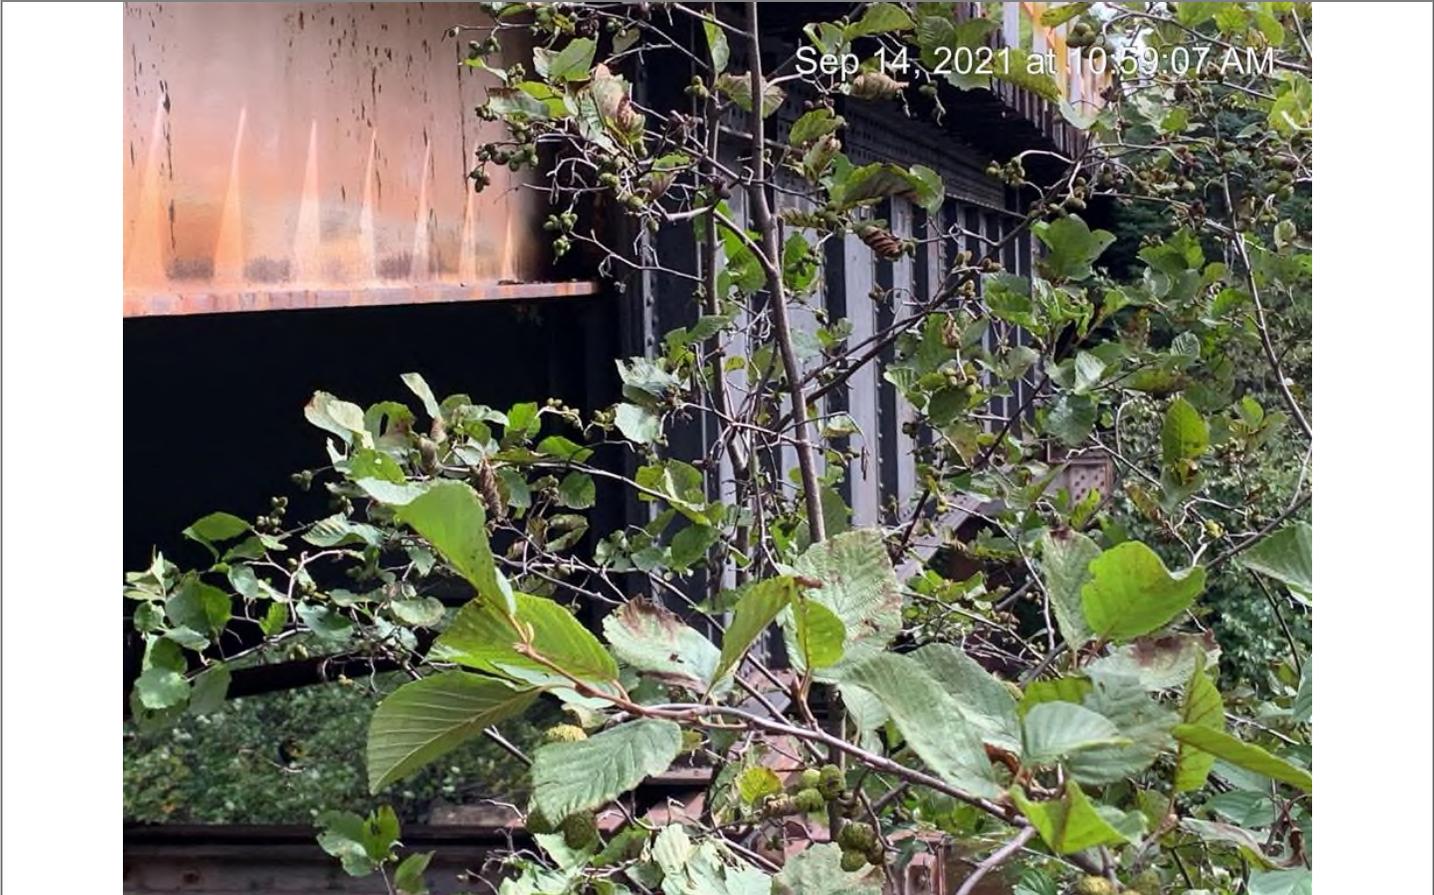
Number	P-158100425-14/09/21-670-YR	Date (AAAA-MM-JJ)	14/09/2021
Location	101.8 Chapais south side looking West		
Remark	Cleaning and brush cutting required

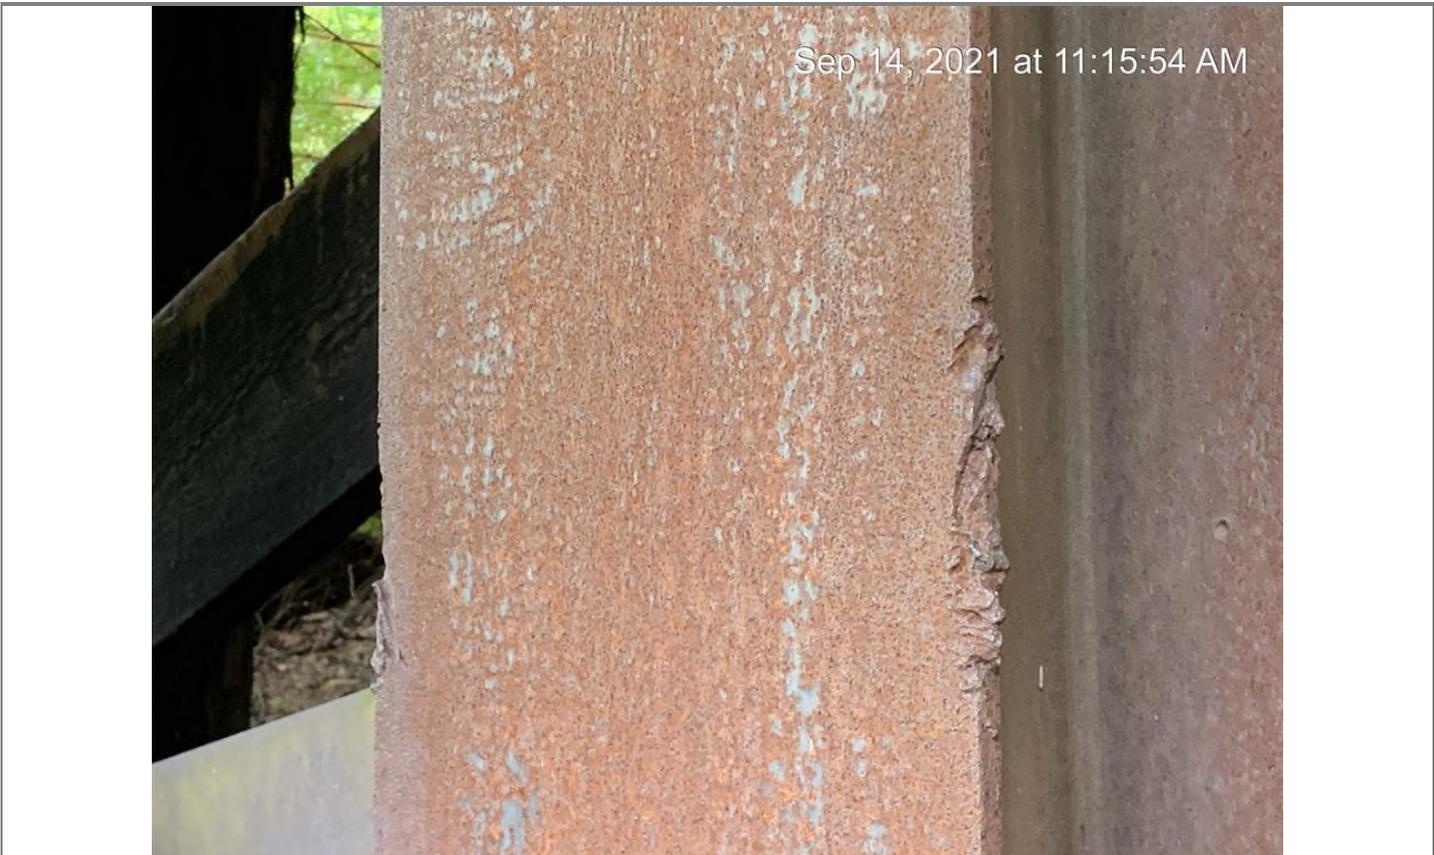
Number	P-158100425-14/09/21-677-YR	Date (AAAA-MM-JJ)	14/09/2021
Location	101.8 Chapais bent under span 5		
Remark	Old weld needs grinding

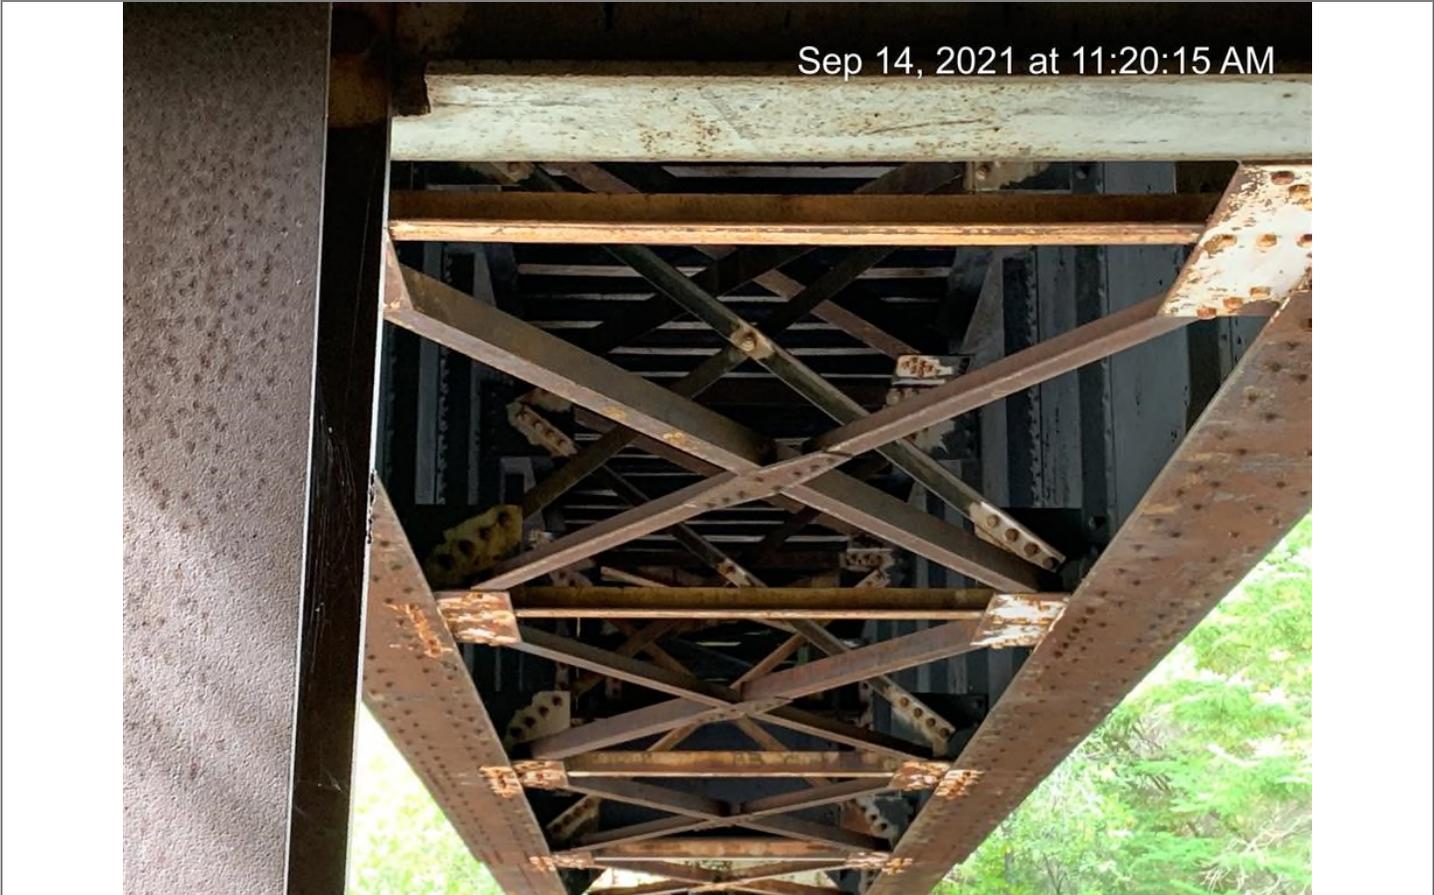
Number	P-158100425-14/09/21-680-YR	Date (AAAA-MM-JJ)	14/09/2021
Location	101.8 Chapais span 4		
Remark	Steel on DPG in good condition.

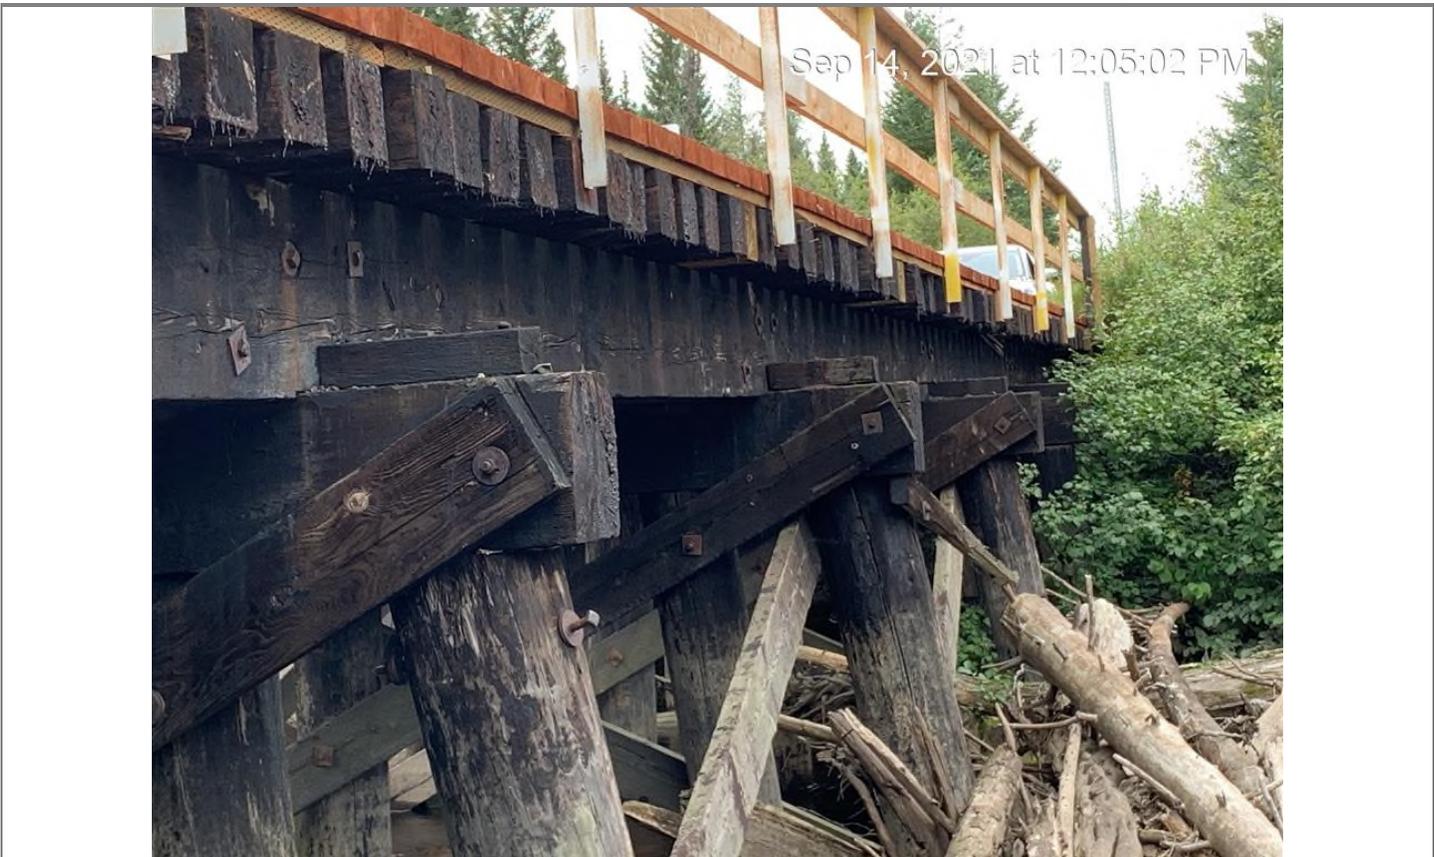
Most cap beams on this bridge are showing signs of crushing and most piles sound hollow when tapping with hammer. There are also many piles with cracks in them.

Number	P-158100425-14/09/21-687-YR	Date (AAAA-MM-JJ)	14/09/2021
Location	104.1 Chapais		
Remarks	West side looking South. Notice debris against the bridge. Caps are soft and starting to crush

Bridge to be replaced with 2 -100 feet TPG due to the limited clearance due to the existing bridge only 12 feet high.

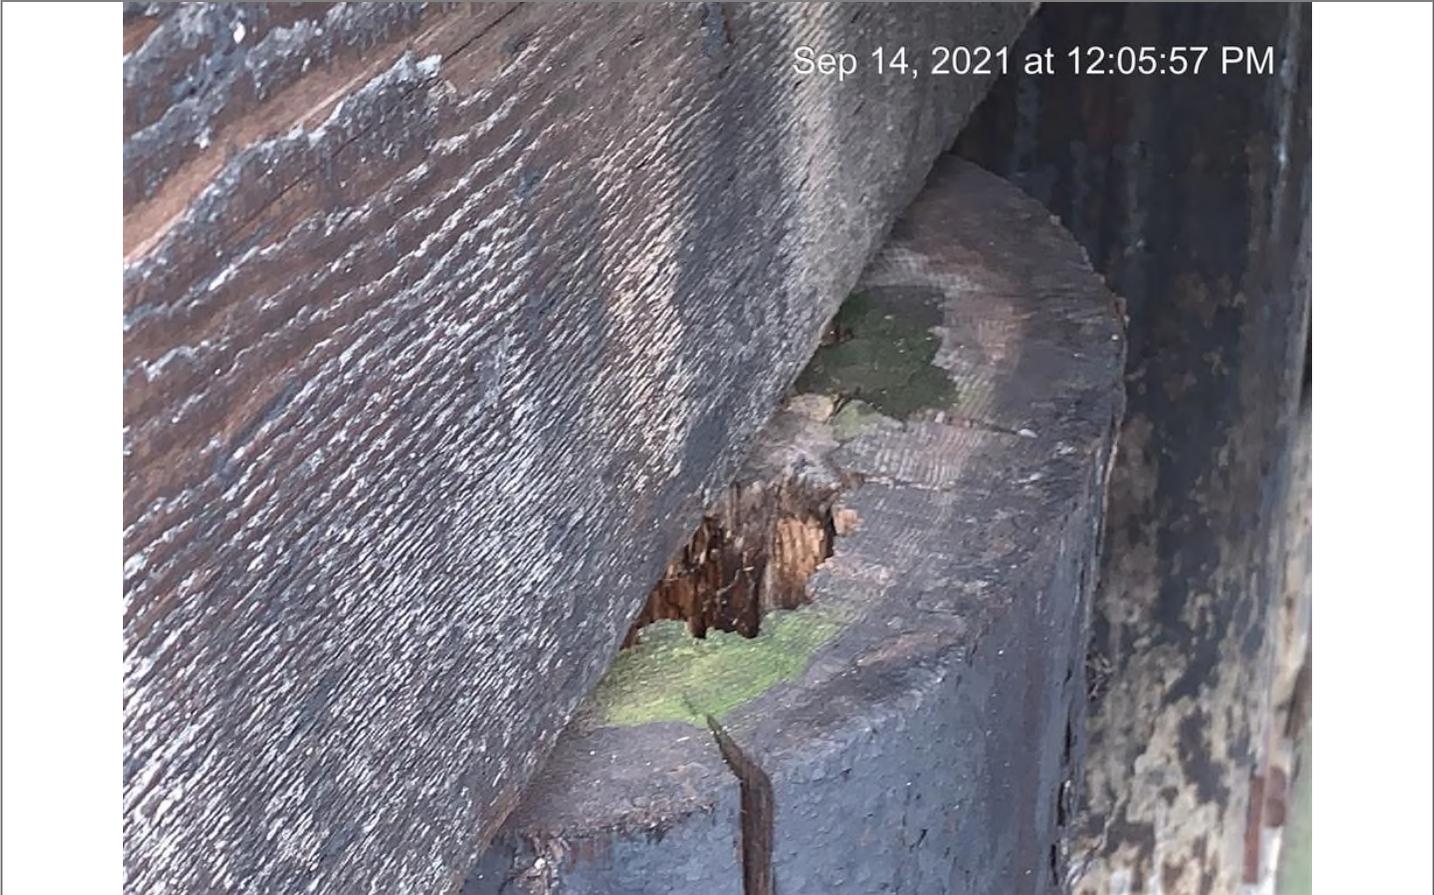
Number	P-158100425-14/09/21-690-YR	Date (AAAA-MM-JJ)	14/09/2021
Location	104.1 Chapais		
Remarks	Rotten piles underneath cap. Most piles sound hallow when tapping with hammer.

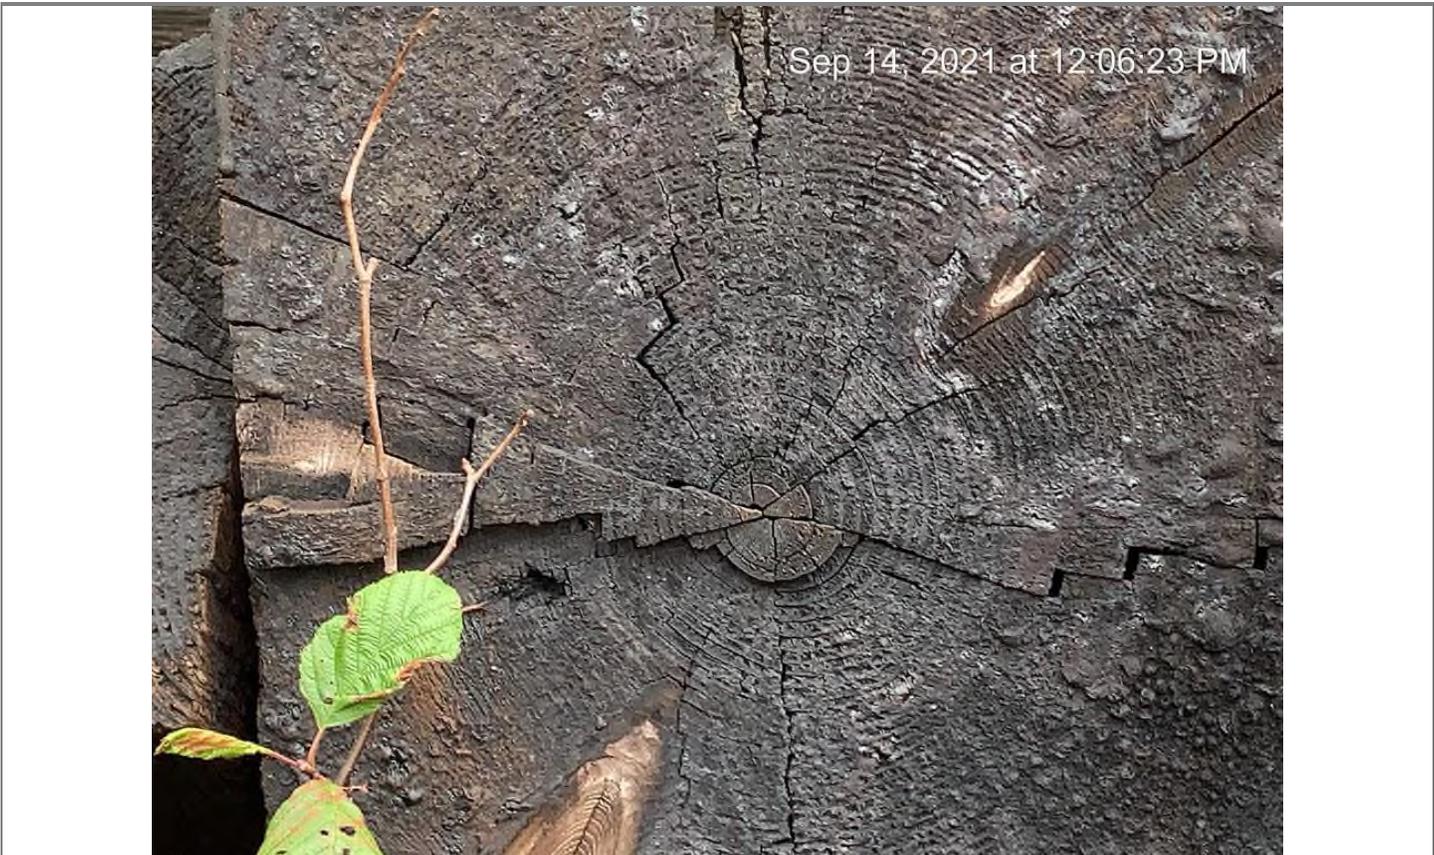
Number	P-158100425-14/09/21-692-YR	Date (AAAA-MM-JJ)	14/09/2021
Location	104.1 Chapais		
Remarks	Caps crushing on most bents.

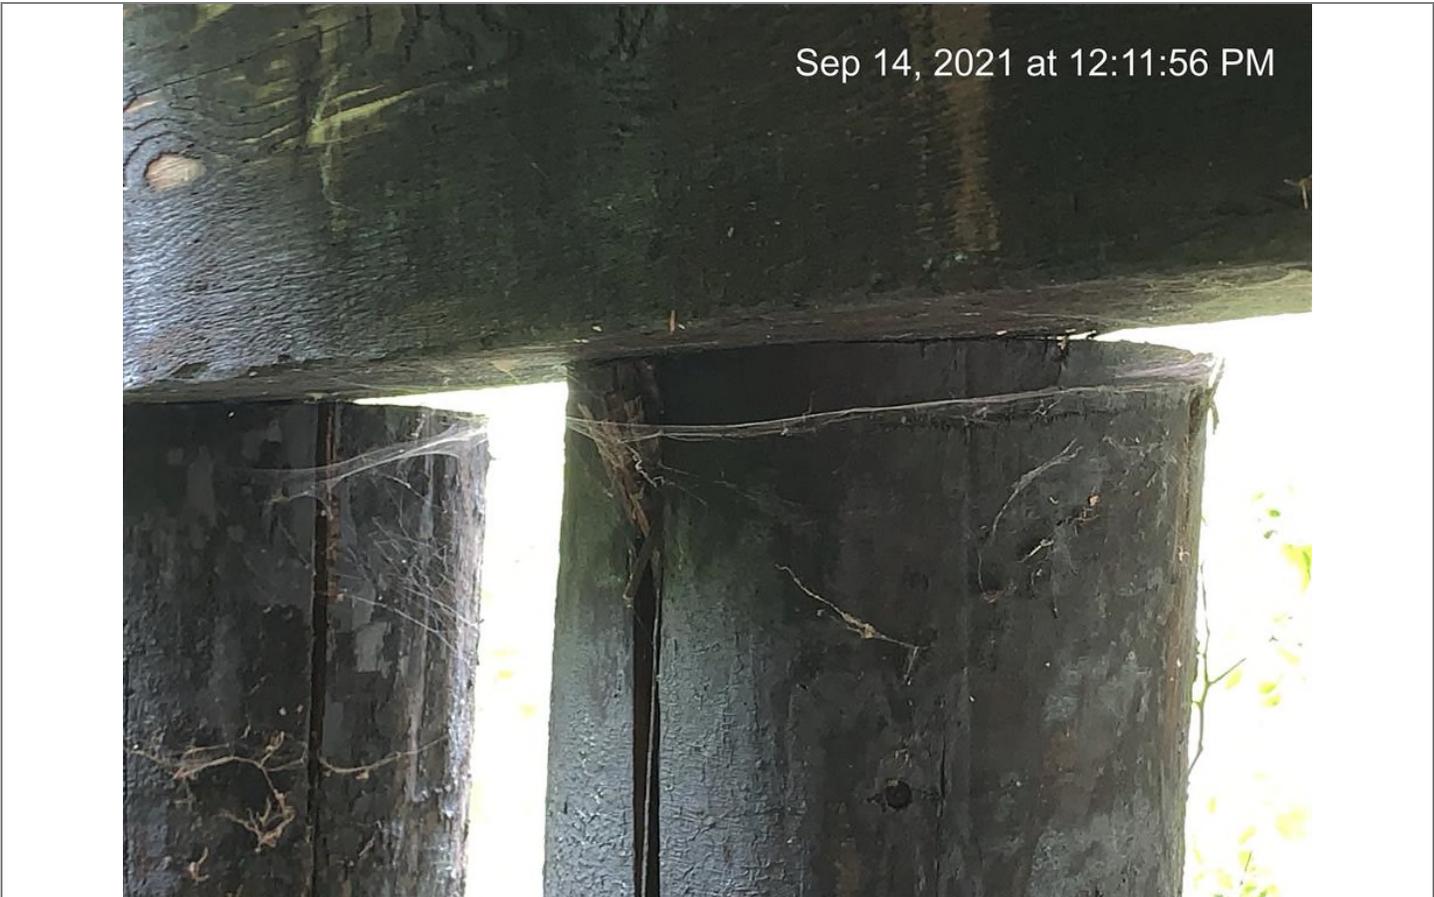
Number	P-158100425-14/09/21-695-YR	Date (AAAA-MM-JJ)	14/09/2021
Location	104.1 Chapais bent # 3		
Remarks	Note vertical cracks on most piles.

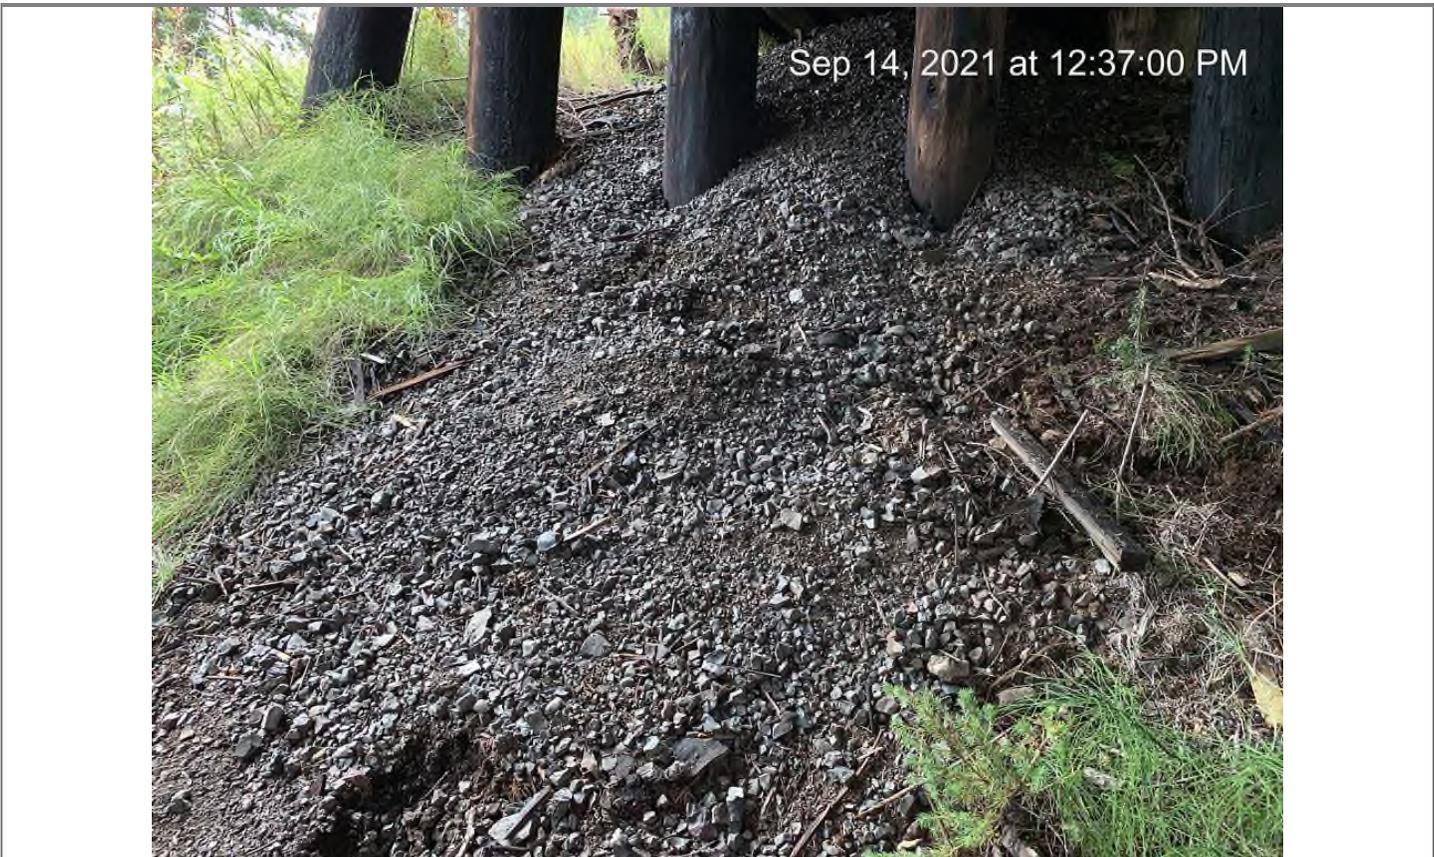
Sol instability underneath span # 2.

Number	P-158100425-14/09/21-698-YR	Date (AAAA-MM-JJ)	14/09/2021
Location	105.6 Chapais		
Remark	Sol instability underneath span # 2

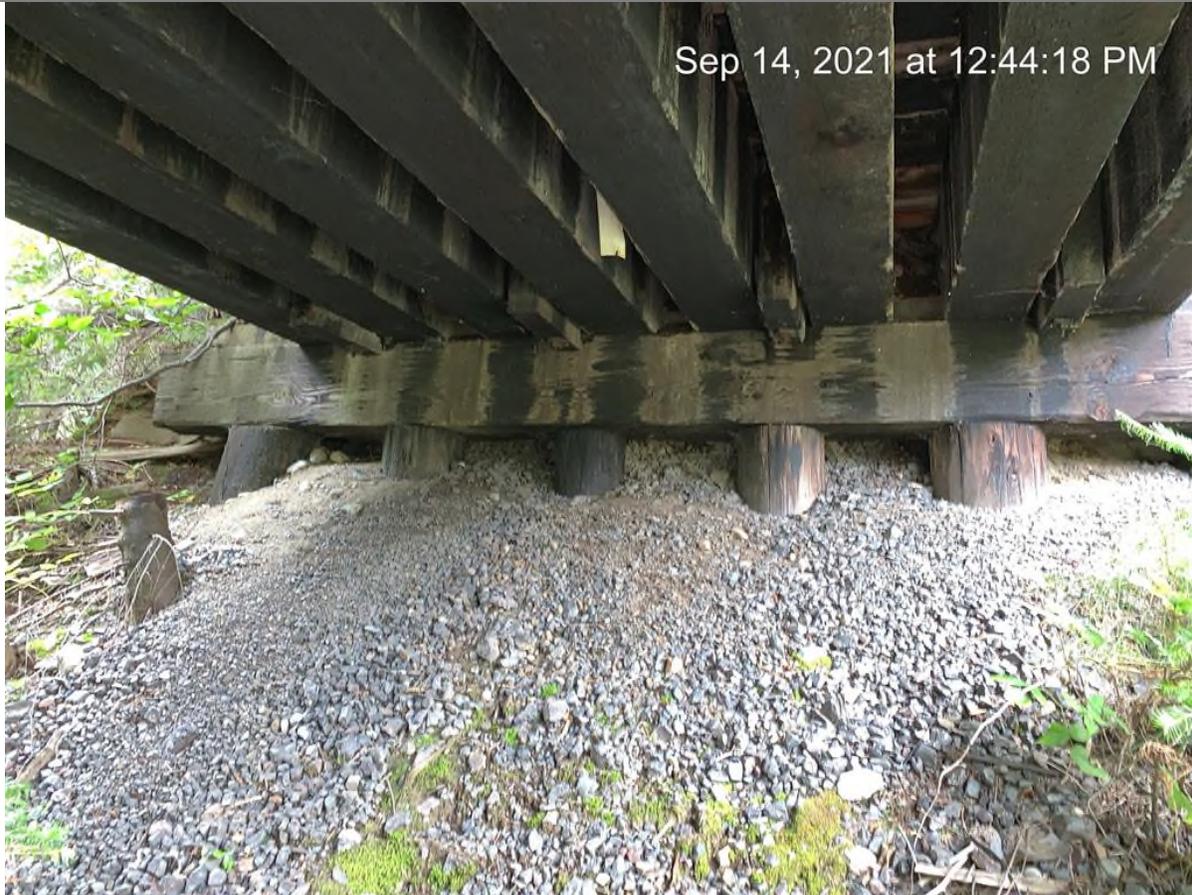
Number	P-158100425-14/09/21-705-YR	Date (AAAA-MM-JJ)	14/09/2021
Location	105.6 Chapais underneath North end		
Remark	Soil instability
