VOLUME 6 - APPENDIX SECTION 6.9 – GREVET-CHAPAIS RAILWAY BRIDGE INSPECTION

Consultant Reference: LGA-1-GN-F-FRN-RT-0006_00_Appendix6.9
2023-04-14

91.0 Chapais O'Sullivan River
LAT. N 49.24208 Long. W 76.27592
Type 3 DPG (Length 186 feet height 22 feet)

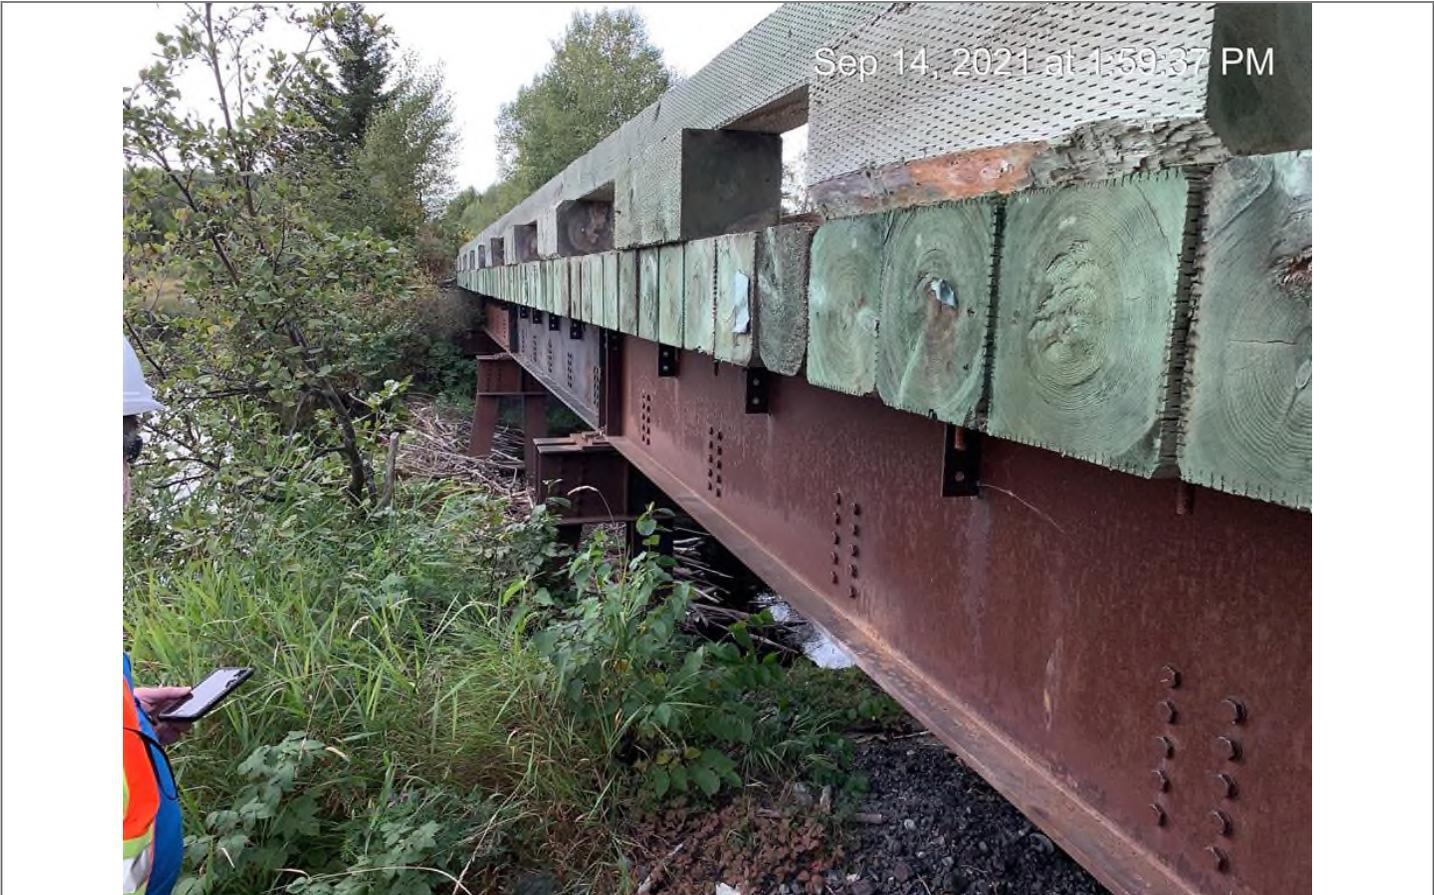
Number	P-158100425-14/09/21-708-YR	Date (AAAA-MM-JJ)	14/09/2021
Location	118.8 Chapais		
Remark	East side looking South. Note – beaver dam to be removed.

Beaver dam should be removed ASAP

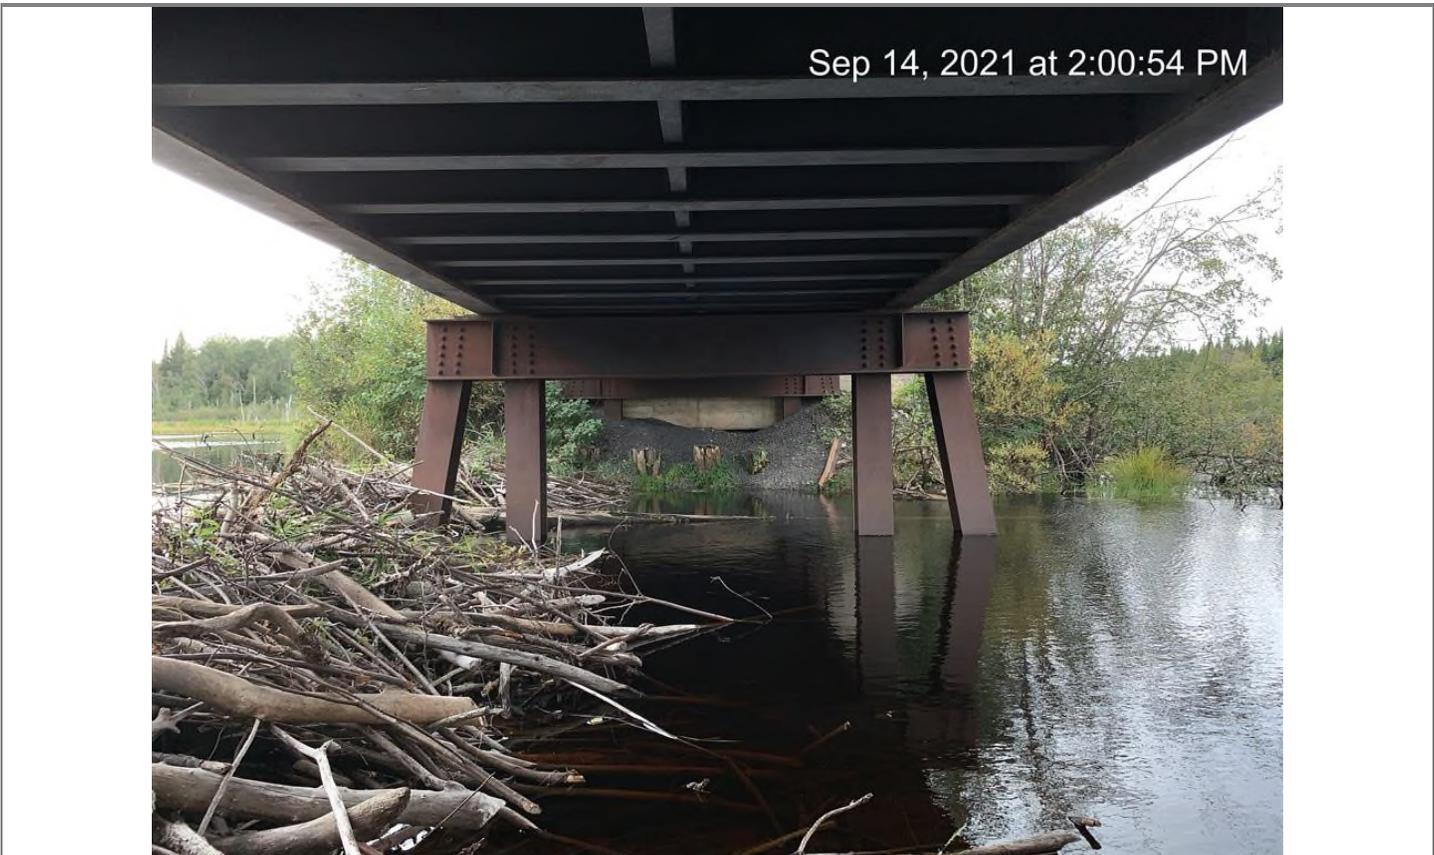
Back walls both ends leaking ballast. Replace with deeper backwalls and install wingwalls on all four corners.

Number	P-158100425-14/09/21-710-YR	Date (AAAA-MM-JJ)	14/09/2021
Location	118.8 Chapais		
Remark	Looking South. Major beaver dam to be removed Note- ballast leaking underneath backwall

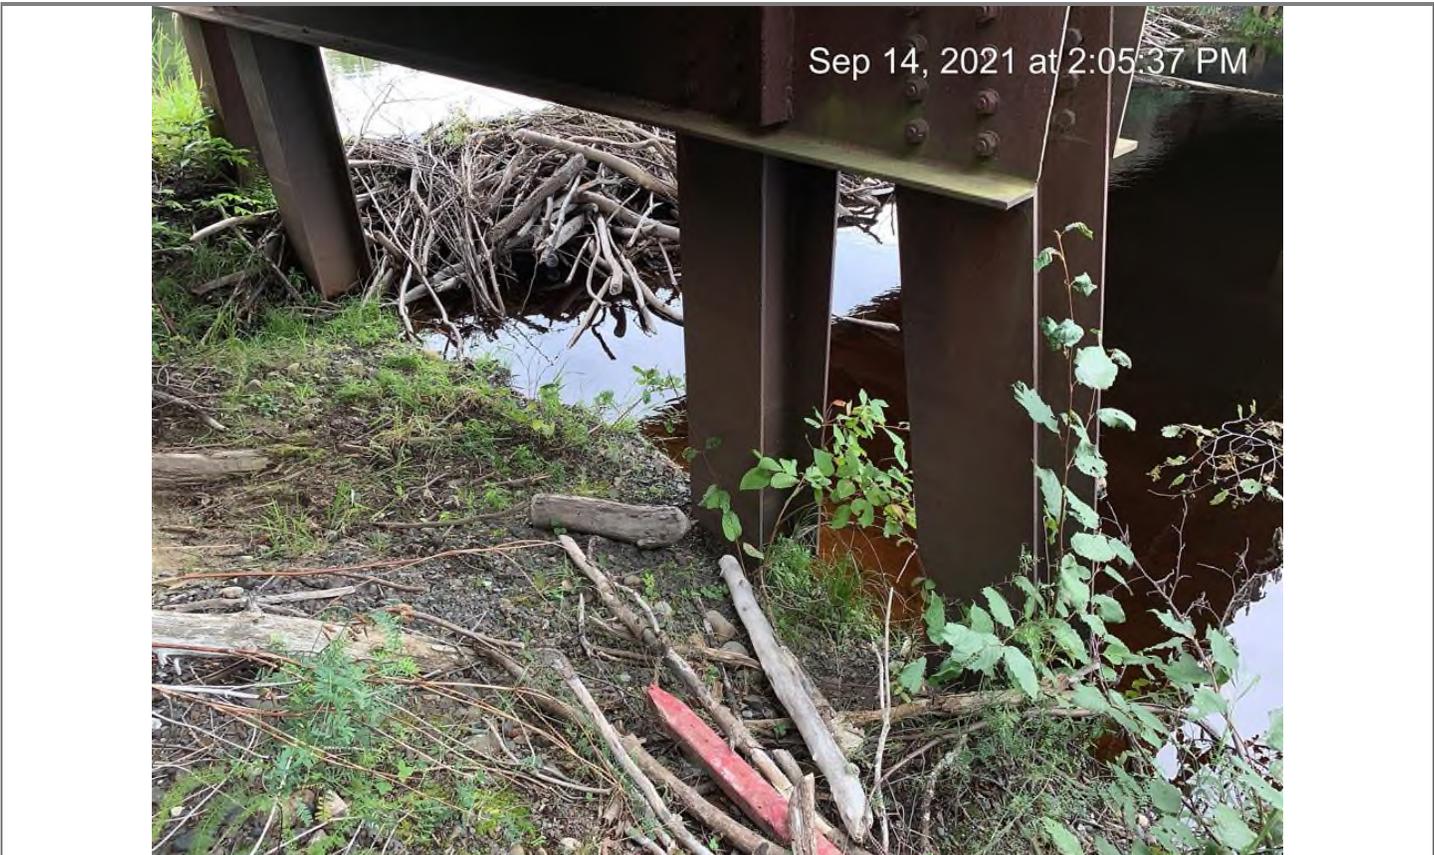
Number	P-158100425-14/09/21-715-YR	Date (AAAA-MM-JJ)	14/09/2021
Location	118.8 Chapais		
Remark	Bent # 2 show signs of corrosion at water line.

Piles should be evaluated at the waterline due to some signs of corrosion with the possibility of encasing in concrete.

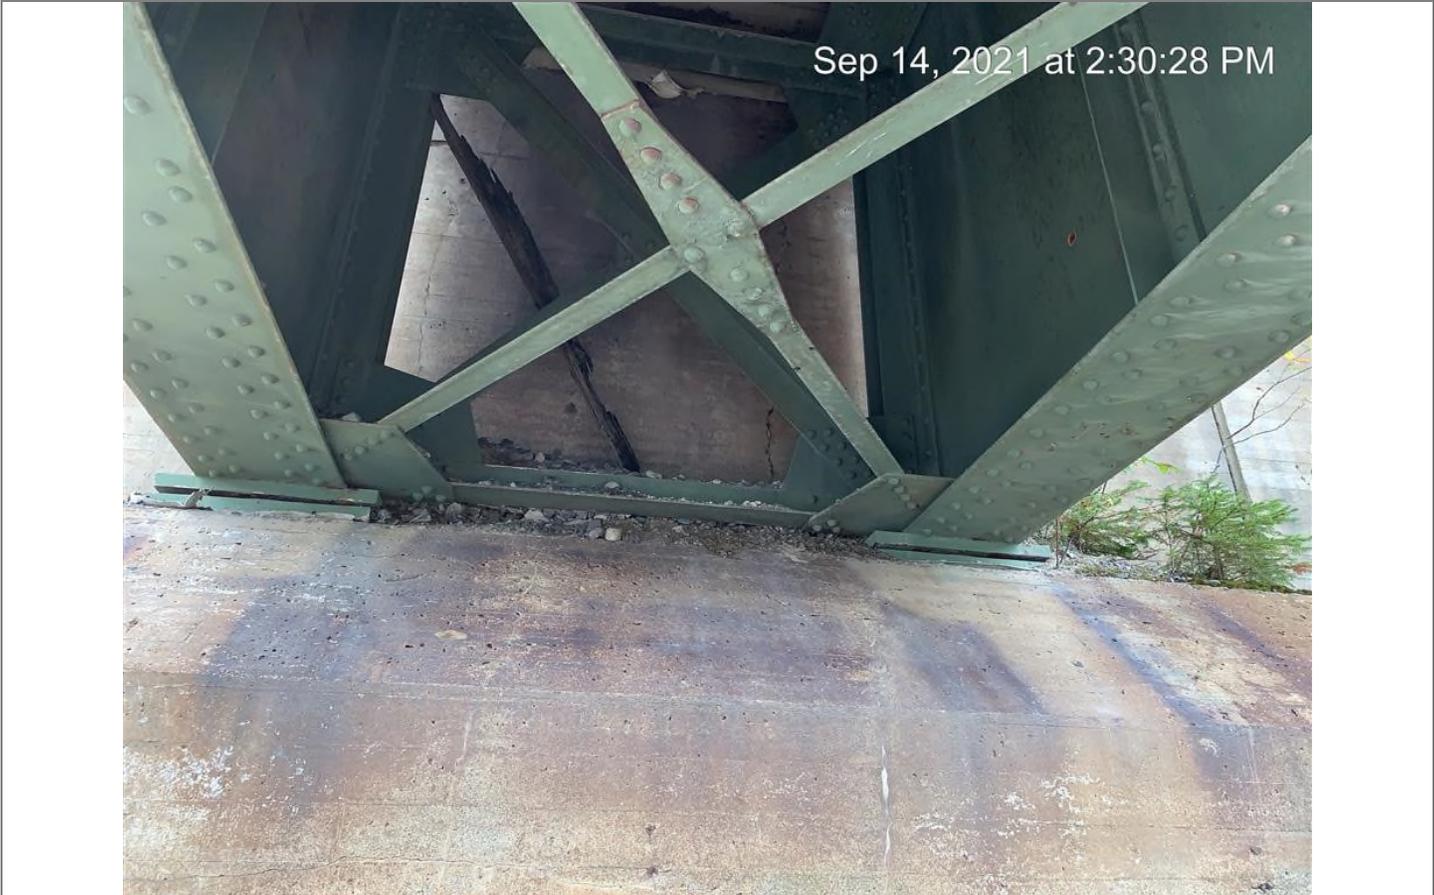
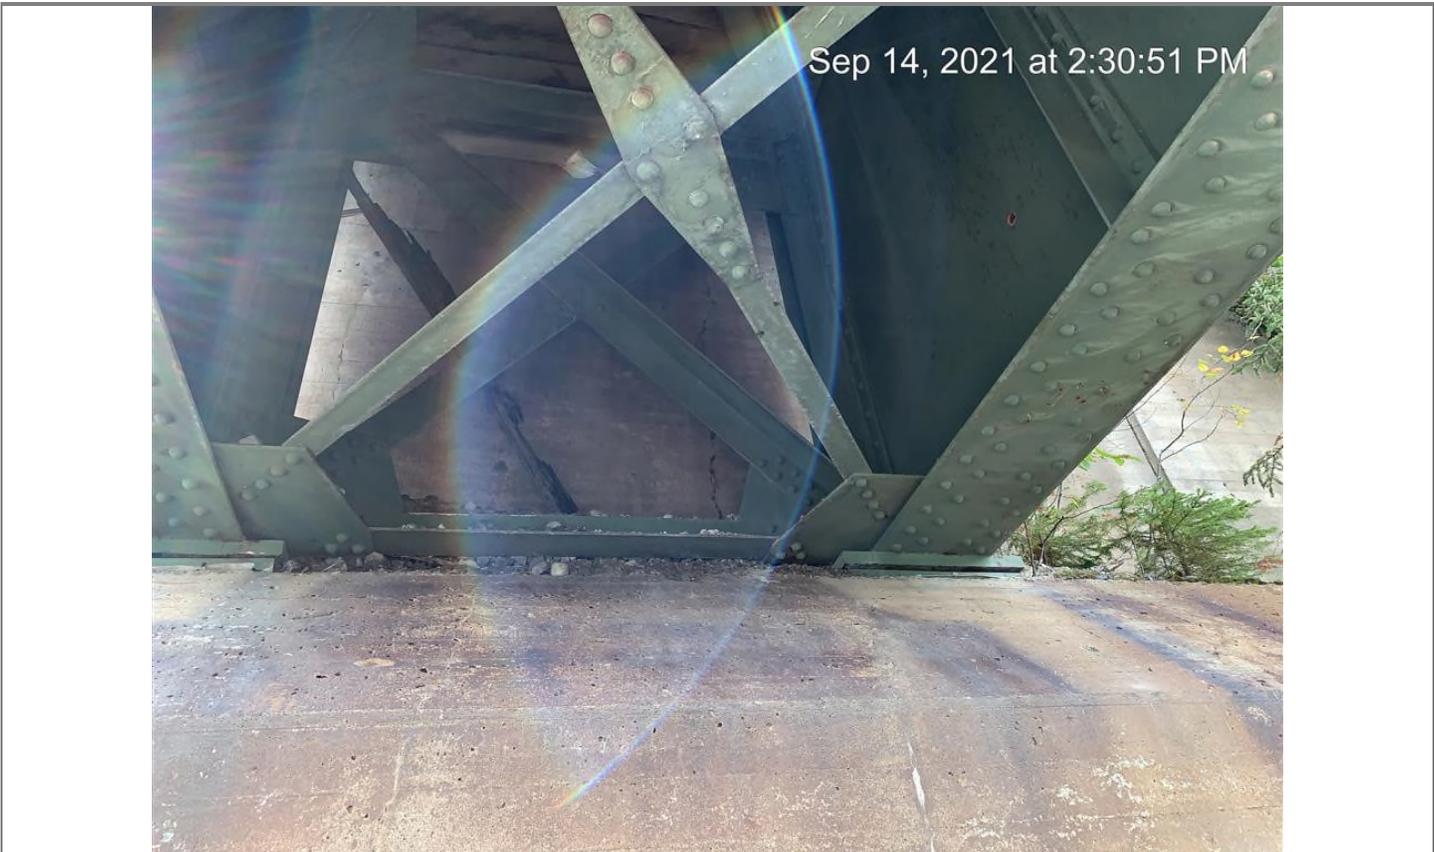
Number	P-158100425-14/09/21-723-YR	Date (AAAA-MM-JJ)	14/09/2021
Location	122.8 Chapais South abutment		
Remark	Backwall cracked on right side of backwall

Number	P-158100425-14/09/21-726-YR	Date (AAAA-MM-JJ)	14/09/2021
Location	122.8 Chapais South abutment		
Remark	Backwall cracked on right side of backwall

Backwall crack at the center on the East abutment. Possibility to repair with epoxy injection.

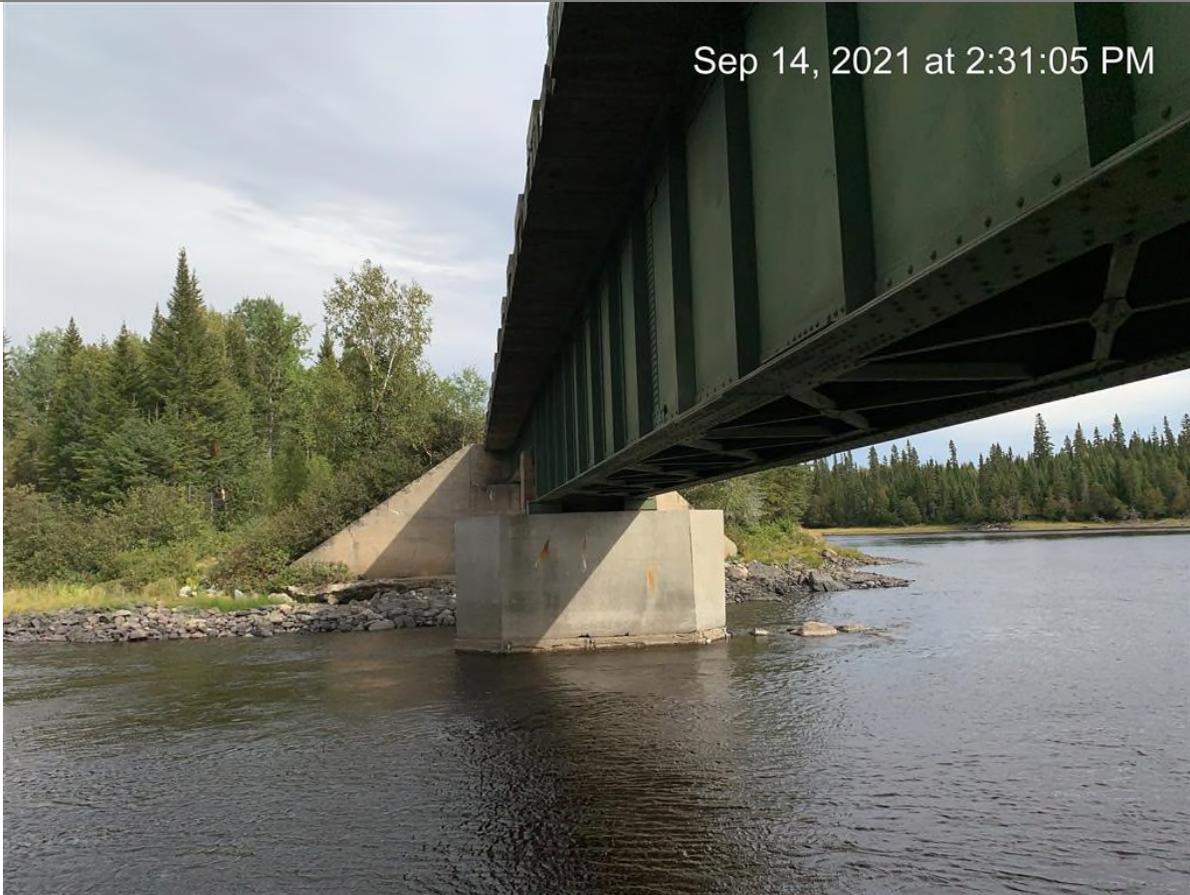
Number	P-158100425-14/09/21-727-YR	Date (AAAA-MM-JJ)	14/09/2021
Location	122.3 Chapais looking Northwest side		
Remark	Note- bottom of pier is eroding. Water flow impacts directly at the nose of pier. Envelop and rip rap required to protect from scour.

Hydraulic study to determine if pier requires more protection and possibly an extra concrete envelop at the base.

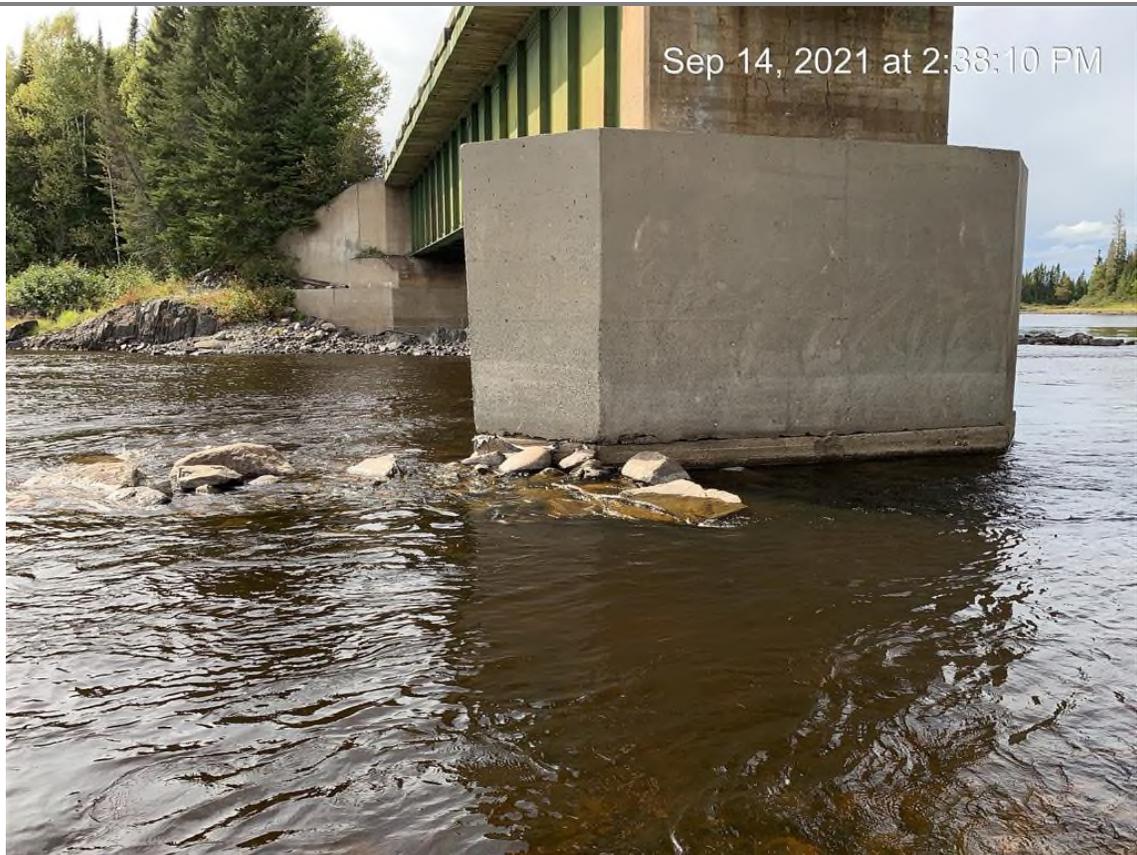
Number	P-158100425-14/09/21-734-YR	Date (AAAA-MM-JJ)	14/09/2021
Location	122.3 Chapais looking Southeast side		
Remark	Water flow hitting directly on nose of pier.

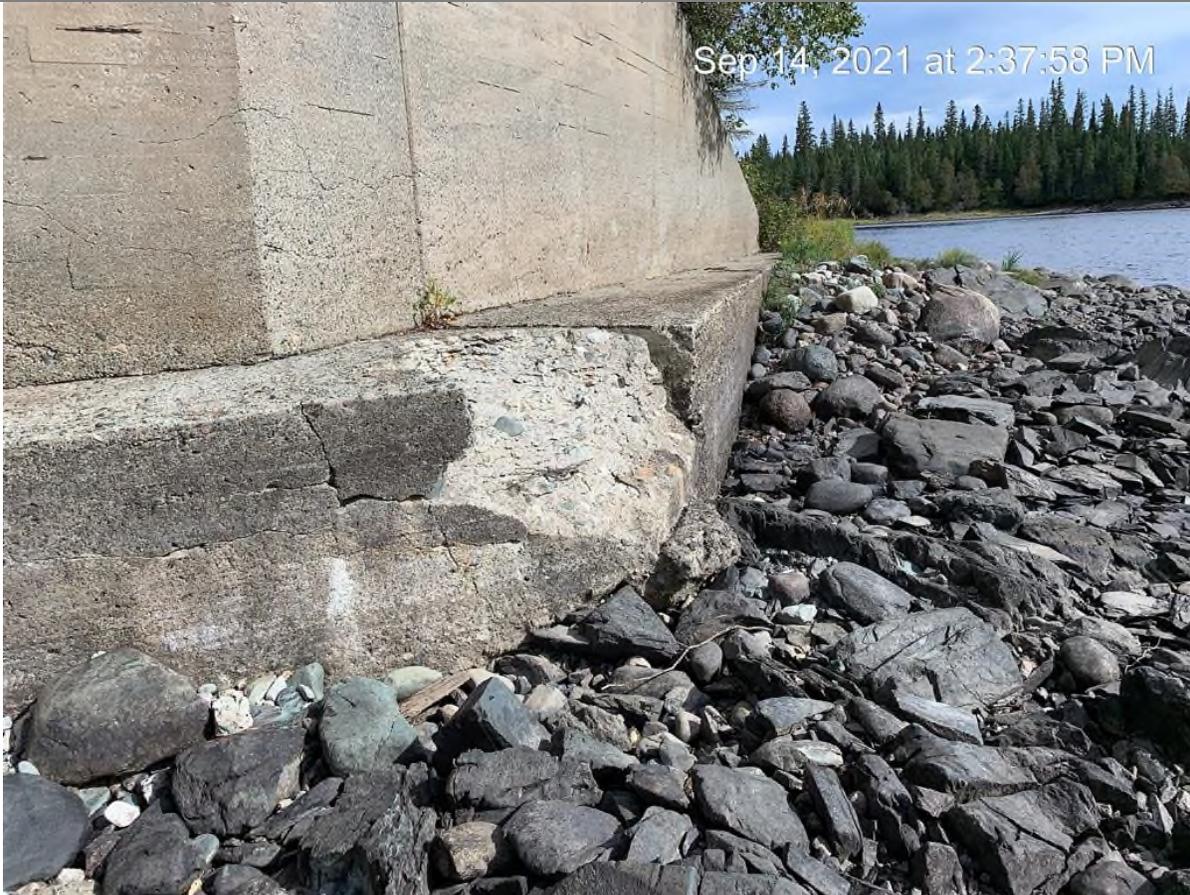
Number	P-158100425-14/09/21-733-YR	Date (AAAA-MM-JJ)	14/09/2021
Location	122.3 North abutment		
Remark	Base of abutment concrete broken off.

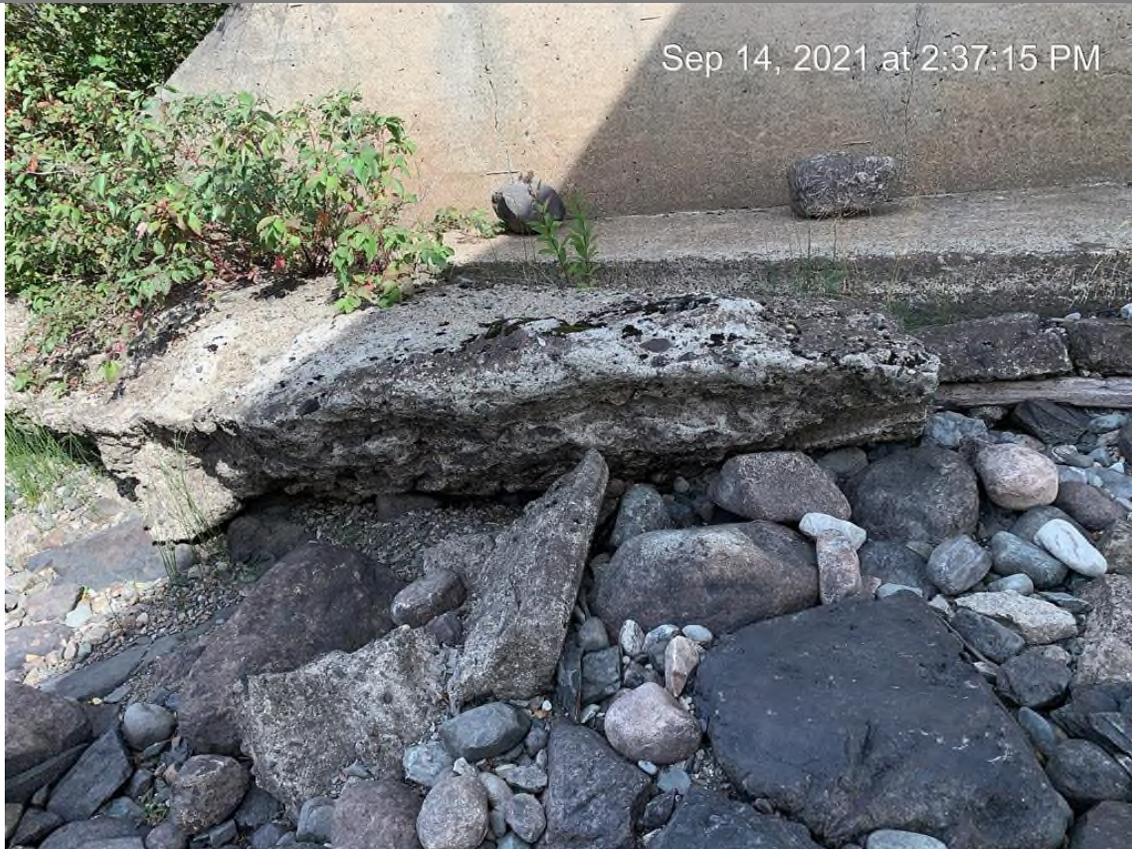
Signs of scouring at both abutments.

Number	P-158100425-14/09/21-730-YR	Date (AAAA-MM-JJ)	14/09/2021
Location	122.3 Chapais North abutment		
Remark	Signs of under scouring

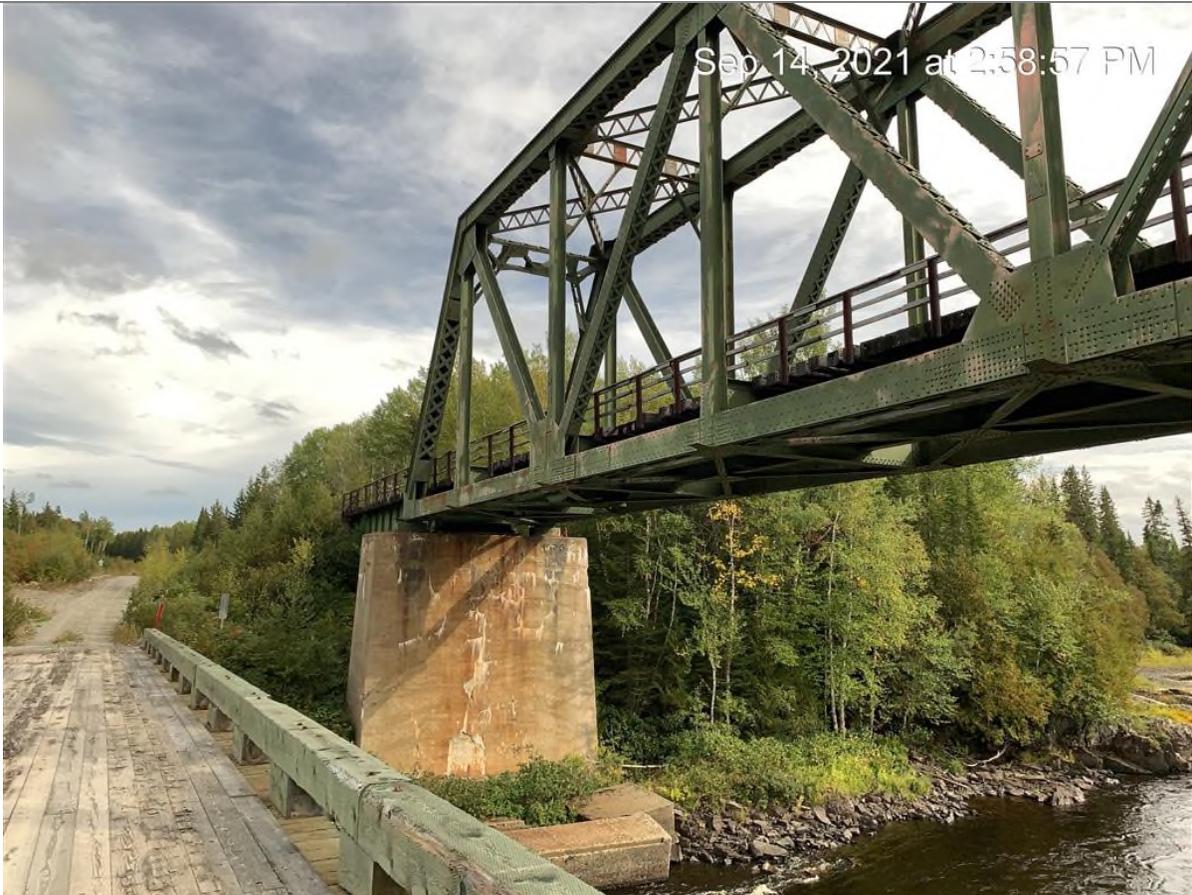
Piers # 2 concrete scaling on surface. To be repaired and waterproofing applied.

Number	P-158100425-14/09/21-739-YR	Date (AAAA-MM-JJ)	14/09/2021
Location	125.3 Chapais Pier # 2		
Remark	Concrete spalling. Repair and waterproof

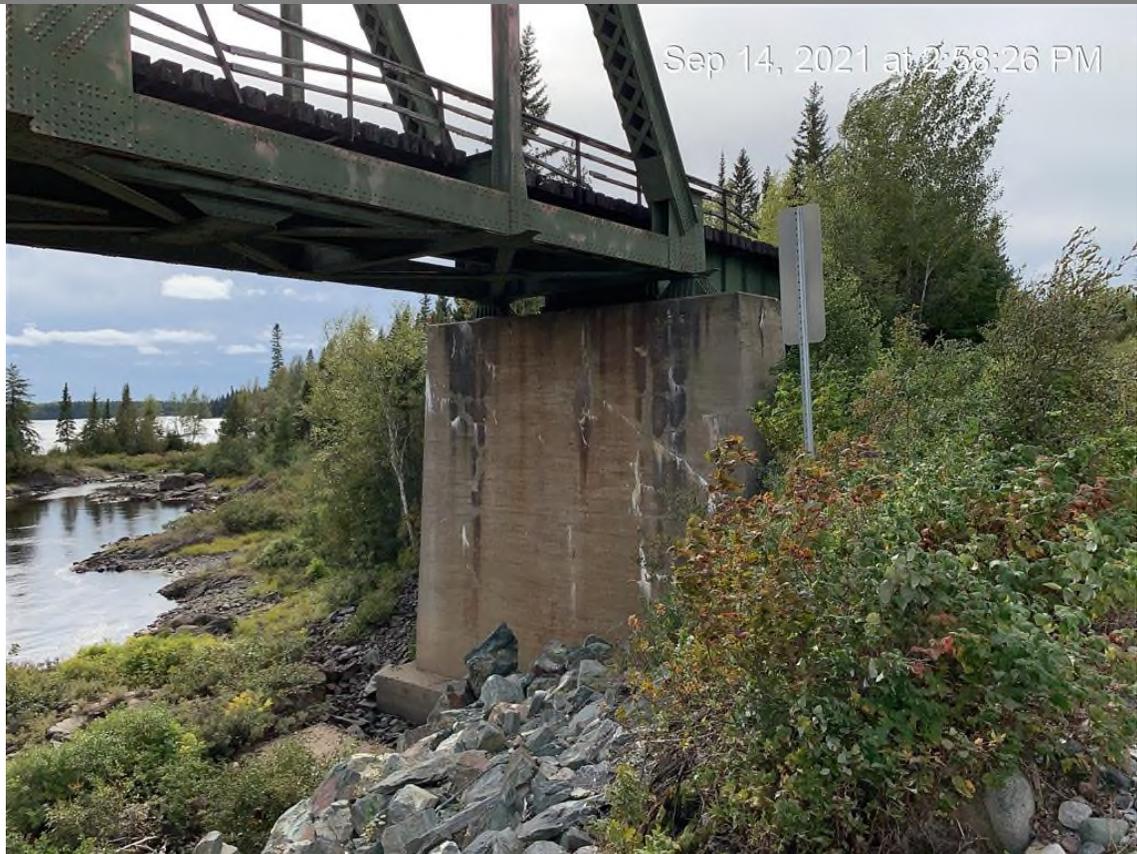
Number	P-158100425-14/09/21-736-YR	Date (AAAA-MM-JJ)	14/09/2021
Location	125.3 Chapais pier # 1		
Remark	Clean and waterproof

Pier # 1 requires cleaning and waterproofing.

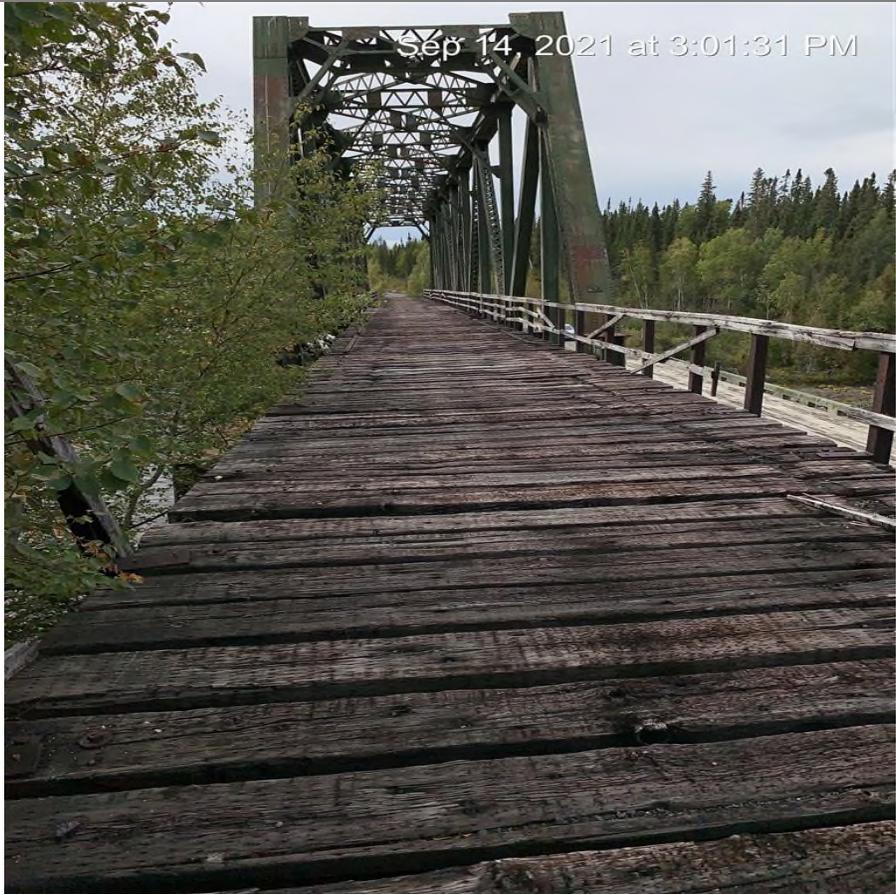
Bridge deck in very poor condition. Existing ties on DPG spans are 12" x 12" x13' and on Truss span 12" x 10" x 13'. Walkway and refuge bays required on both sides.

Number	P-158100425-14/09/21-741-YR	Date (AAAA-MM-JJ)	14/09/2021
Location	125.3 deck looking South		
Remark	Deck and handrailing in very poor condition

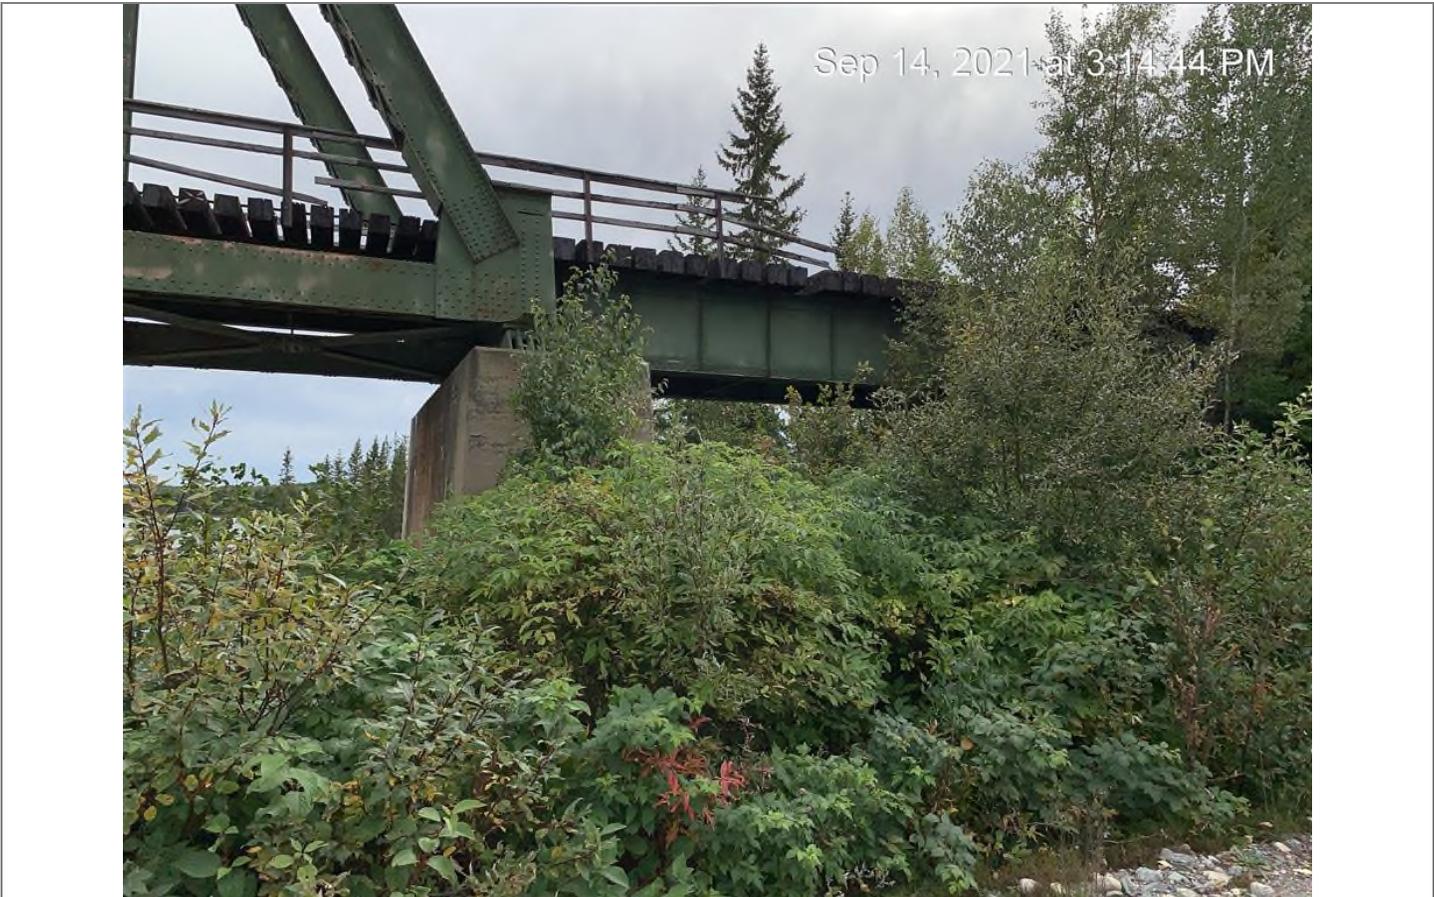
Number	P-158100425-14/09/21-747-YR	Date (AAAA-MM-JJ)	14/09/2021
Location	125.3 Looking East		
Remark	Needs cleaning and brush cutting

The whole bridge needs to be cleaned and brush cutting to be done.

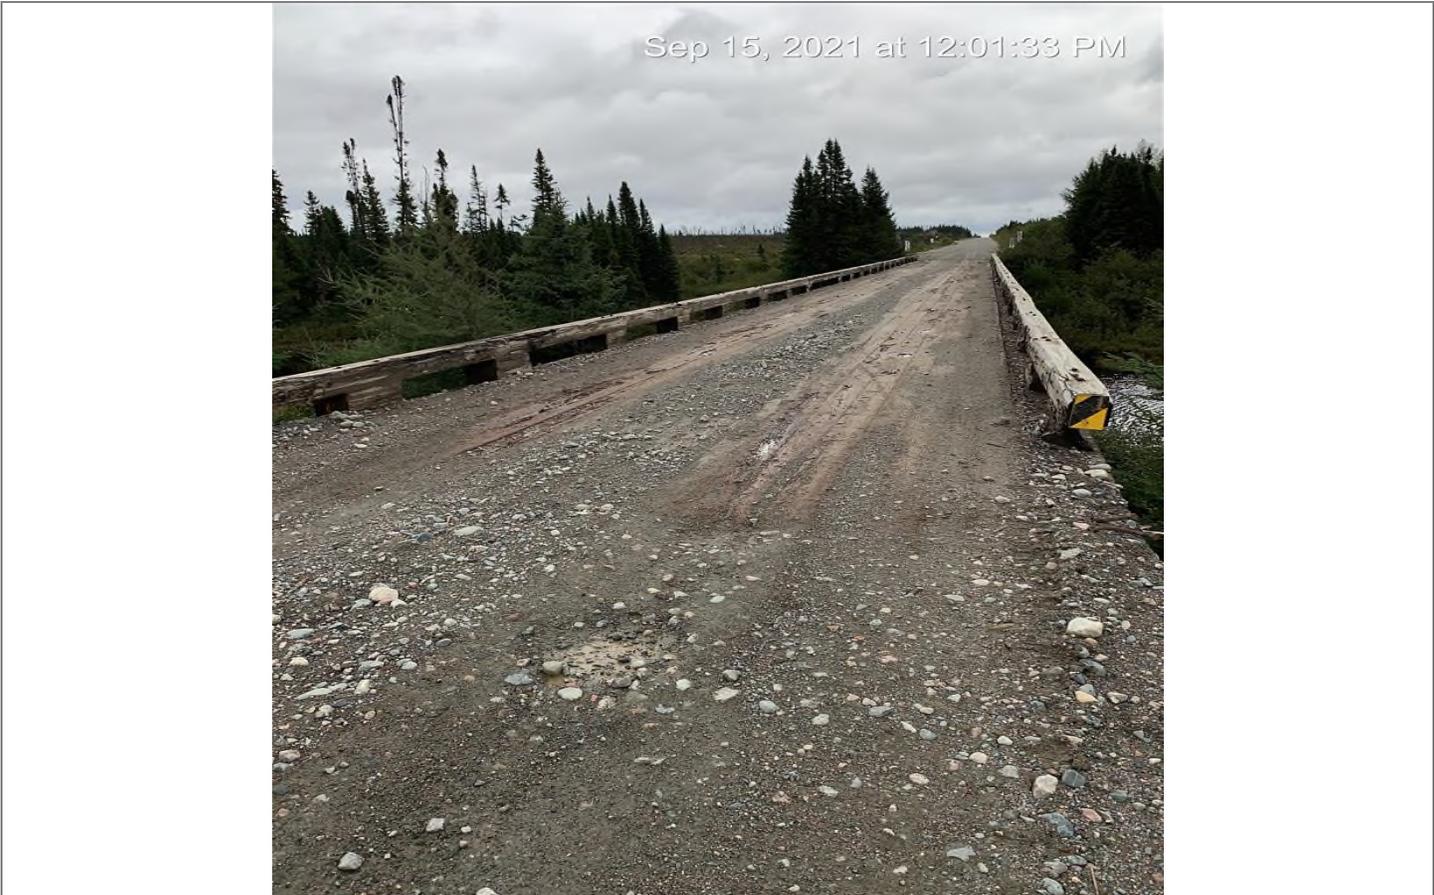
Number	P-158100425-15/09/21-772-YR	Date (AAAA-MM-JJ)	15/09/2021
Location	141.7 Chapais looking North		
Remark	Section of curb missing right side

Railing on deck of this bridge is missing sections and in poor condition. Should be repaired ASAP for traffic safety.

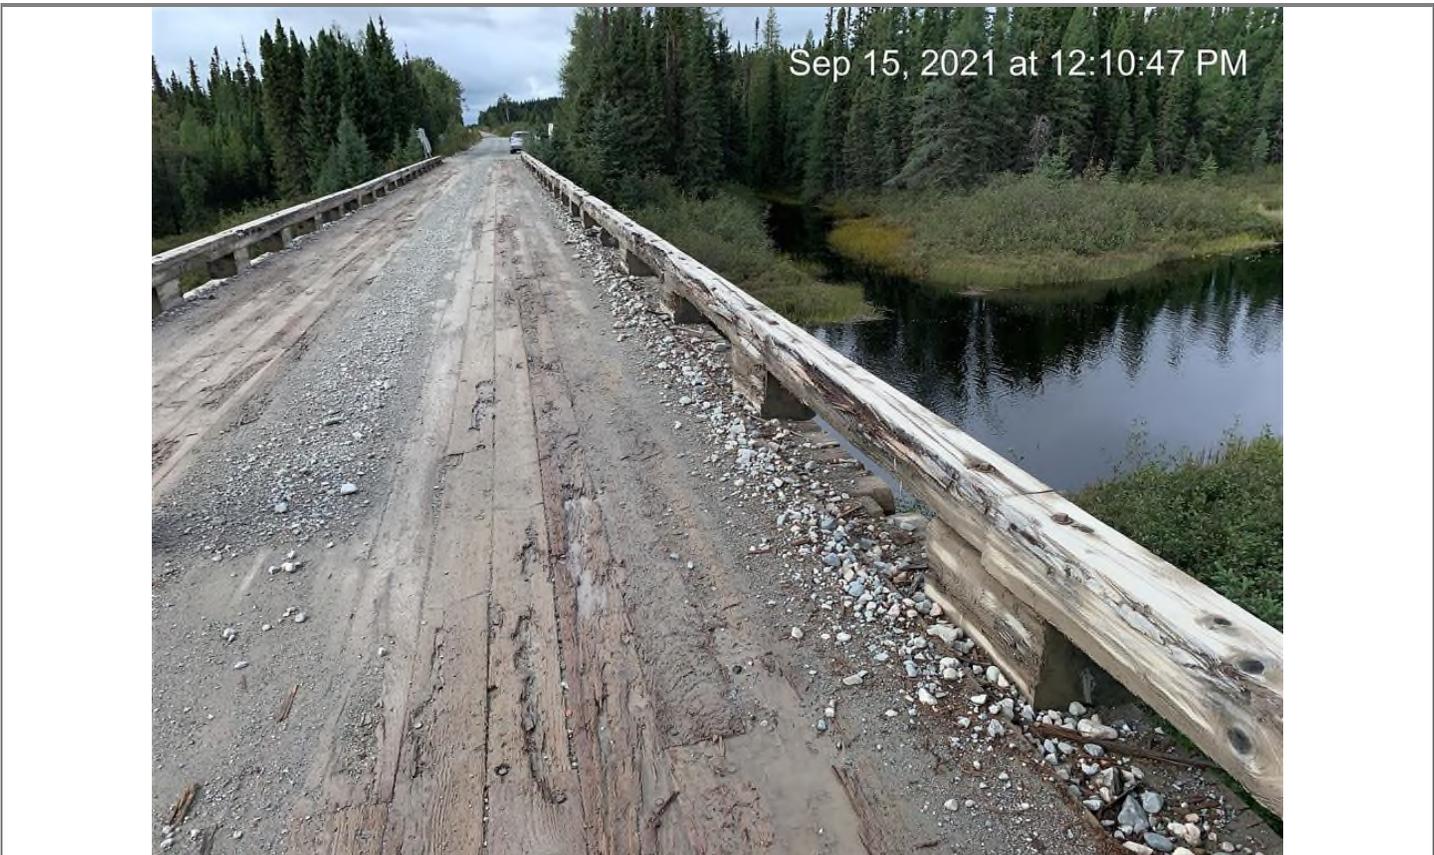
Number	P-158100425-15/09/21-789-YR	Date (AAAA-MM-JJ)	15/09/2021
Location	141.7 Chapais looking south		
Remark	Curb is soft and show signs of rot.

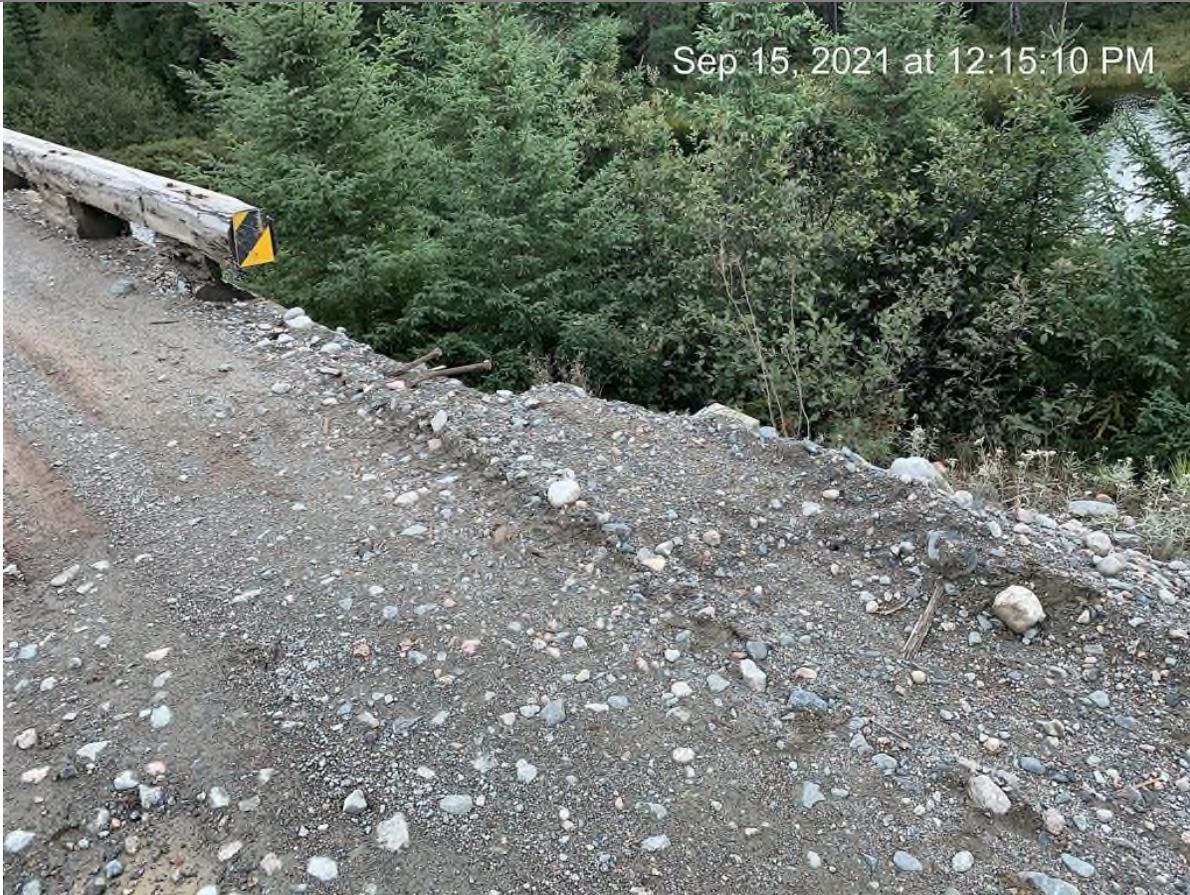
Number	P-158100425-15/09/21-801-YR	Date (AAAA-MM-JJ)	15/09/2021
Location	141.7 Chapais South end right side		
Remark	Missing curb section.

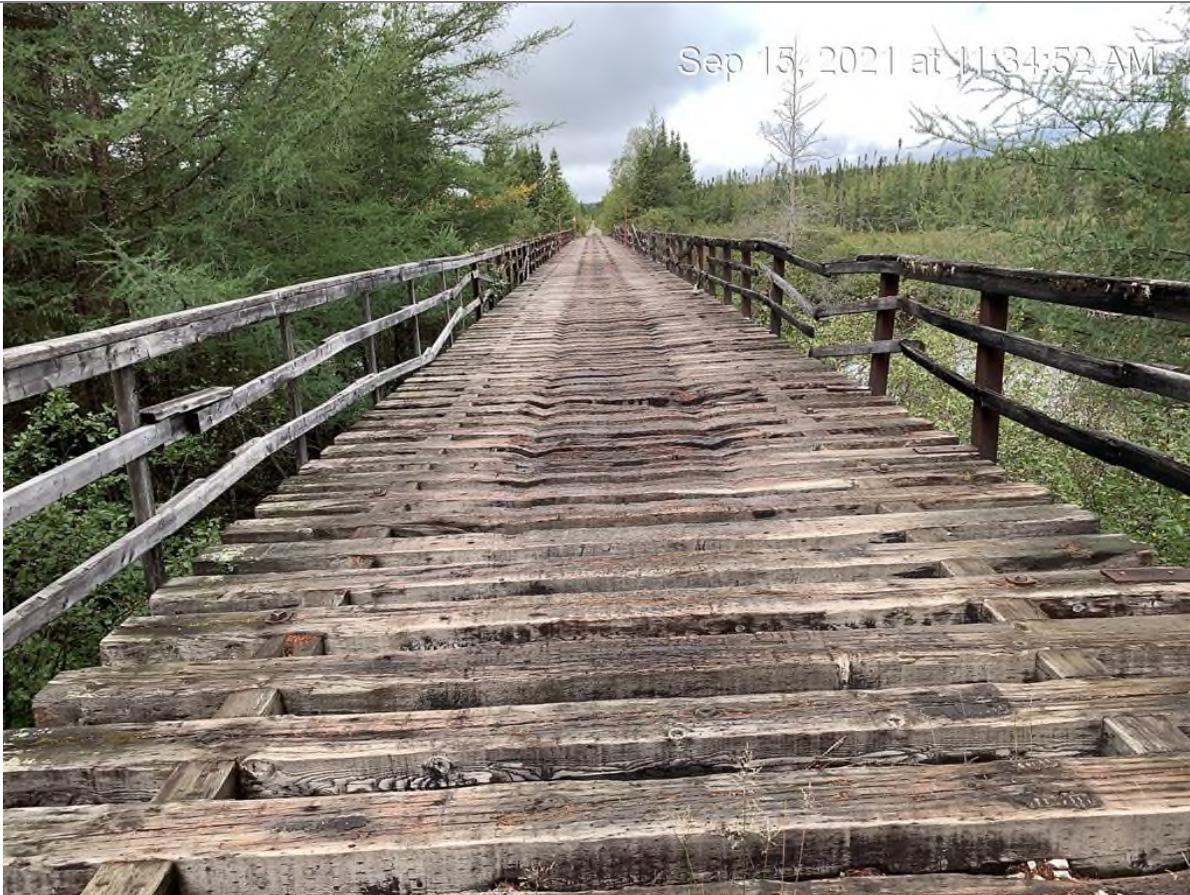
Number	P-158100425-15/09/21-769-YR	Date (AAAA-MM-JJ)	15/09/2021
Location	156.0 Chapais – deck looking south		
Remark	Ties and handrailing in bad condition. Barrier should be installed both ends for public safety.

Safety barriers should be installed each end of the bridge ASAP for public safety

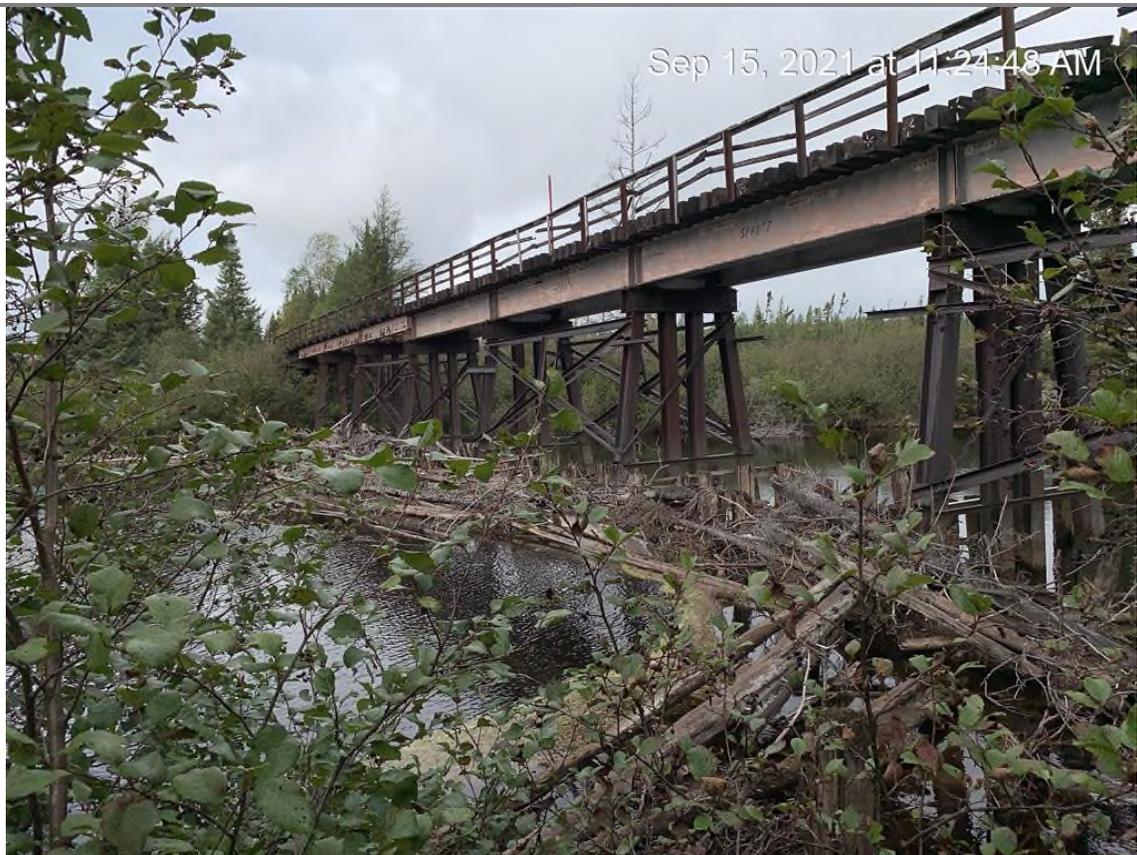
Number	P-158100425-14/09/21-760-YR	Date (AAAA-MM-JJ)	15/09/2021
Location	156.0 Chapais Est side looking south		
Remark	Accumulation of debris against steel bents

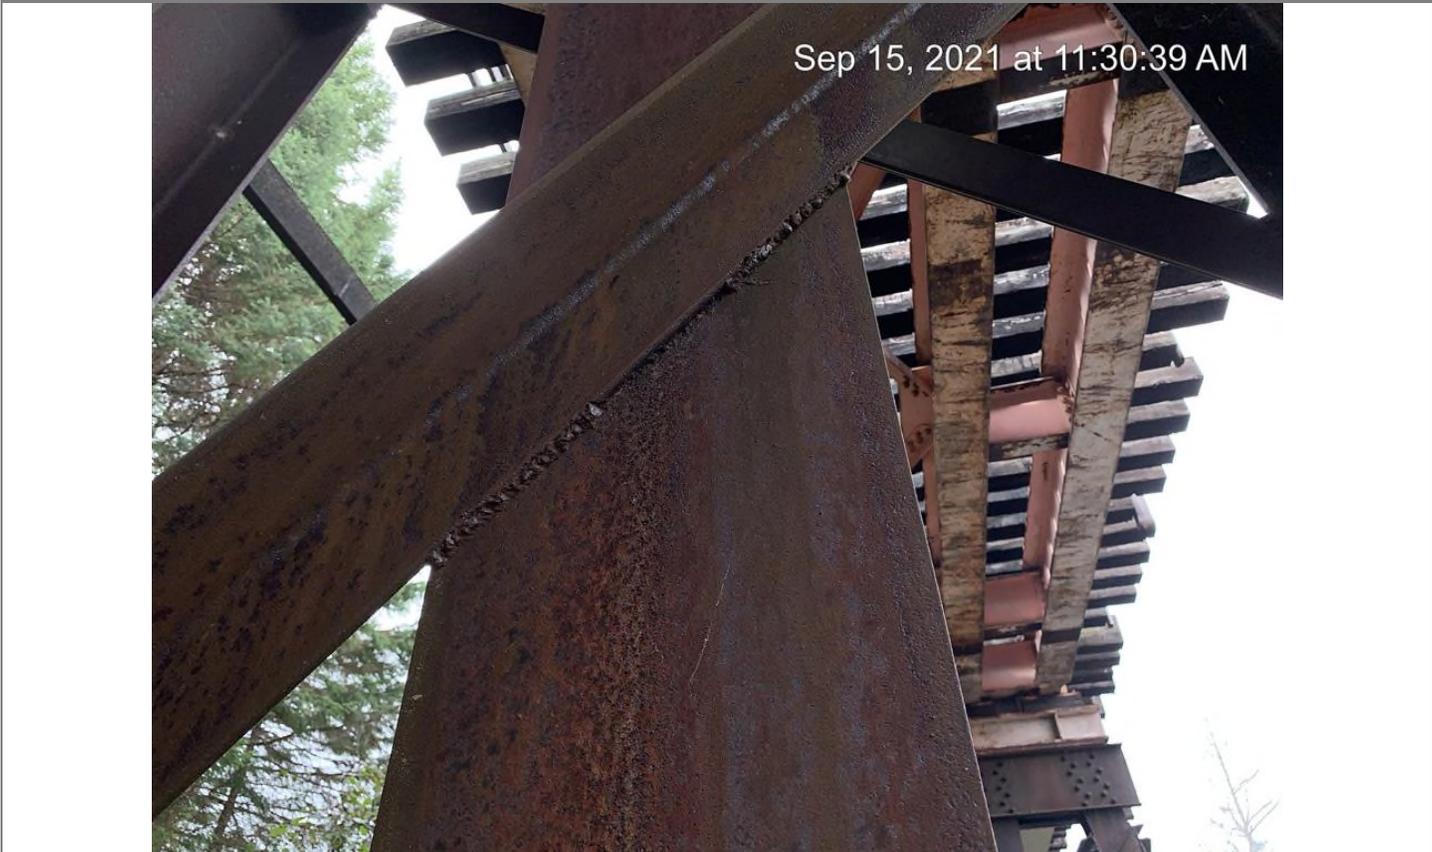
Bridge to be demolish due to lack of capacity and general overall poor condition.
Most welds all over the entire bridge are deficient and are very poor-quality.
Bridge deck and railing in very poor condition. Not even safe to walk across.

Number	P-158100425-15/09/21-765-YR	Date (AAAA-MM-JJ)	15/09/2021
Location	156.0 Chapais		
Remark	Poor weld quality
