VOLUME 6 - APPENDIX SECTION 6.9 – GREVET-CHAPAIS RAILWAY BRIDGE INSPECTION

Consultant Reference: LGA-1-GN-F-FRN-RT-0006_00_Appendix6.9
2023-04-14

91.0 Chapais O'Sullivan River
LAT. N 49.24208 Long. W 76.27592
Type 3 DPG (Length 186 feet height 22 feet)

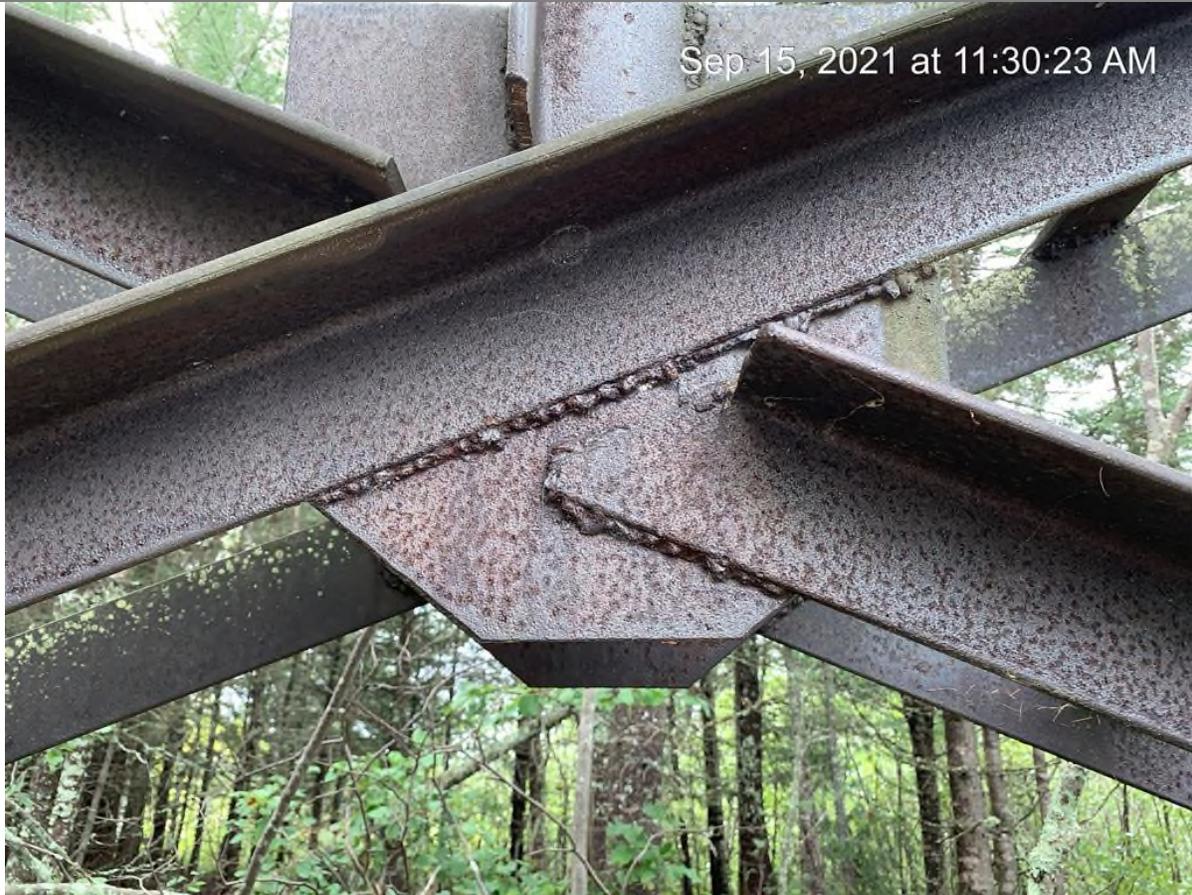
Bridge to be demolish due to lack of capacity and general overall poor condition.
Most welds all over the entire bridge are deficient and are very poor-quality.
Bridge deck and railing in very poor condition. Not even safe to walk across.

Number	P-158100425-15/09/21-764-YR	Date (AAAA-MM-JJ)	15/09/2021
Location	156.0 Chapais		
Remark	Poor weld quality

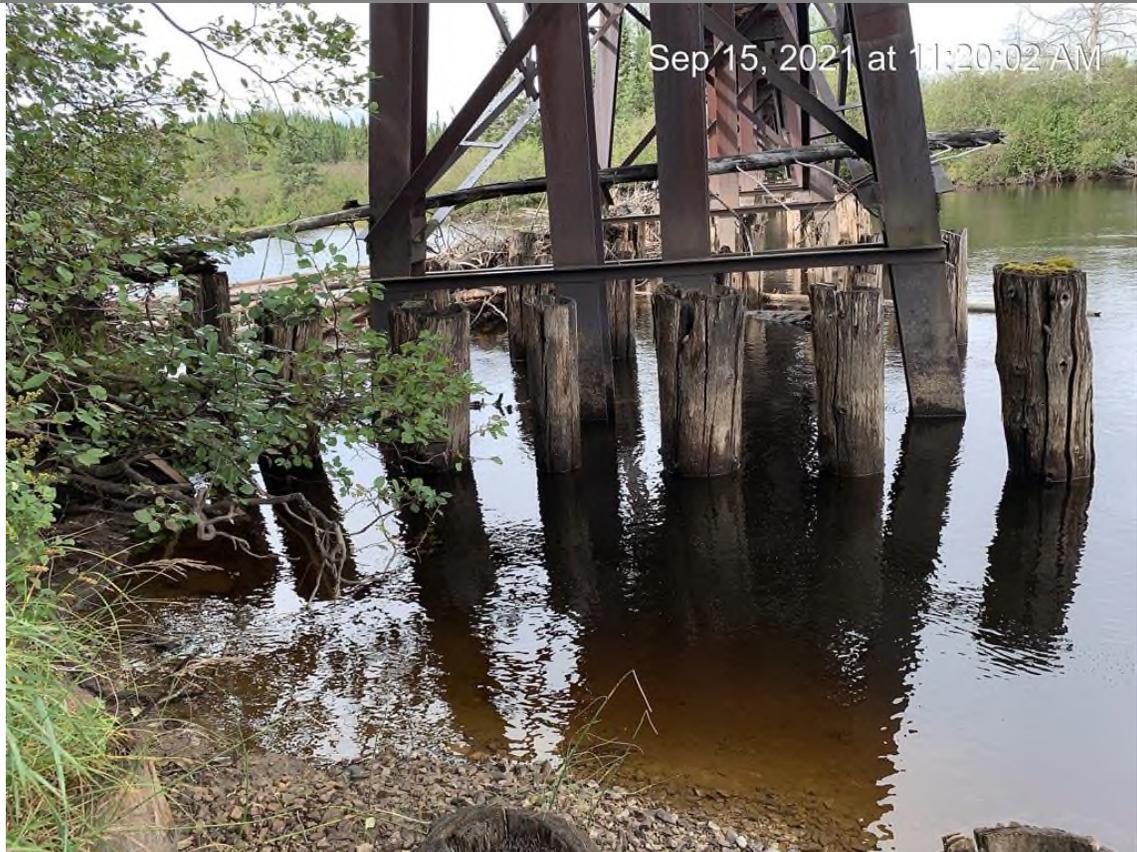
Number	P-158100425-15/09/21-759-YR	Date (AAAA-MM-JJ)	15/09/2021
Location	156.0 Chapais		
Remark	Note corrosion on steel pile at water level

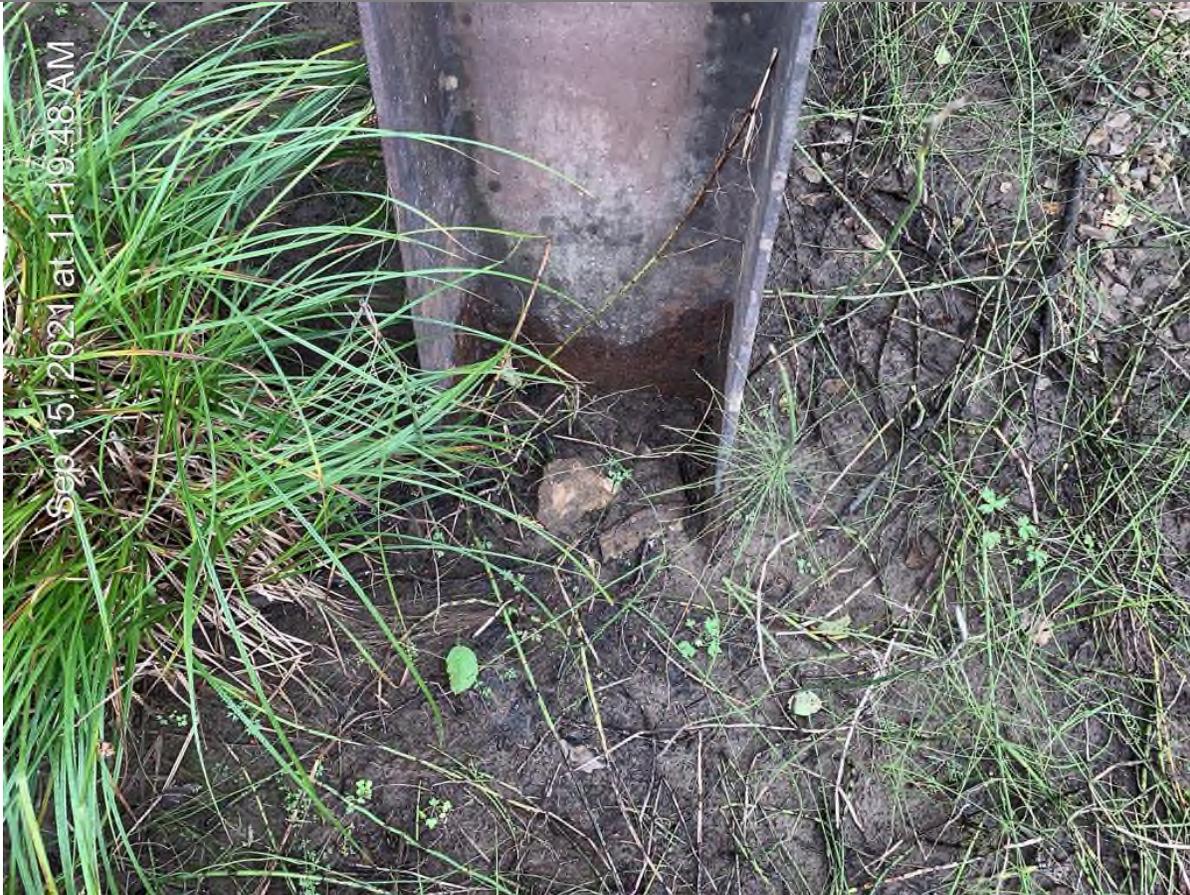
Number	P-158100425-15/09/21-757-YR	Date (AAAA-MM-JJ)	15/09/2021
Location	156.0 Chapais		
Remark	H Pile corroded at ground line.

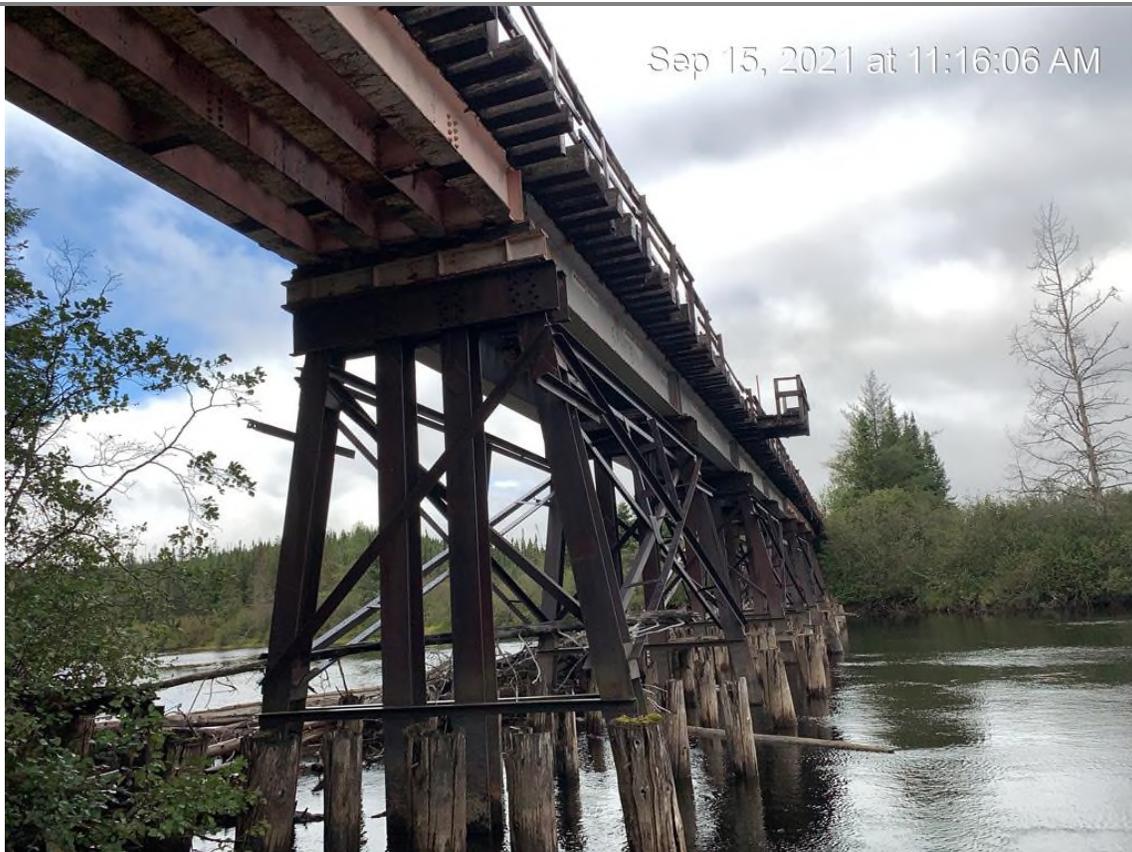
Number	P-158100425-15/09/21-755-YR	Date (AAAA-MM-JJ)	15/09/2021
Location	156.0 Chapais looking South		
Remark	Bridge was probably built-in emergency with different types of beam spans.
