ENGINEERING CONSULTING SERVICES
VOLUME 6 - APPENDIX
SECTION 6.25 – WEMINDJI ACCESS ROAD
Feasibility Study Final Report Phase I

Feasibility study of
Maquatua River crossing
bridge - Wemindji.

**DAMAGE SURVEY OF THE ACCESS ROAD
BRIDGE OVER MAQUATUA RIVER IN
WEMINDJI**

2019 Damage Survey Report,
Wemindji, QC Canada
Project #152700393

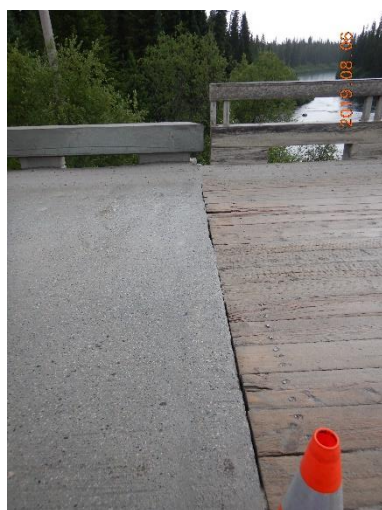
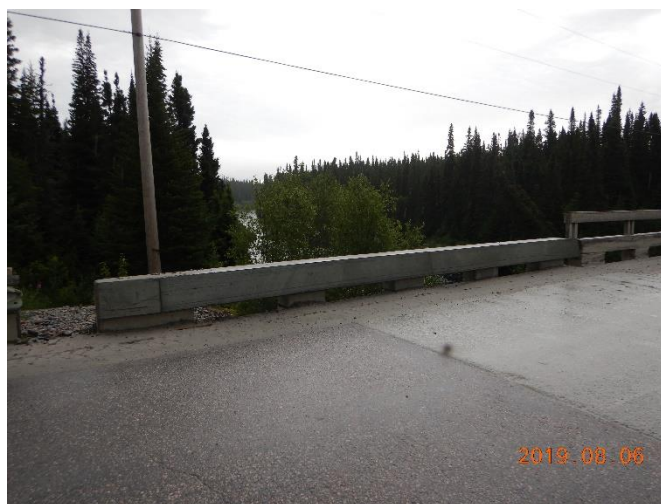
Figure 10 : *Western approach transition*

A smooth transition for the vehicles is critical in order to eliminate any impact on the structure itself or any impact to the approach. West approach provides a smooth transition between the approaches' surface and the bridge; wooden planking and the asphalt of the approach are at the same level.

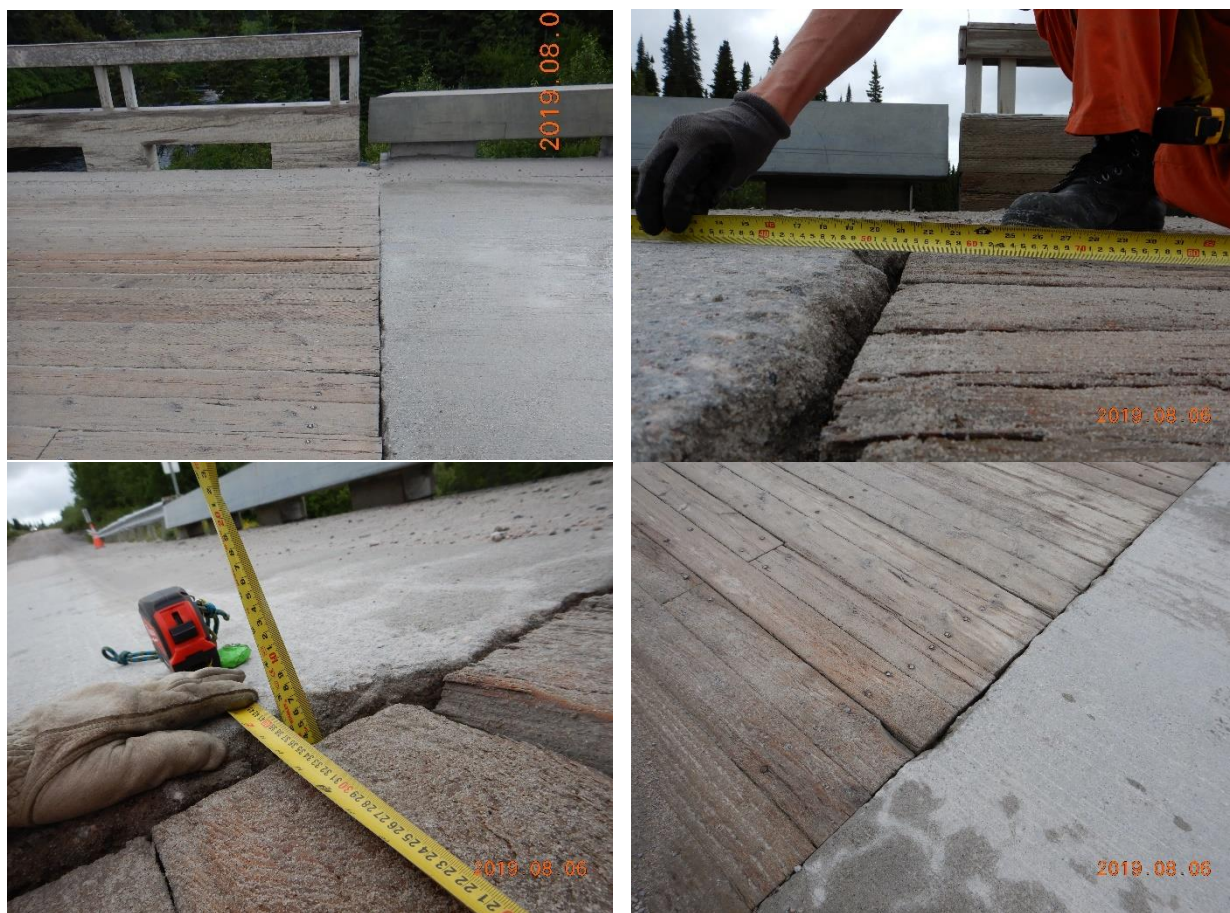
Figure 11 : Eastern approach transition

Eastern approach presents a slight unevenness between the concrete part and the wooden planking of the bridge deck that may cause low impact on the structure.

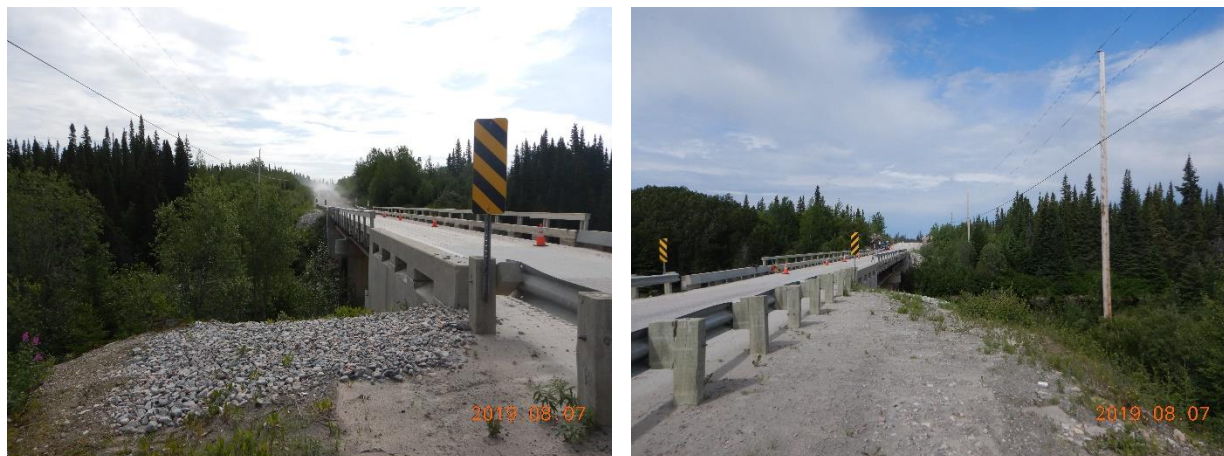
Figure 12 : Embankments

The embankments are made of sand and gravel. No loss of granular material was identified at each corner of the approaches or in front of the abutment's walls. Embankments are in good condition.

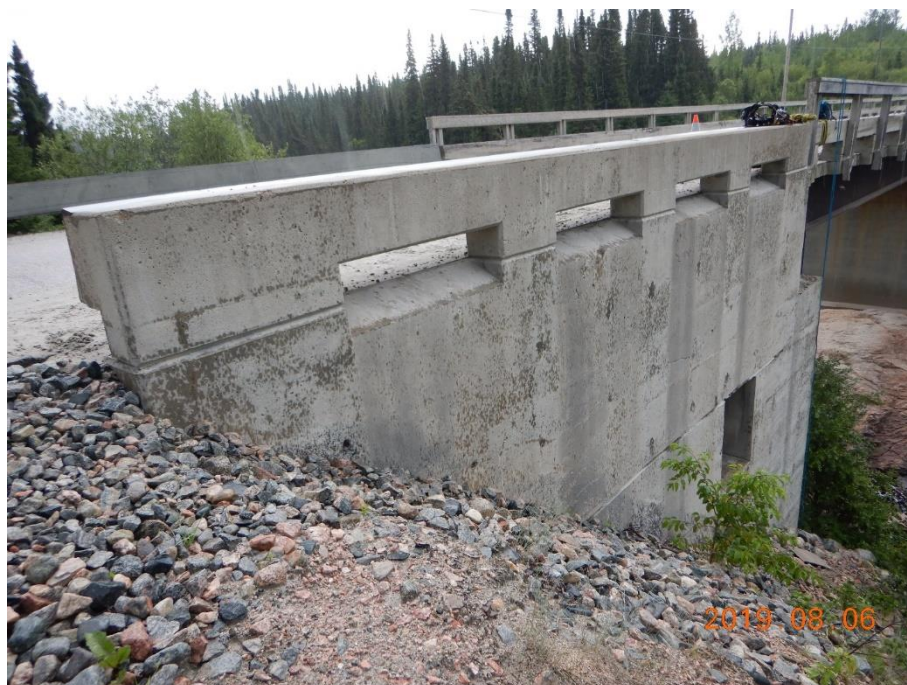
Figure 13 : Slope protection, wingwall no.1

The purpose of the slope protection is to prevent the erosion of the embankment material. The slope protection is made of stones of different diameters. While some plants are growing through the stones and some sliding of stones at the top of the slope protection (wingwall no. 1) was observed, its condition is good.

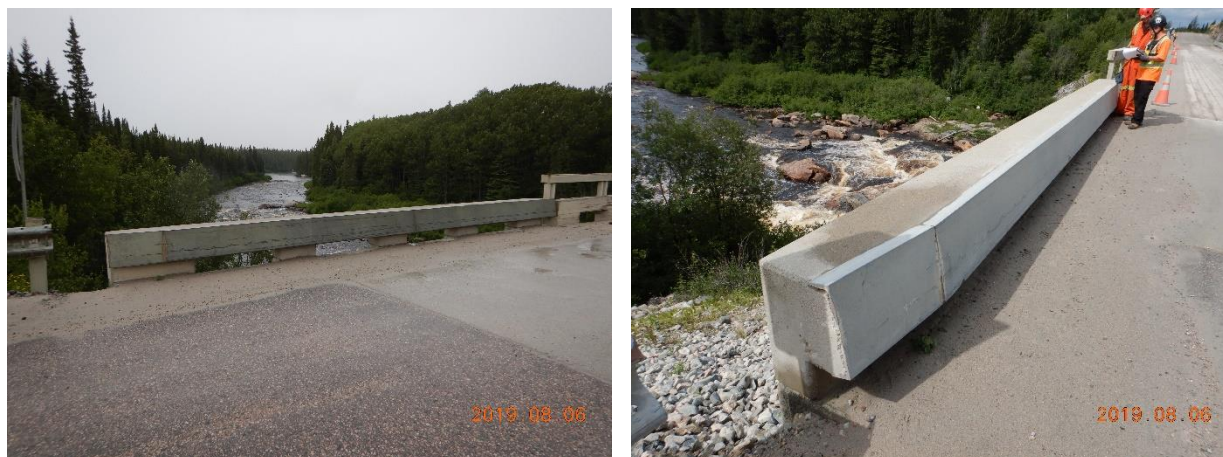
Figure 15 : Concrete guardrails

The second device is made of concrete rails and concrete posts covered with a “C” formed steel channel. Those concrete guardrails are located at the top of the four sidewalls. No material defect was noted on the concrete barriers and their condition is good.

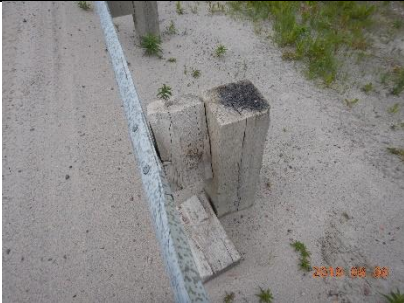
West approach		
North-West corner		
  <p>Permanent deformation of flex beam and torn up guardrail.</p>

<p>Broken wood posts offset blocks</p>	  <p>No connection device between the wood and galvanized steel railing and the concrete barrier</p>

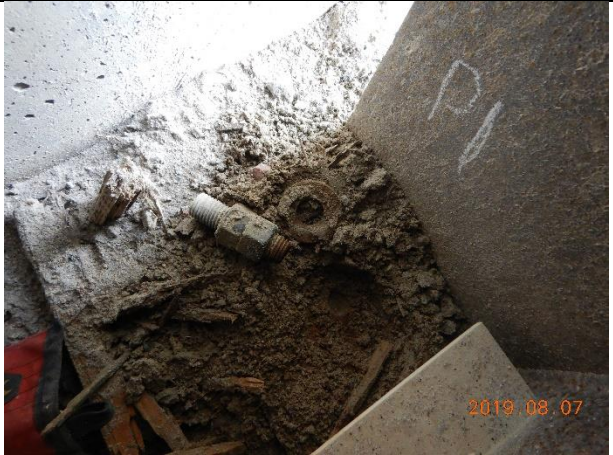
East abutment		
Beam #1	One sectioned bolt

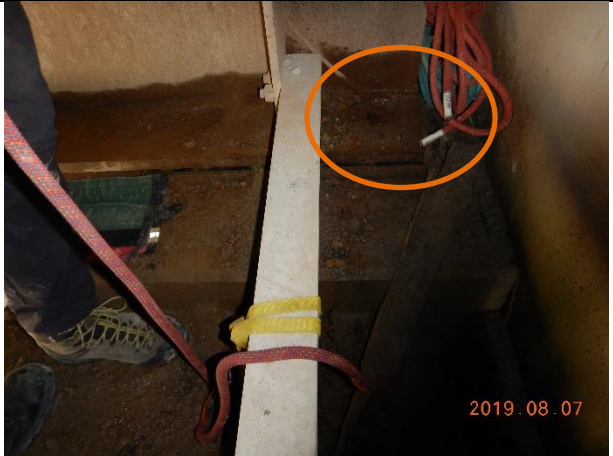
Beam #3	One sectioned bolt

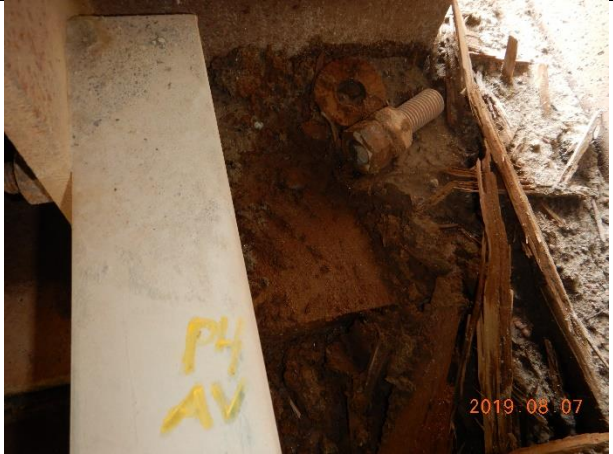
Beam #4	One sectioned bolt (interior face)

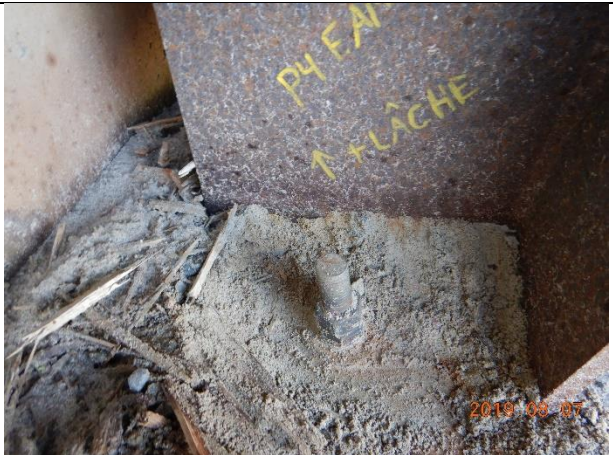
One bent and loose bolt (exterior face)

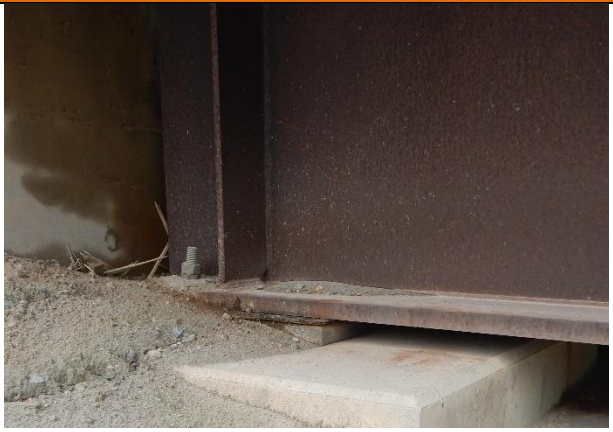
West abutment		
Beam #1	One bent bolt

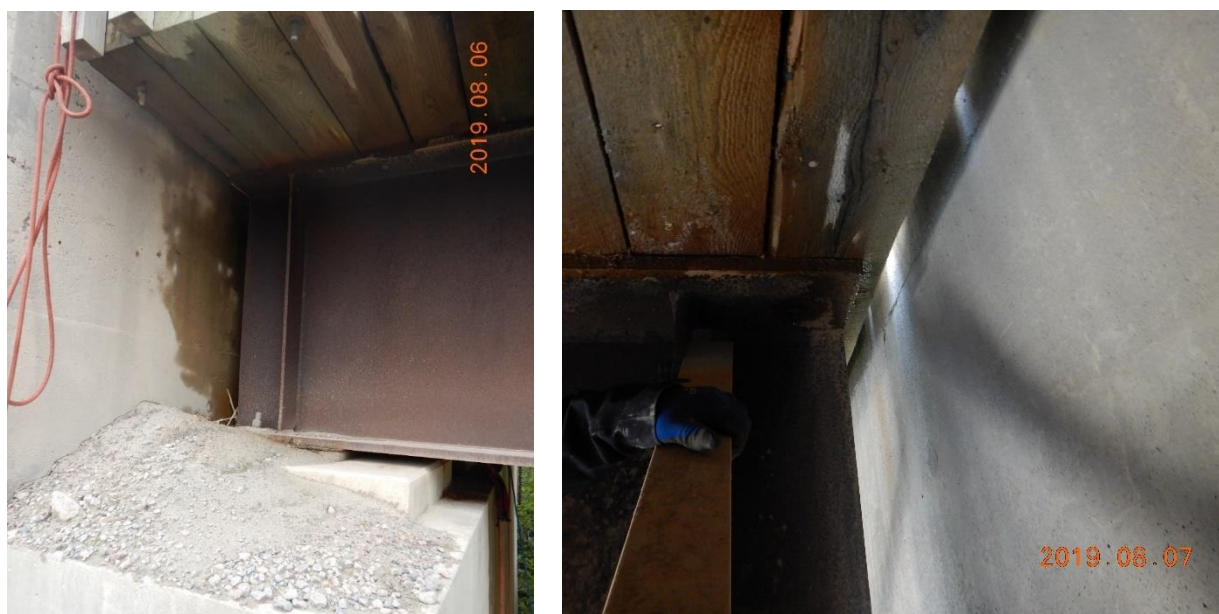
Figure 21 : Ballast walls (Left: West and Right: East)

Ballast walls of west and east abutments are in good condition. No concrete deficiencies were noted on these elements. Narrow cracks were observed (width opening < 0,8 mm).

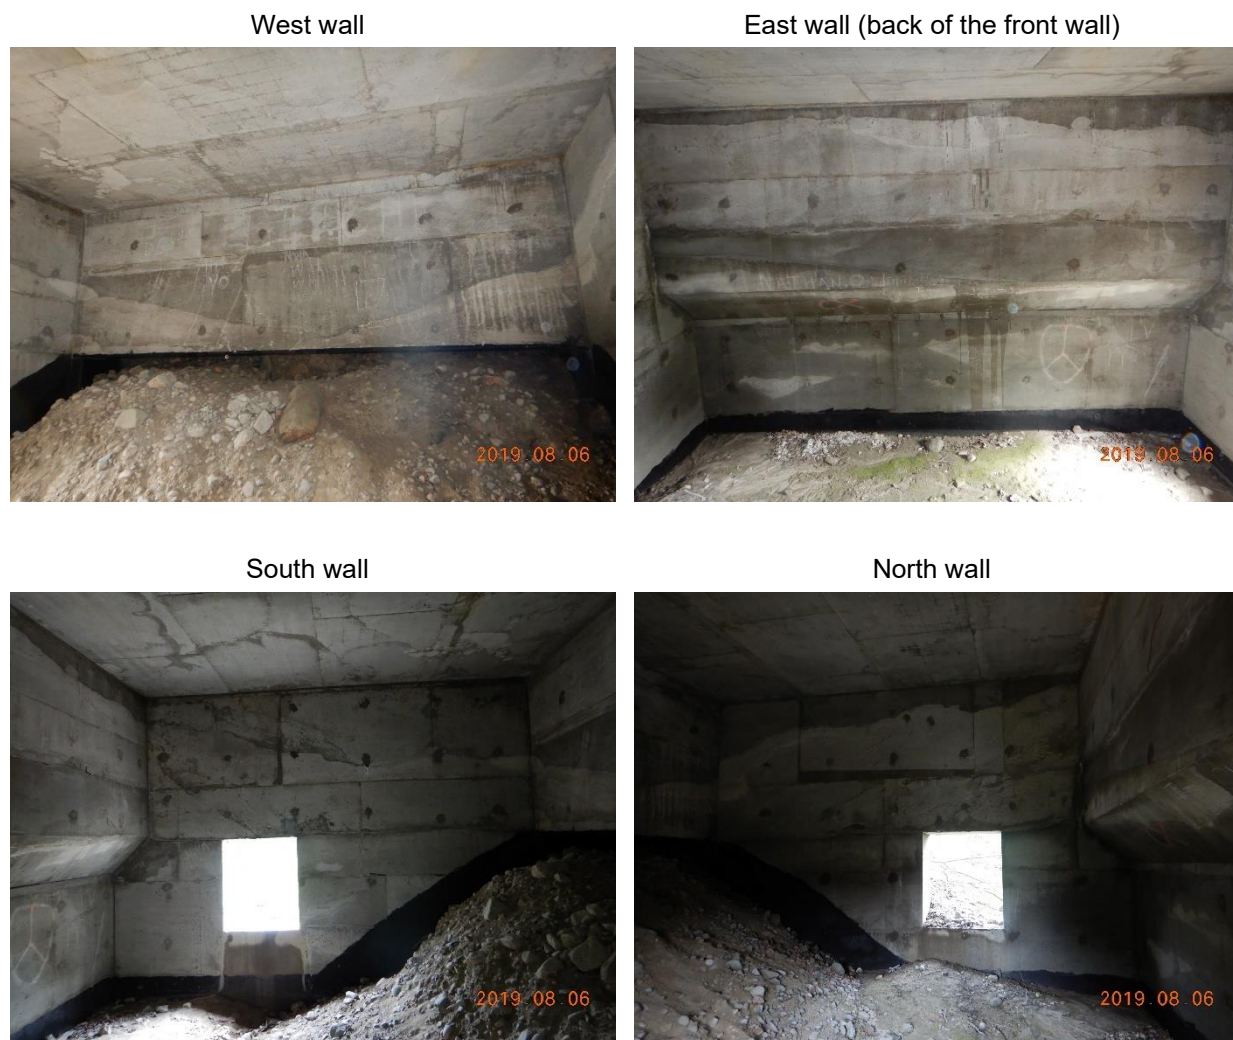
Figure 22 : West abutment's interior

Both abutments' interior are accessible through an opening in the sidewalls. Walls and deck soffits of both abutments are in good condition. Narrow cracks were noted on the concrete (width opening < 0,8 mm).

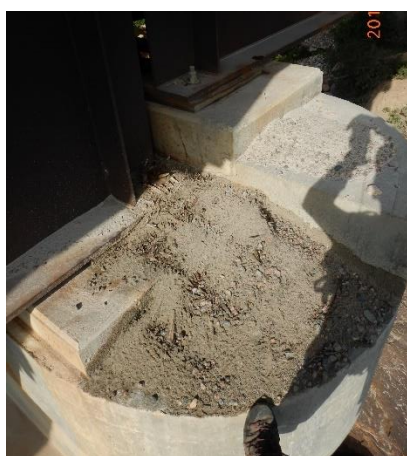
The pier-wall is the concrete element that transfers the load from the pier cap to the foundation. Both ends are shielded by a steel plate. The wall is in good condition, both concrete and steel plates. Narrow cracks were observed in the concrete (width opening < 0,8 mm).

Vertical crack width < 0.8 mm

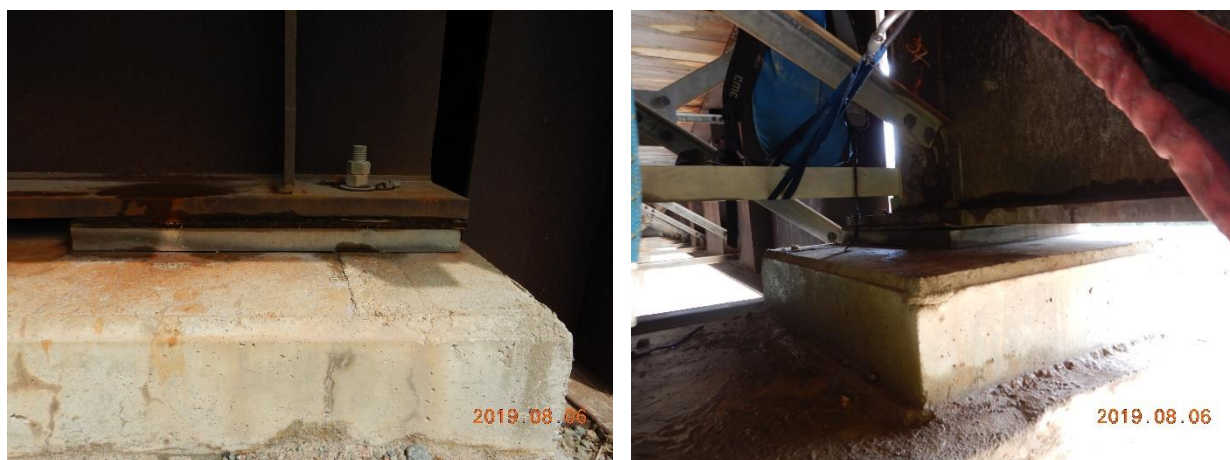
Figure 28 : *Pile's bearings and pedestals*

Concrete bearings (steel plates and elastomeric plates) and pedestals are located under each beam. The bearings are in good condition. Bearing pedestals are in good condition and no defects were identified.

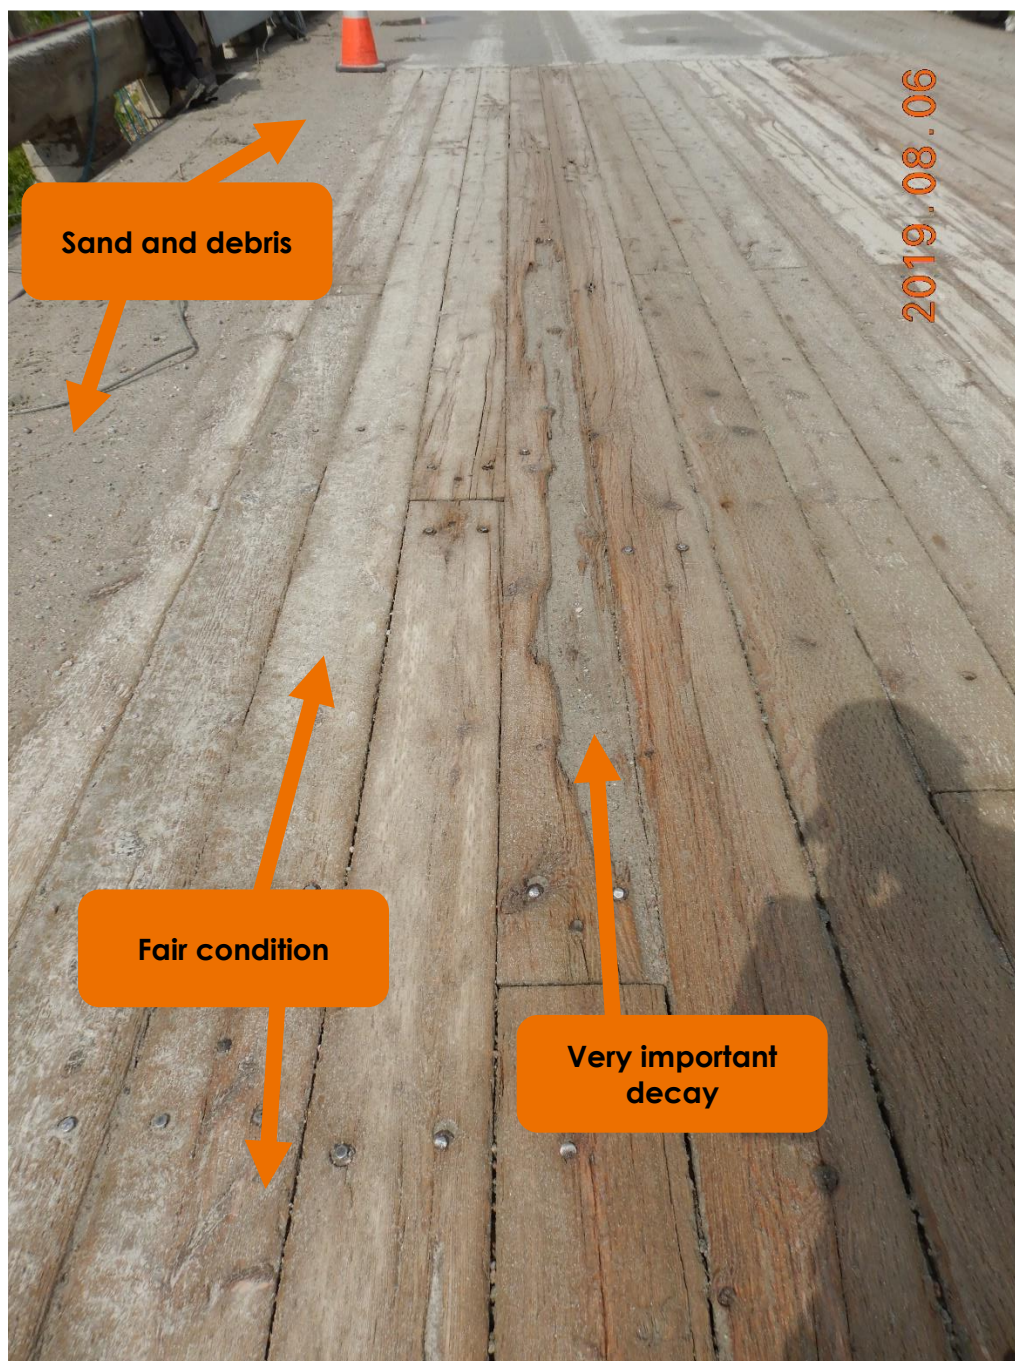
Figure 32 : *Wooden Plank Surface*

The wearing surface is made of wooden planks. The roadside (25% of the surface) is covered of sand and debris, which makes it not possible to inspect. The visible part of the surface (the clean part) has 5% of its wooden planks with important decay. Another 5% has very important decay. A few bolts were scattered on the surface. There is no joint on the wearing surface above the pile. The wearing surface is in a fair condition.

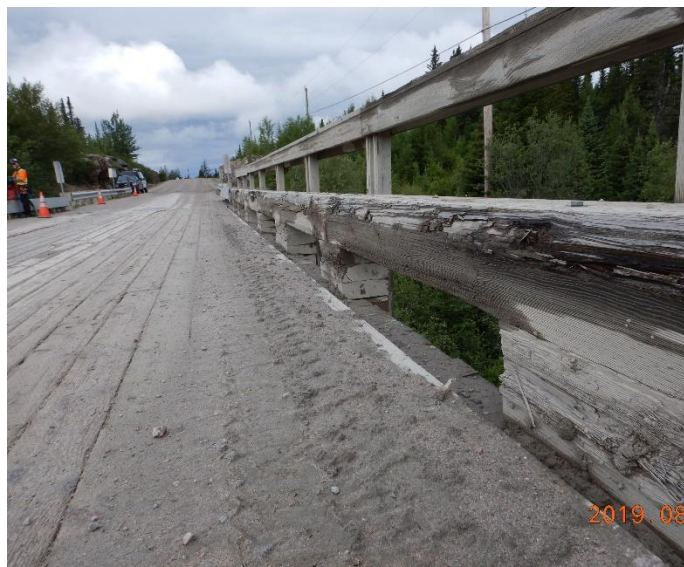
Curbs – general view of abrasion

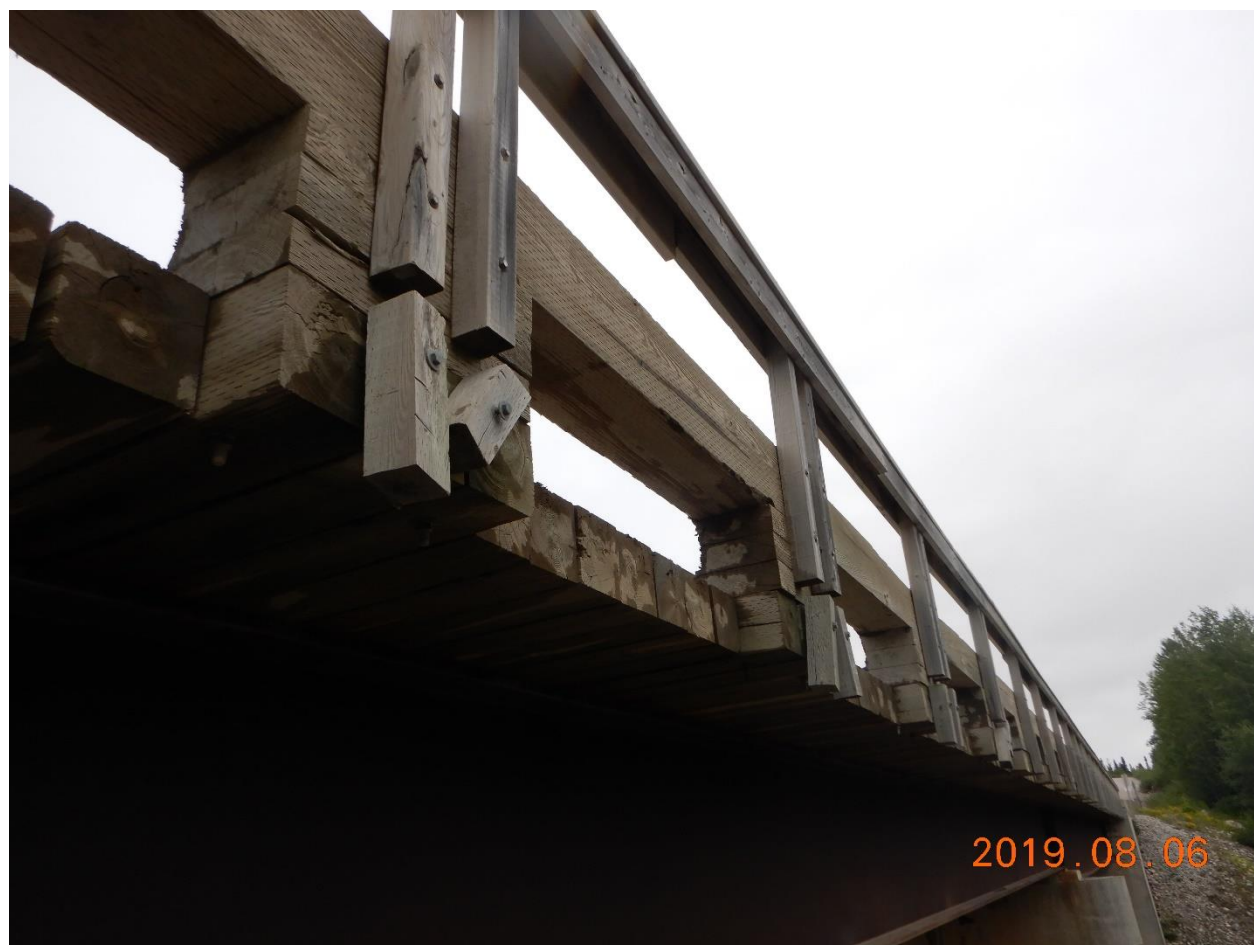
Figure 34 : *Wood guardrails – span 1*

Both sides of the bridge are protected by wood guardrails. In some places, the posts of the guardrails are not fixed to the timbers, where they should be. Instead, they are fixed to the curbs or the anchor of the curbs. At some places, posts are cut. Therefore, the condition of the guardrails is judged to be poor.
