ENGINEERING CONSULTING SERVICES
VOLUME 6 - APPENDIX
SECTION 6.25 – WEMINDJI ACCESS ROAD
Feasibility Study Final Report Phase I

Feasibility study of Maquatua River crossing bridge - Wemindji.

**DAMAGE SURVEY OF THE ACCESS ROAD
BRIDGE OVER MAQUATUA RIVER IN
WEMINDJI**

2019 Damage Survey Report,
Wemindji, QC Canada
Project #152700393

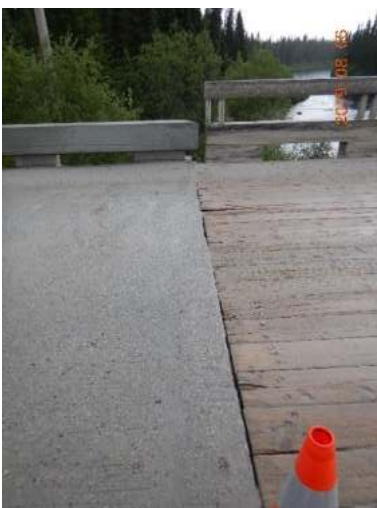
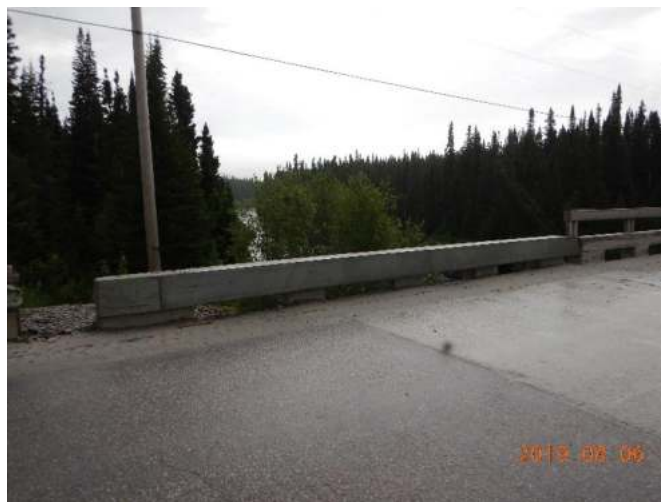
Figure 10 : Western approach transition

A smooth transition for the vehicles is critical in order to eliminate any impact on the structure itself or any impact to the approach. West approach provides a smooth transition between the approaches' surface and the bridge; wooden planking and the asphalt of the approach are at the same level.

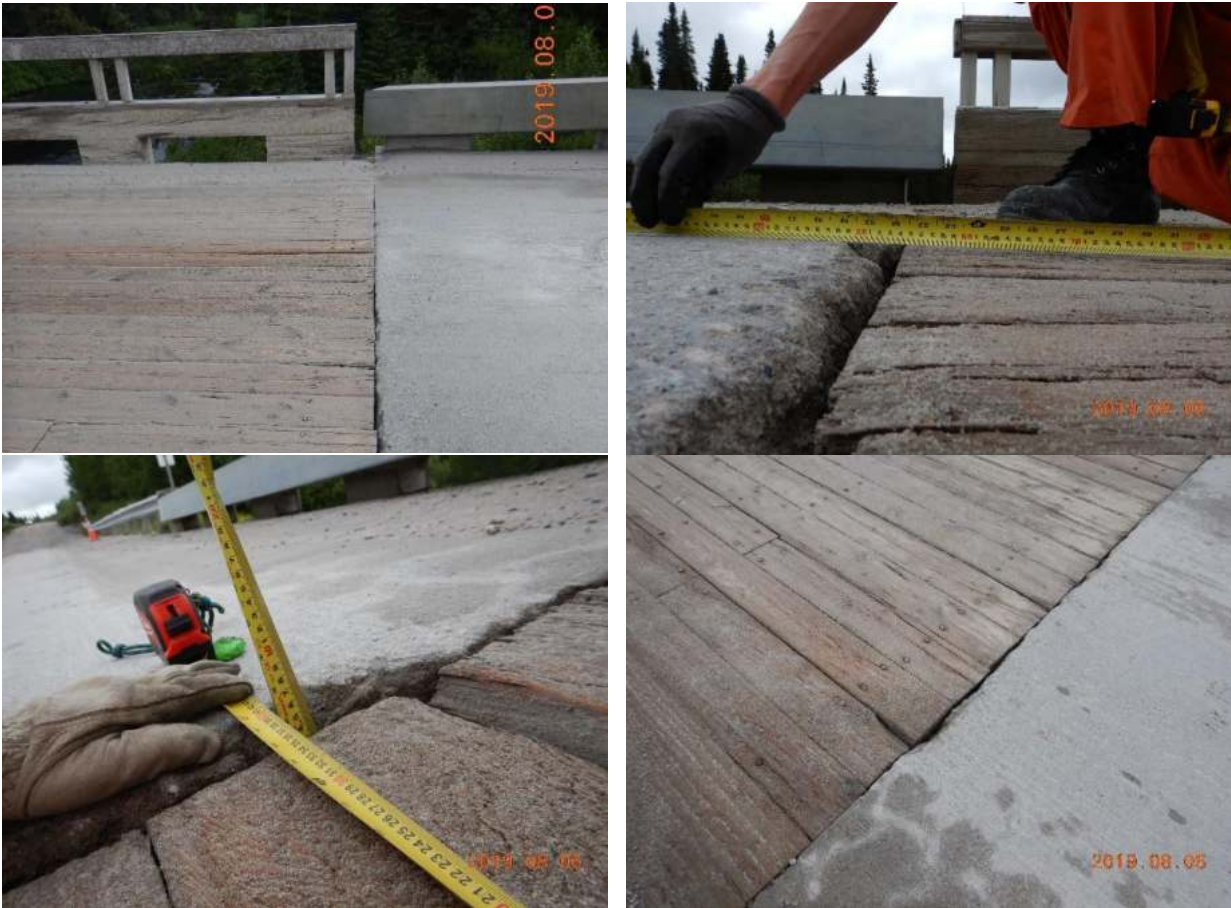
Figure 11 : Eastern approach transition

Eastern approach presents a slight unevenness between the concrete part and the wooden planking of the bridge deck that may cause low impact on the structure.

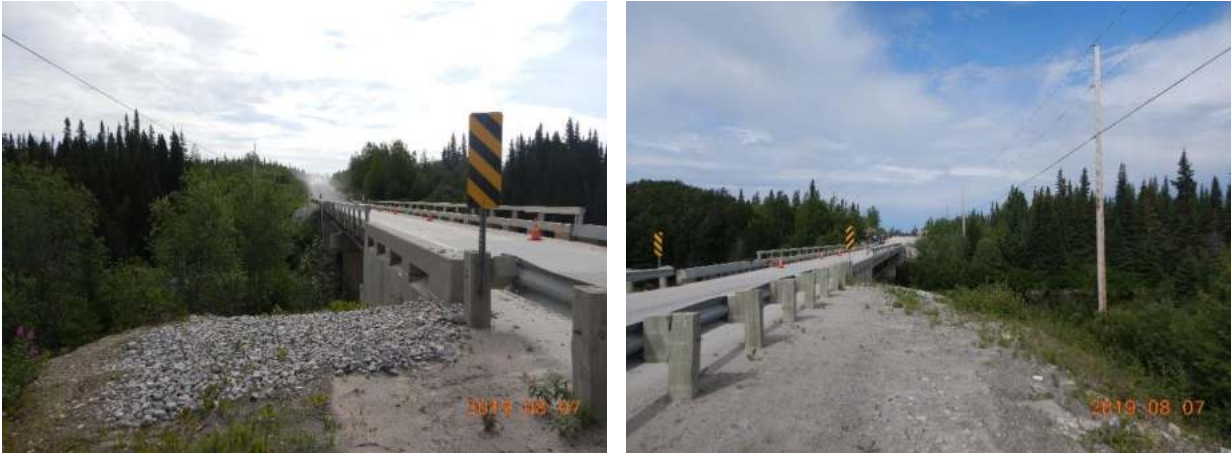
Figure 12 : Embankments

The embankments are made of sand and gravel. No loss of granular material was identified at each corner of the approaches or in front of the abutment's walls. Embankments are in good condition.

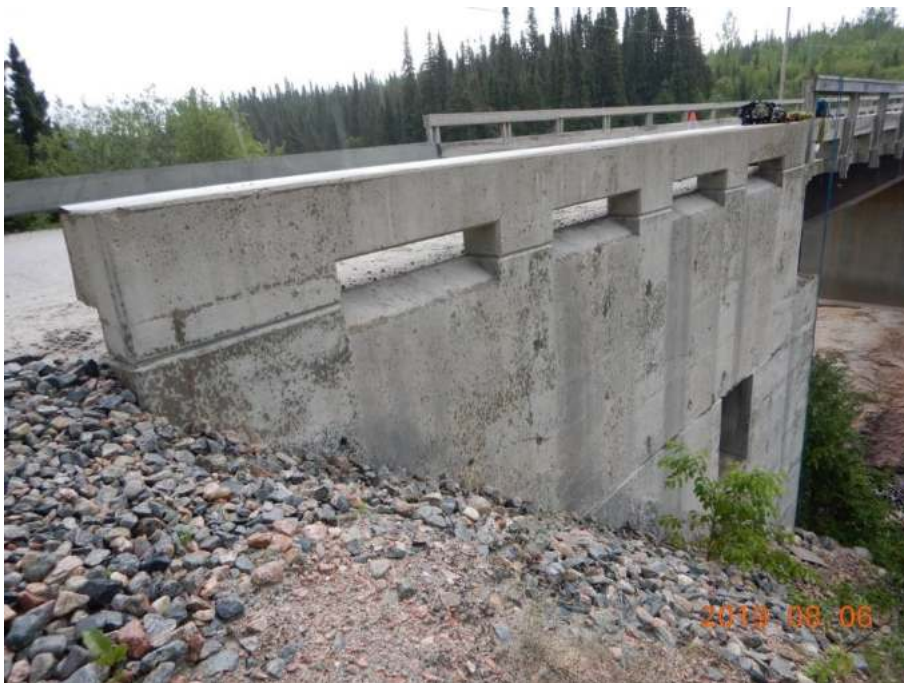
Figure 13 : Slope protection, wingwall no.1

The purpose of the slope protection is to prevent the erosion of the embankment material. The slope protection is made of stones of different diameters. While some plants are growing through the stones and some sliding of stones at the top of the slope protection (wingwall no. 1) was observed, its condition is good.

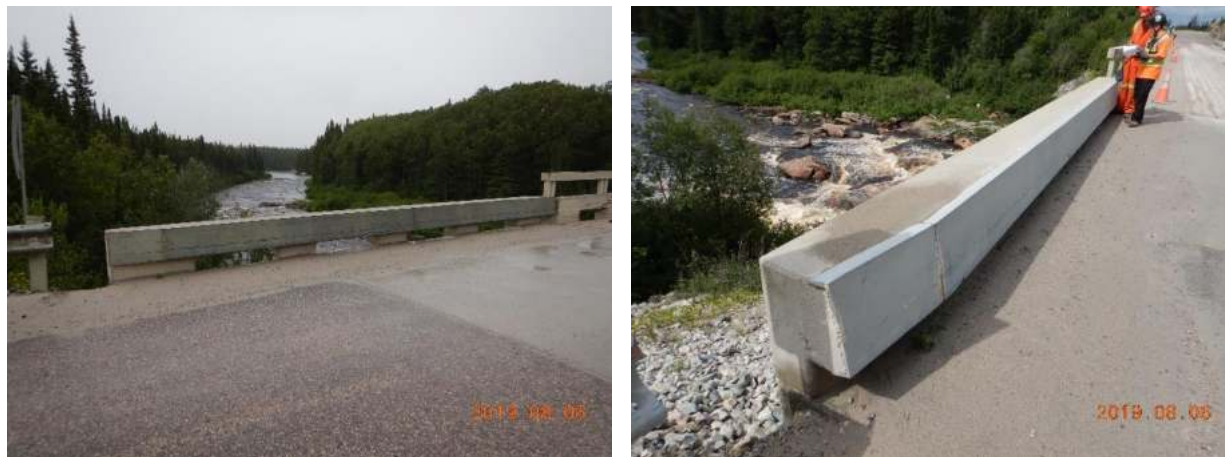
Figure 15 : Concrete guardrails

The second device is made of concrete rails and concrete posts covered with a “C” formed steel channel. Those concrete guardrails are located at the top of the four sidewalls. No material defect was noted on the concrete barriers and their condition is good.

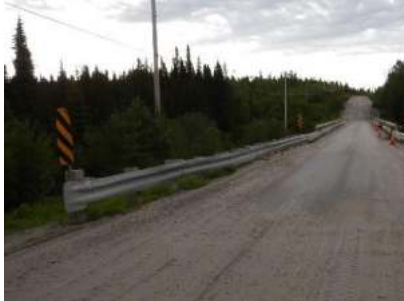
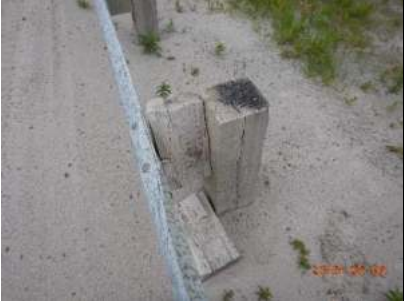
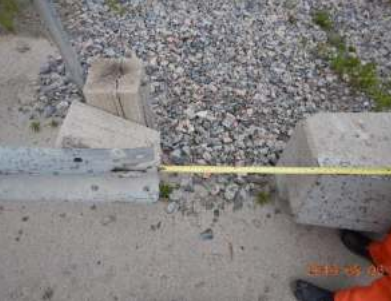
West approach		
North-West corner

Permanent deformation of flex beam and torn up guardrail.	Broken wood posts offset blocks	No connection device between the wood and galvanized steel railing and the concrete barrier

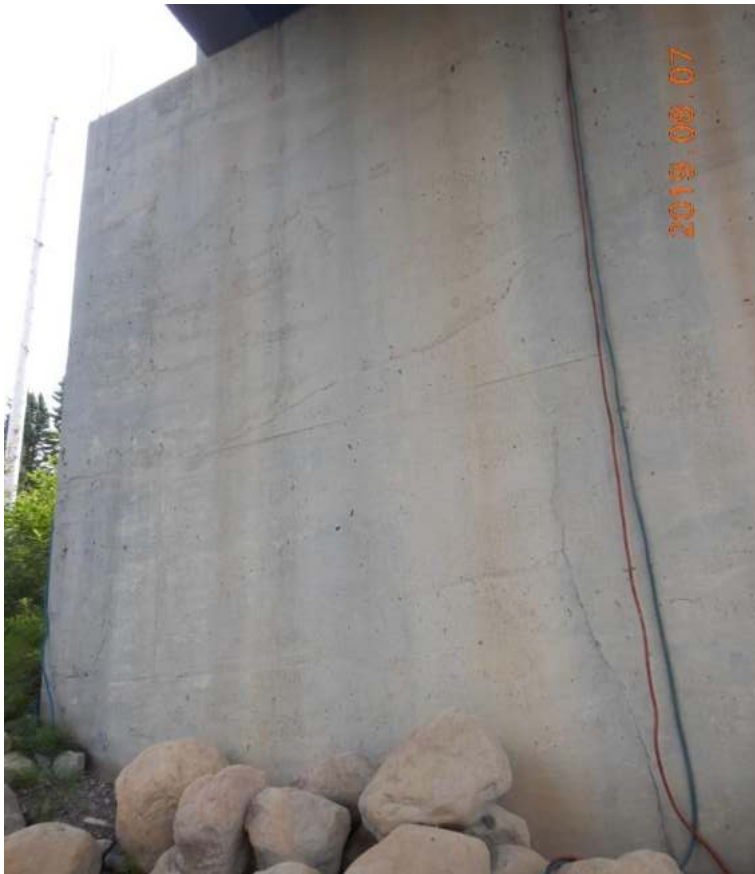
Figure 17 : Cold joint and narrow cracks on the East front wall

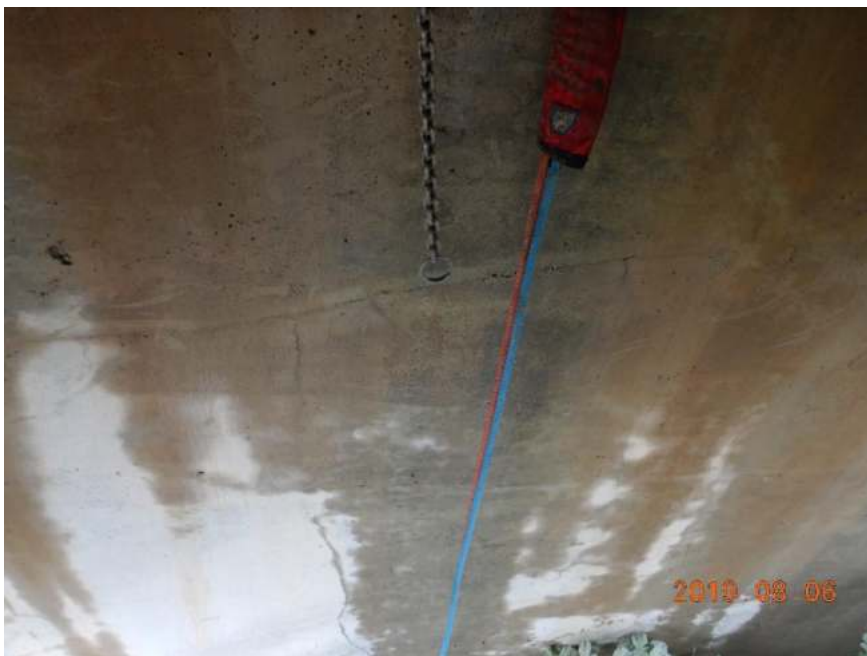
Figure 18 : Cold joint and narrow cracks on the West front wall

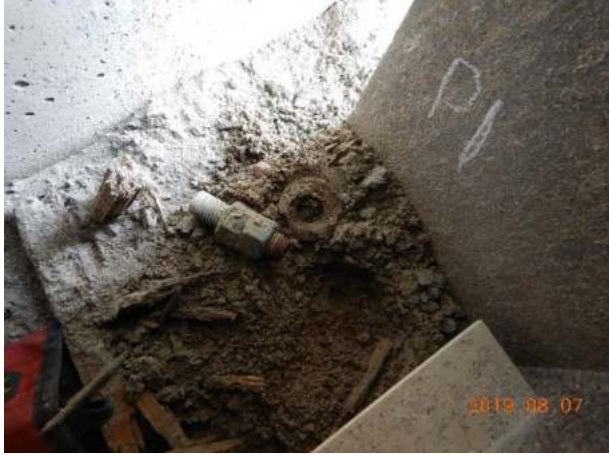
East abutment		
Beam #1	One sectioned bolt

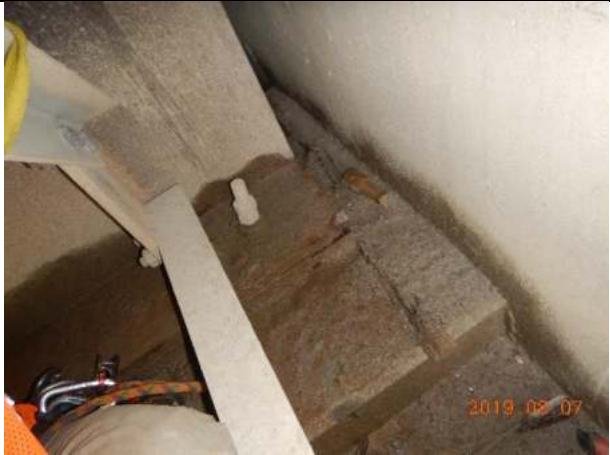
A photograph showing a sectioned bolt in a concrete abutment. The bolt is broken and surrounded by debris and dirt. The date stamp '2019.08.07' is visible in the bottom right corner.
Beam #2	One bent bolt

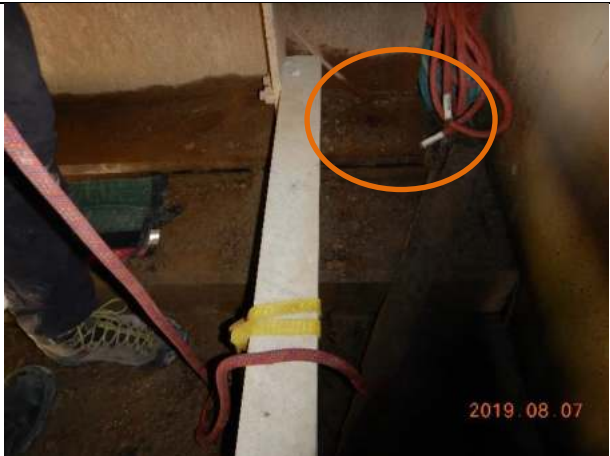
A photograph showing a bent bolt in a concrete abutment. The bolt is curved and appears to be under stress. The date stamp '2019.08.07' is visible in the bottom right corner.
Beam #3	One sectioned bolt

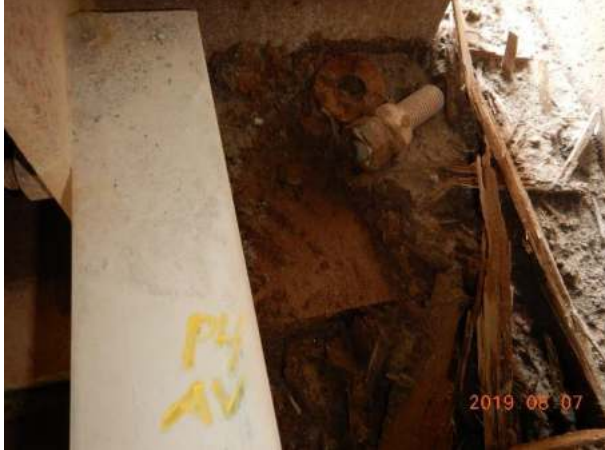
Beam #4	One sectioned bolt (interior face)

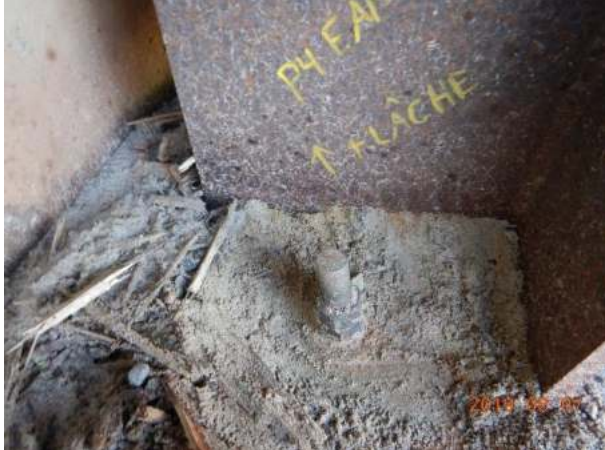
One bent and loose bolt (exterior face)

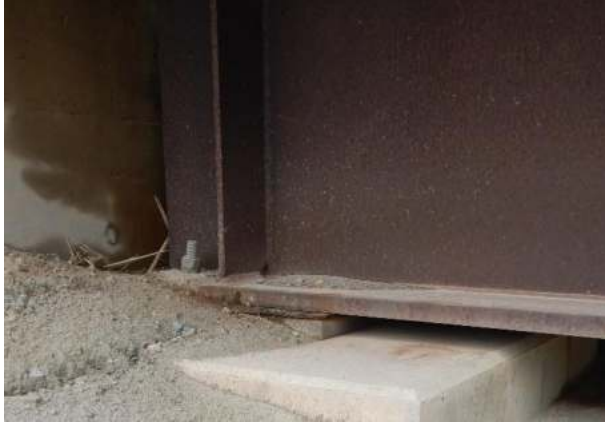
West abutment		
Beam #1	One bent bolt

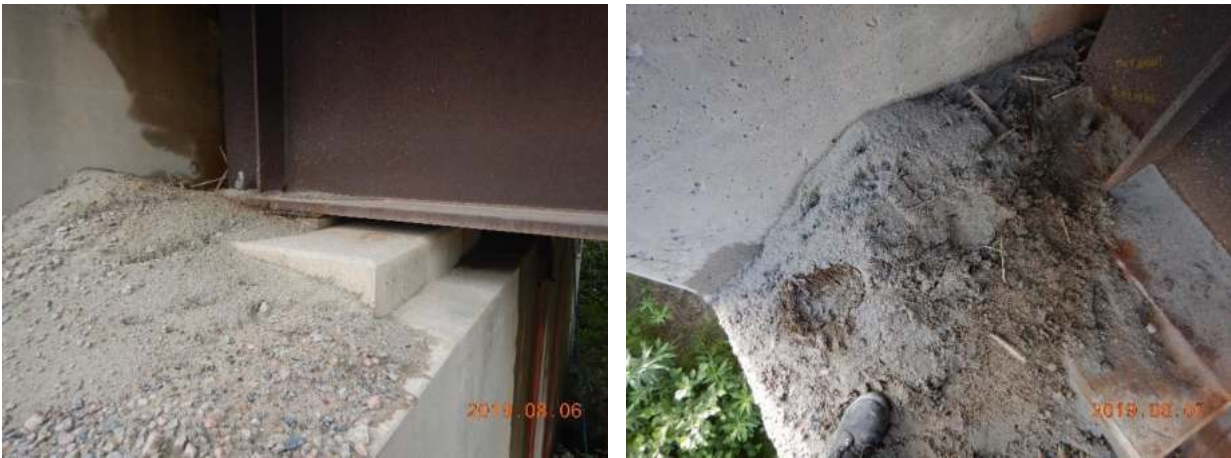
Figure 20 : Debris on the bearing pedestals (West and East)

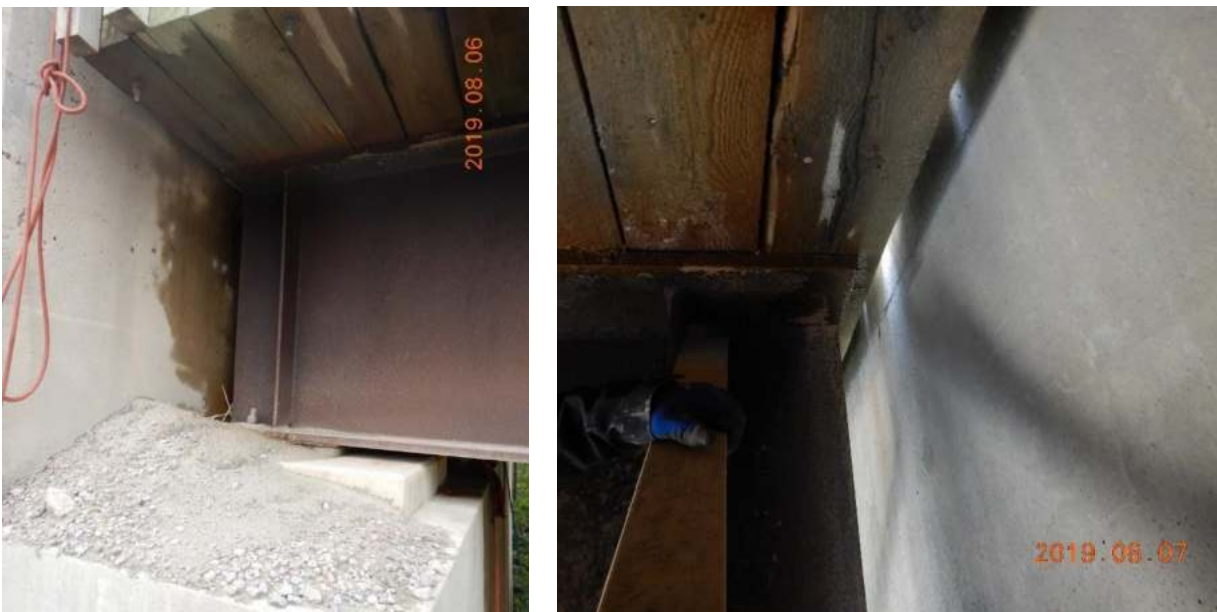
Figure 21 : Ballast walls (Left: West and Right: East)

Ballast walls of west and east abutments are in good condition. No concrete deficiencies were noted on these elements. Narrow cracks were observed (width opening < 0,8 mm).

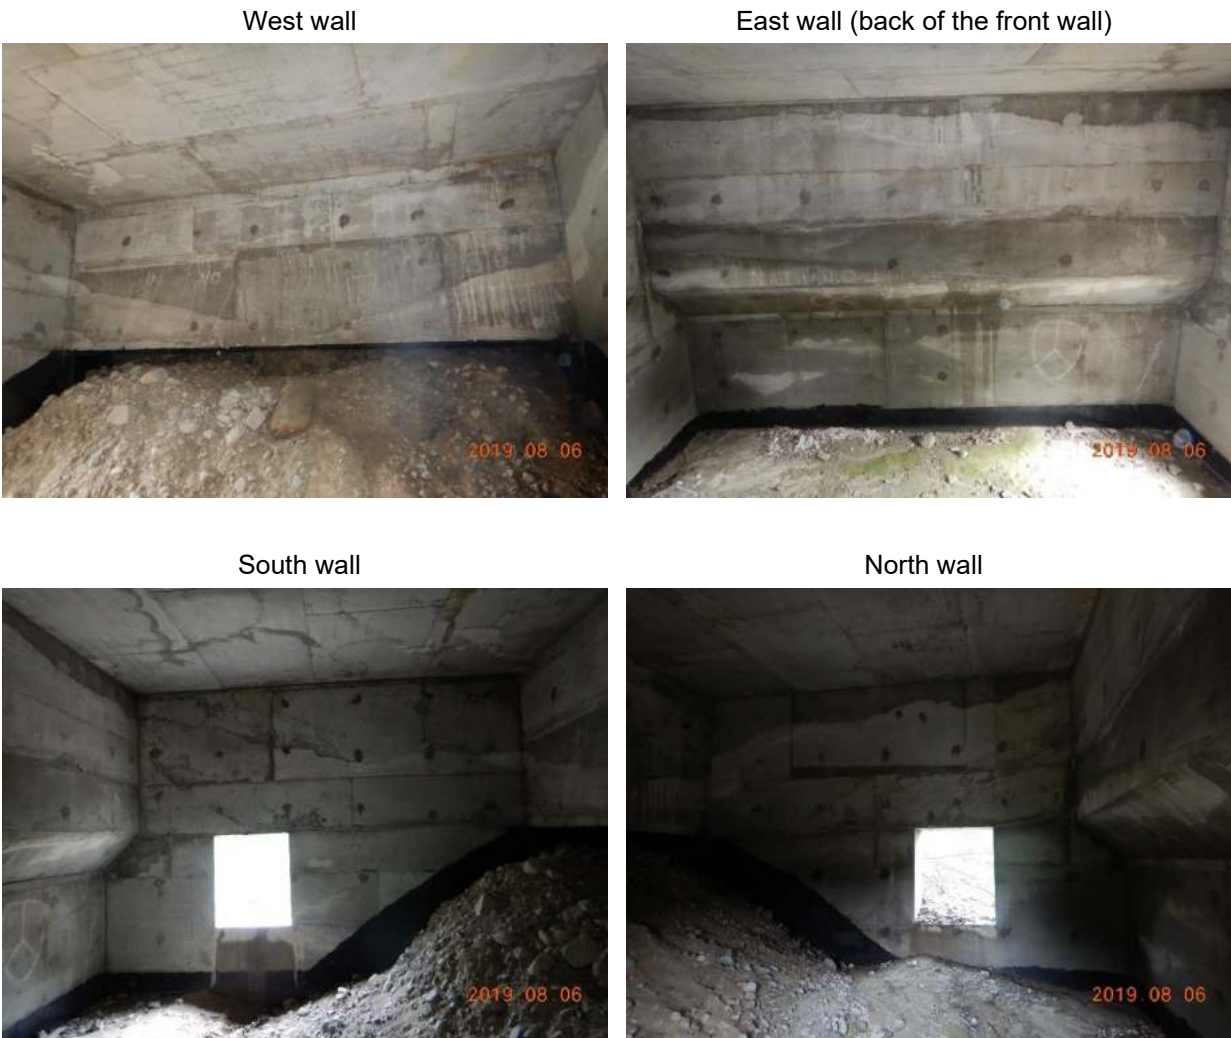
Figure 22 : West abutment's interior

Both abutments' interior are accessible through an opening in the sidewalls. Walls and deck soffits of both abutments are in good condition. Narrow cracks were noted on the concrete (width opening < 0,8 mm).

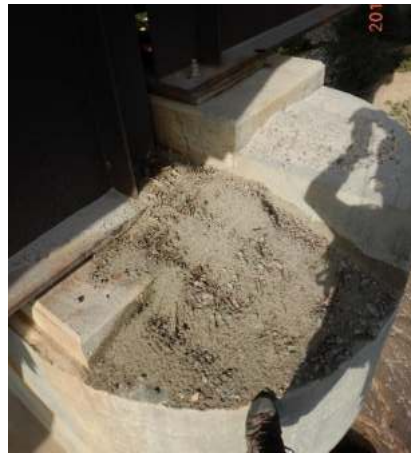
The pier-wall is the concrete element that transfers the load from the pier cap to the foundation. Both ends are shielded by a steel plate. The wall is in good condition, both concrete and steel plates. Narrow cracks were observed in the concrete (width opening < 0,8 mm).

Vertical crack width < 0.8 mm

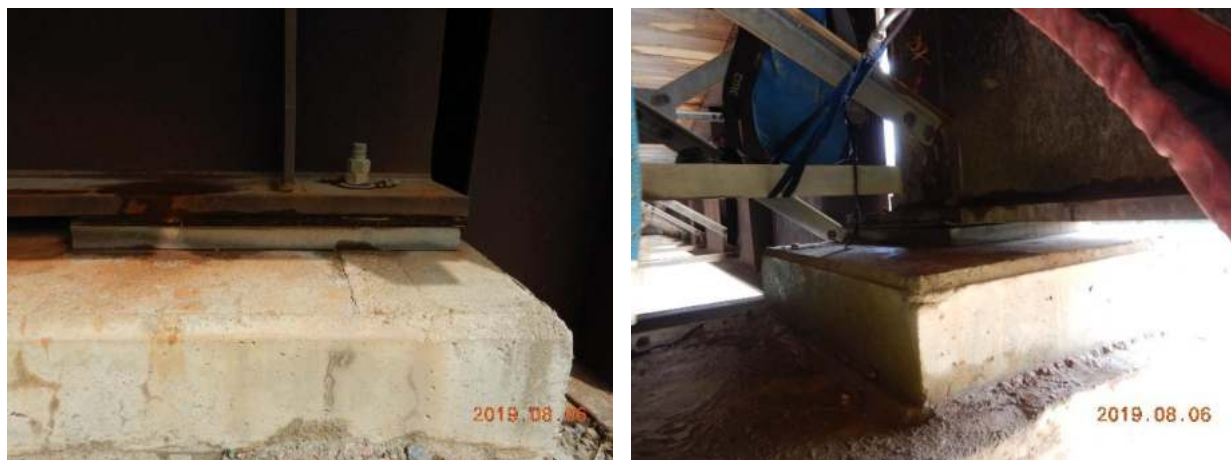
Figure 28 : Pile's bearings and pedestals

Concrete bearings (steel plates and elastomeric plates) and pedestals are located under each beam. The bearings are in good condition. Bearing pedestals are in good condition and no defects were identified.

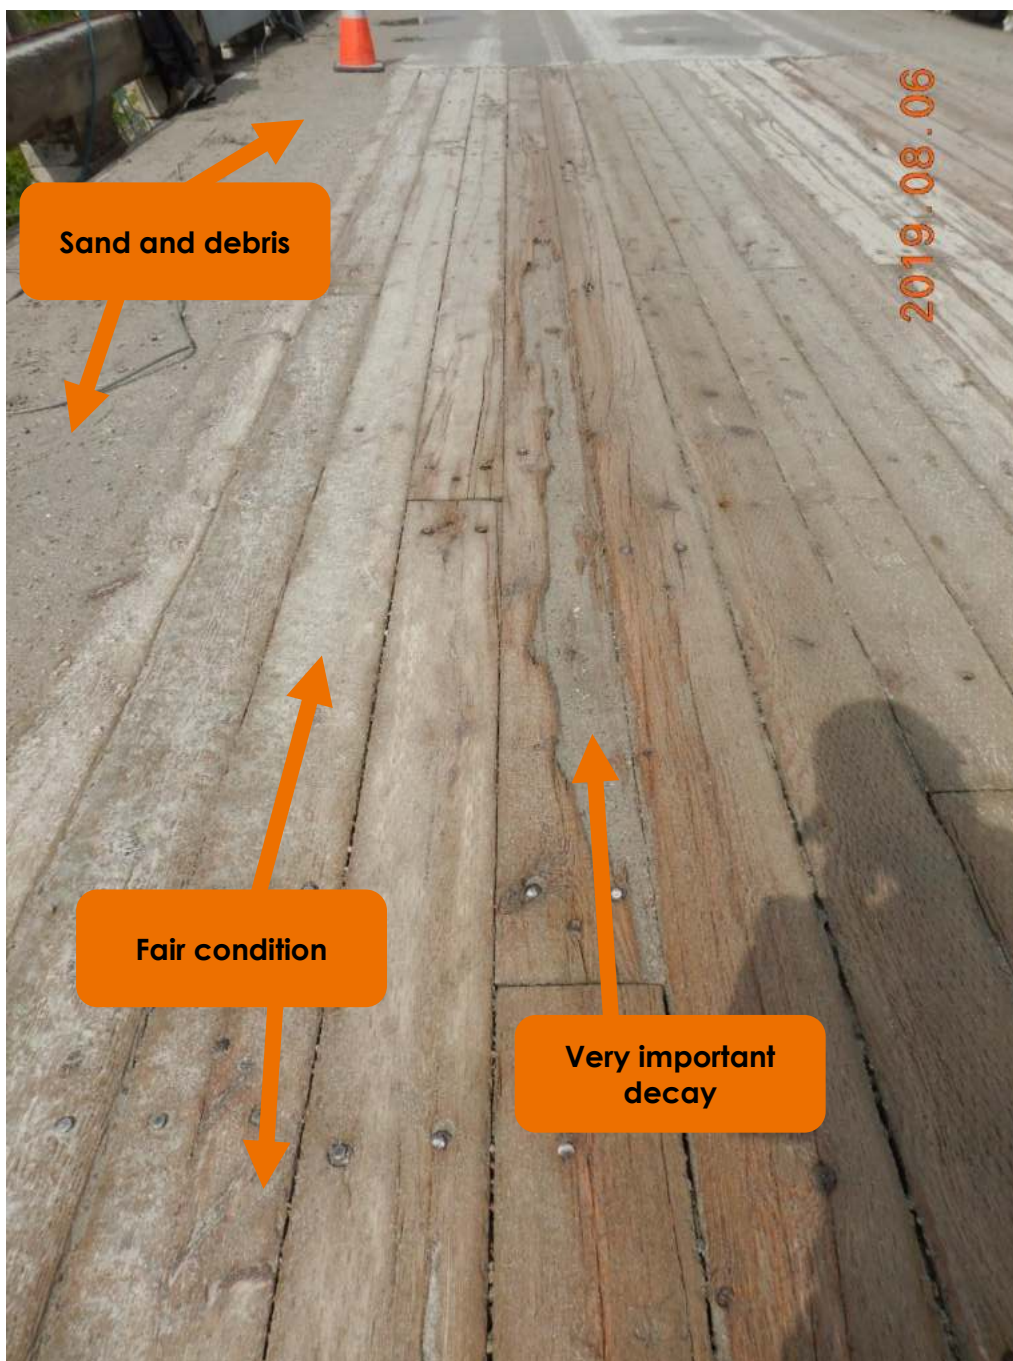
Figure 32 : Wooden Plank Surface

The wearing surface is made of wooden planks. The roadside (25% of the surface) is covered of sand and debris, which makes it not possible to inspect. The visible part of the surface (the clean part) has 5% of its wooden planks with important decay. Another 5% has very important decay. A few bolts were scattered on the surface. There is no joint on the wearing surface above the pile. The wearing surface is in a fair condition.

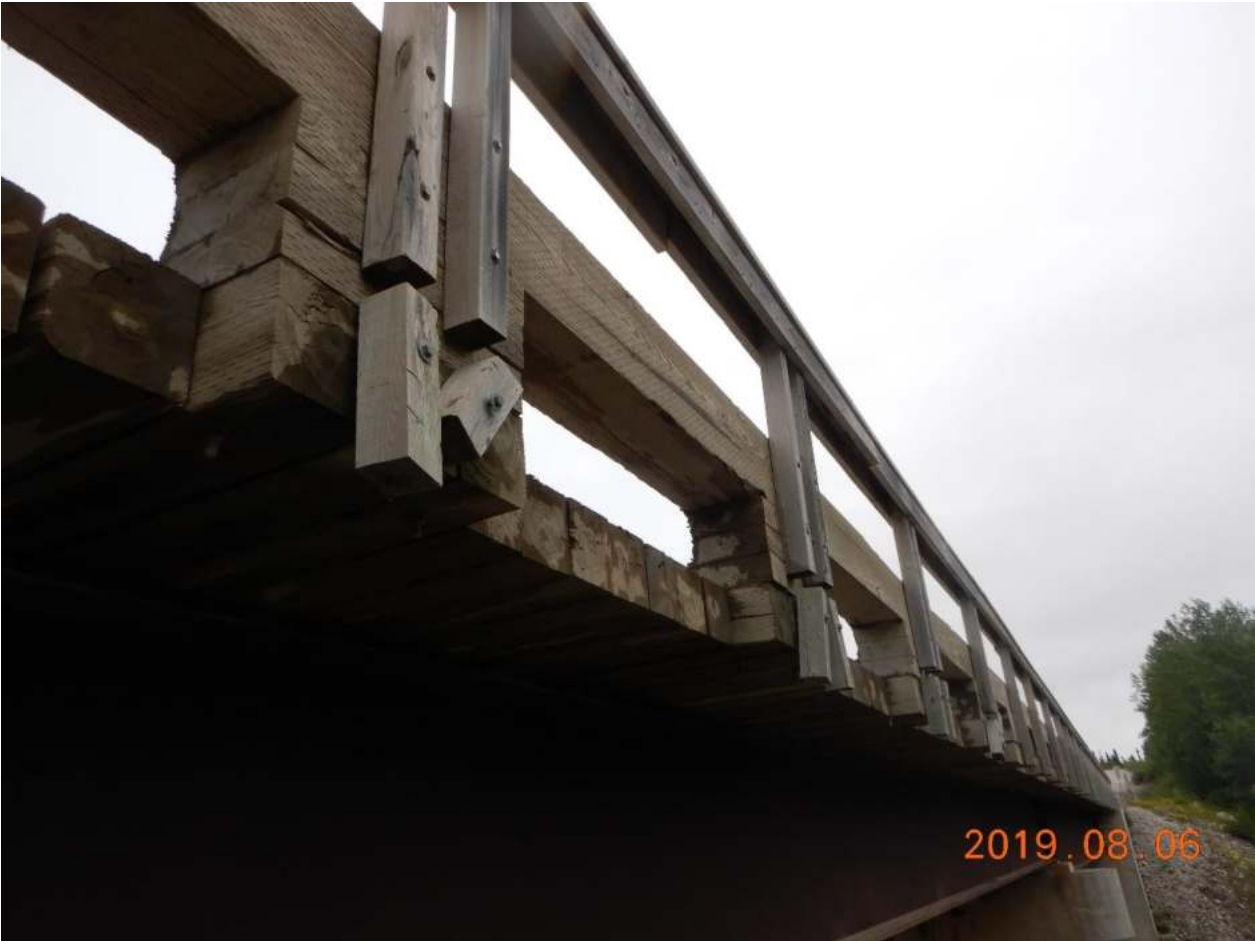
Figure 34 : Wood guardrails – span 1

Both sides of the bridge are protected by wood guardrails. In some places, the posts of the guardrails are not fixed to the timbers, where they should be. Instead, they are fixed to the curbs or the anchor of the curbs. At some places, posts are cut. Therefore, the condition of the guardrails is judged to be poor.
