VOLUME 6 - ANNEXES
SECTION 6.25 – ROUTE D'ACCÈS WEMINDJI
Rapport final de l'étude de faisabilité Phase I

La Grande Alliance Étude
de faisabilité Phase I

Rapport Technique -Route
d'accès Wemindji

Damage Survey of the Access Road Bridge Over Maquatua River in Wemindji

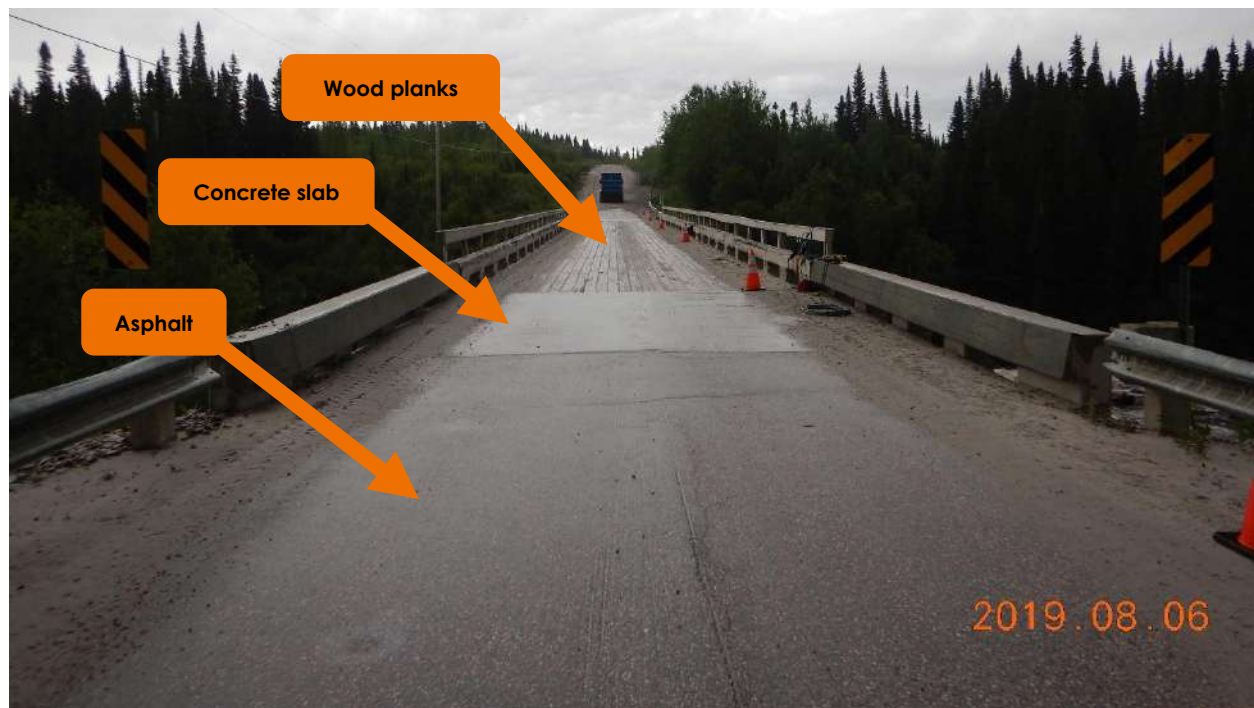
Figure 8 : Western approach

The approaches' asphalt pavement is making the transition between the gravel and the concrete surface (concrete deck of the hollowed abutments). It is damaged by cracks and potholes that allows the water to infiltrate the infrastructure under the pavement and possibly accelerate its deterioration. A concrete slab serves as pavement transition between the asphalt approaches and the wooden planks. No expansion joint is separating the different materials.

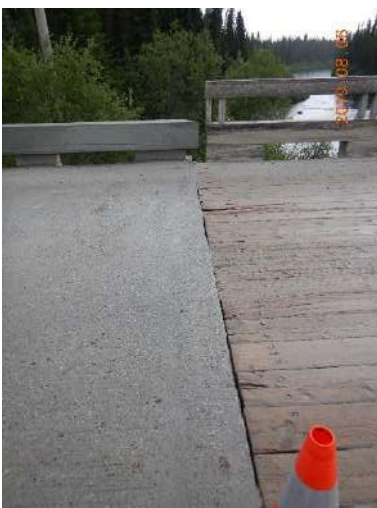
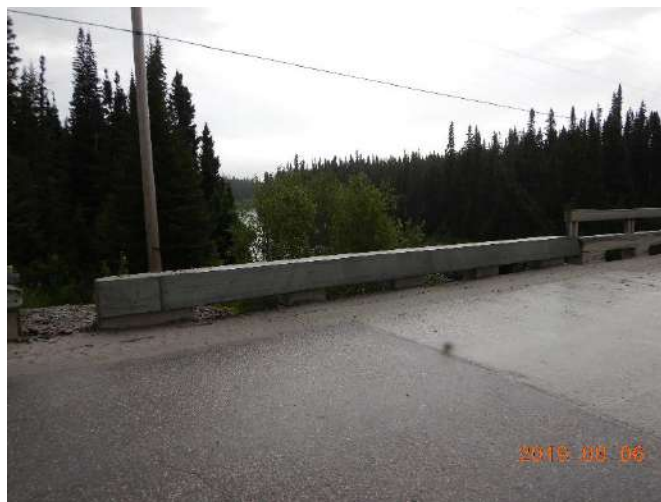
Figure 10 : Western approach transition

A smooth transition for the vehicles is critical in order to eliminate any impact on the structure itself or any impact to the approach. West approach provides a smooth transition between the approaches' surface and the bridge; wooden planking and the asphalt of the approach are at the same level.

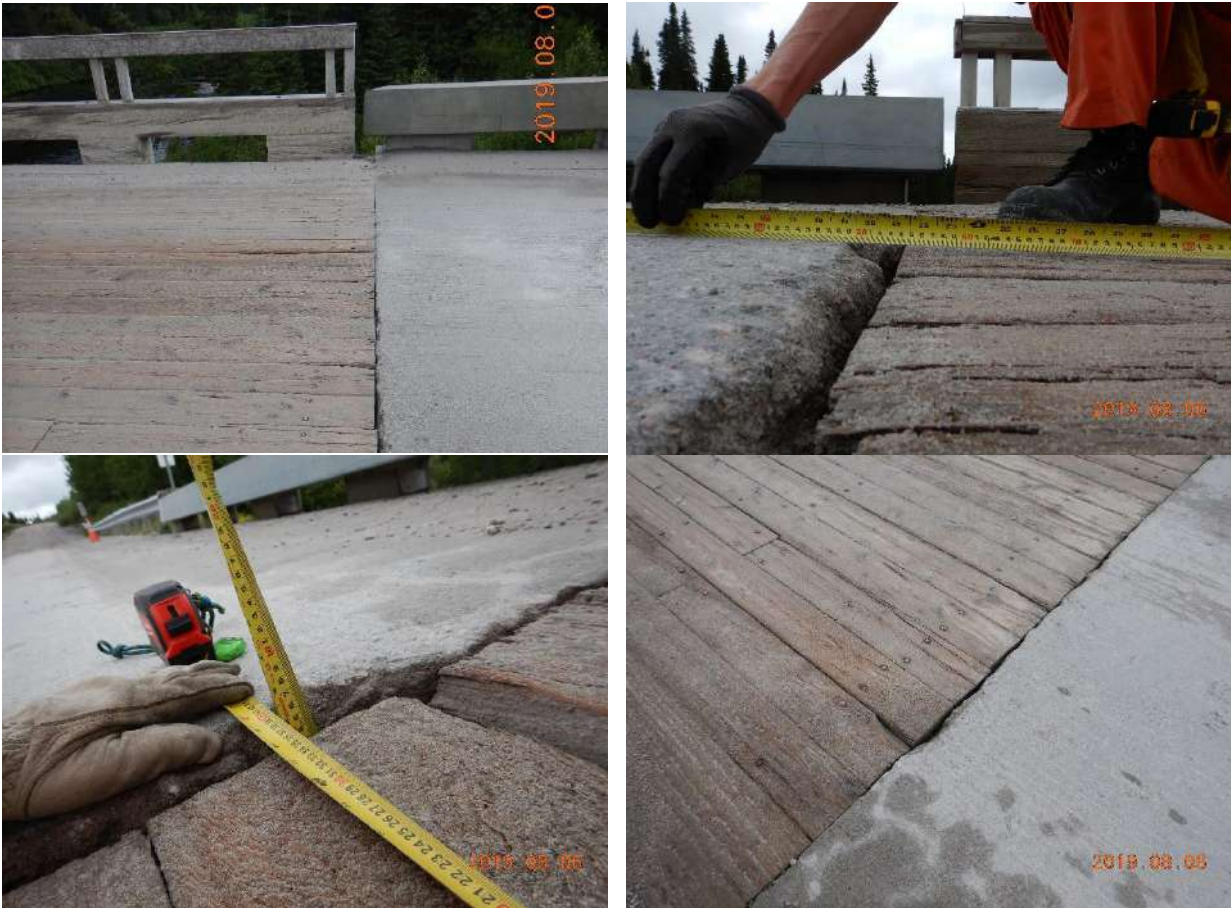
Figure 11 : Eastern approach transition

Eastern approach presents a slight unevenness between the concrete part and the wooden planking of the bridge deck that may cause low impact on the structure.

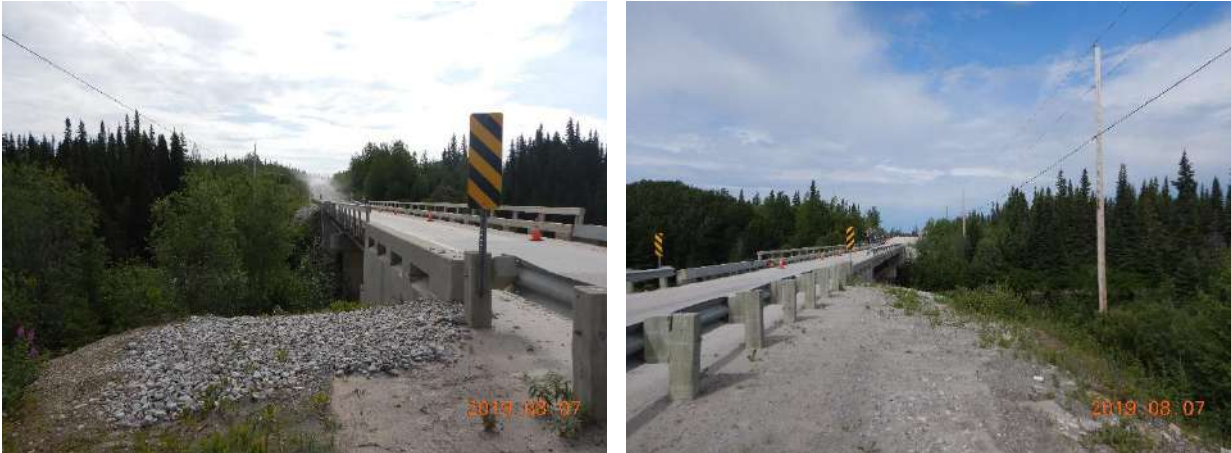
Figure 12 : Embankments

The embankments are made of sand and gravel. No loss of granular material was identified at each corner of the approaches or in front of the abutment's walls. Embankments are in good condition.

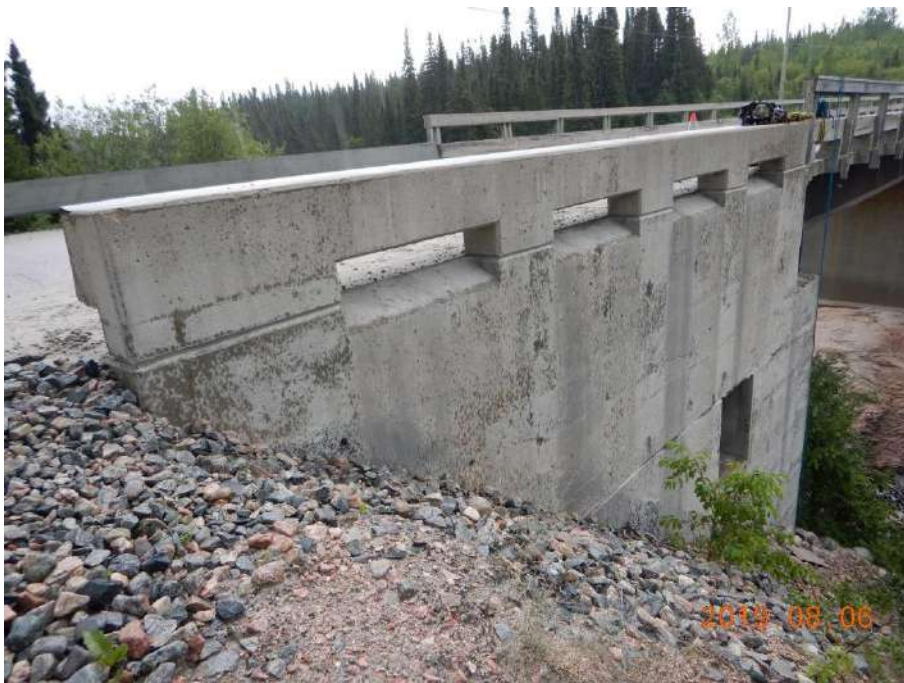
Figure 13 : Slope protection, wingwall no.1

The purpose of the slope protection is to prevent the erosion of the embankment material. The slope protection is made of stones of different diameters. While some plants are growing through the stones and some sliding of stones at the top of the slope protection (wingwall no. 1) was observed, its condition is good.

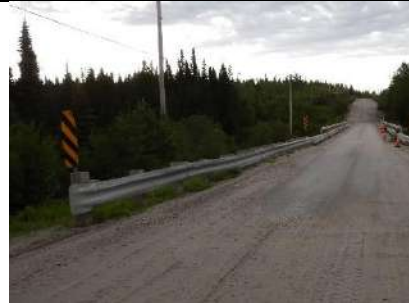
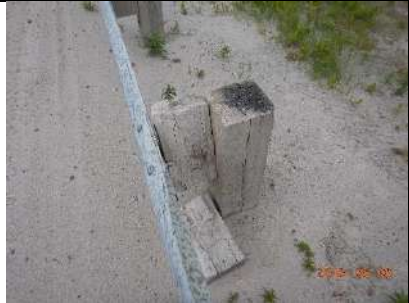
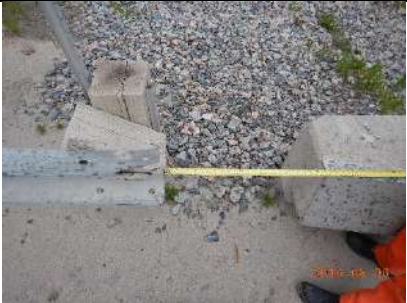
West approach		
North-West corner

Permanent deformation of flex beam and torn up guardrail.	Broken wood posts offset blocks	No connection device between the wood and galvanized steel railing and the concrete barrier

The guardrail posts on the bridge are deficient (not fixed to the transverse beams) and there is no stiffness transition and link between the flexible guard rails on the approaches and the concrete rails on the concrete slab. To ensure security of the users, corrective work is to be done in the short term. Repair of the guardrail is estimated at \$24,900.

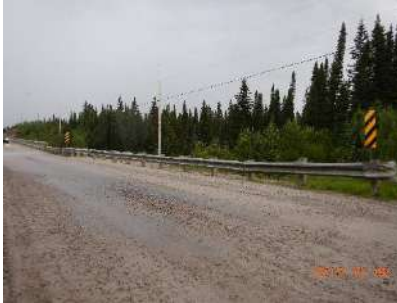
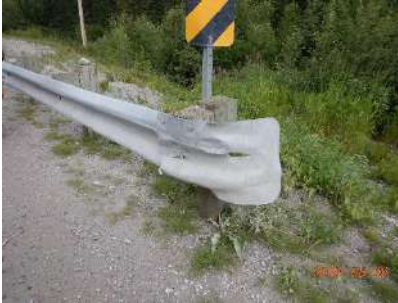
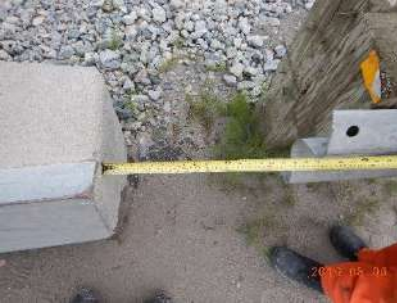
East approach		
North-East corner

Permanent deformation of guardrail and torn guardrail extremity.	Torn guardrail.	No connection device between the wood and galvanized steel railing and the concrete barrier

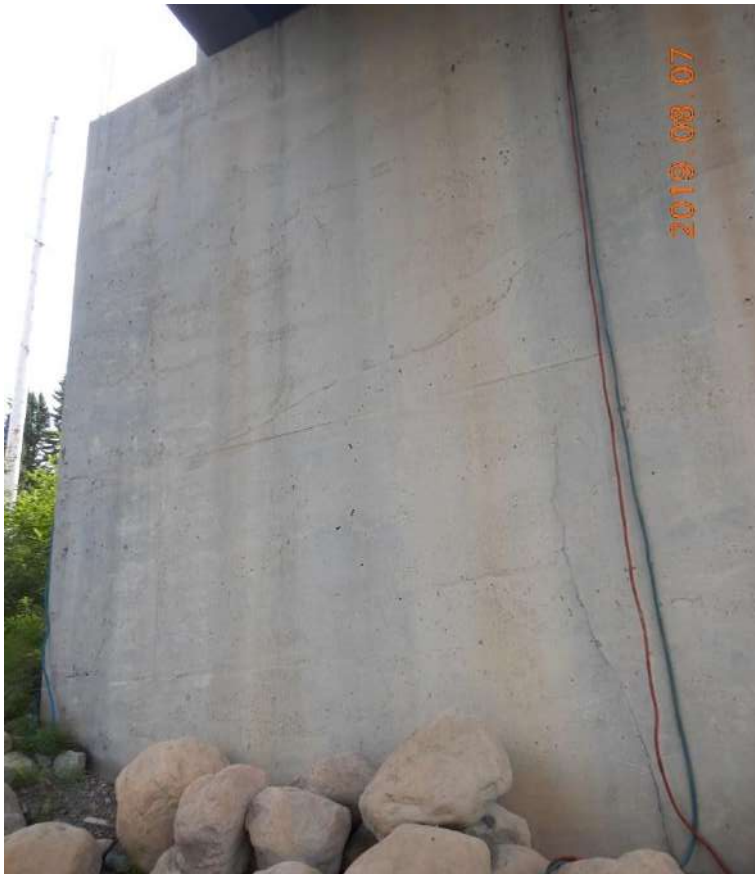
The front walls of the abutment are perpendicular to the bridge alignment. Both abutment walls are in good condition. Narrow cracks (width opening < 0,8 mm) and cold joints in concrete were identified on each front wall. General views of each front walls and typical cracks are shown in the figures below.

Figure 17 : Cold joint and narrow cracks on the East front wall

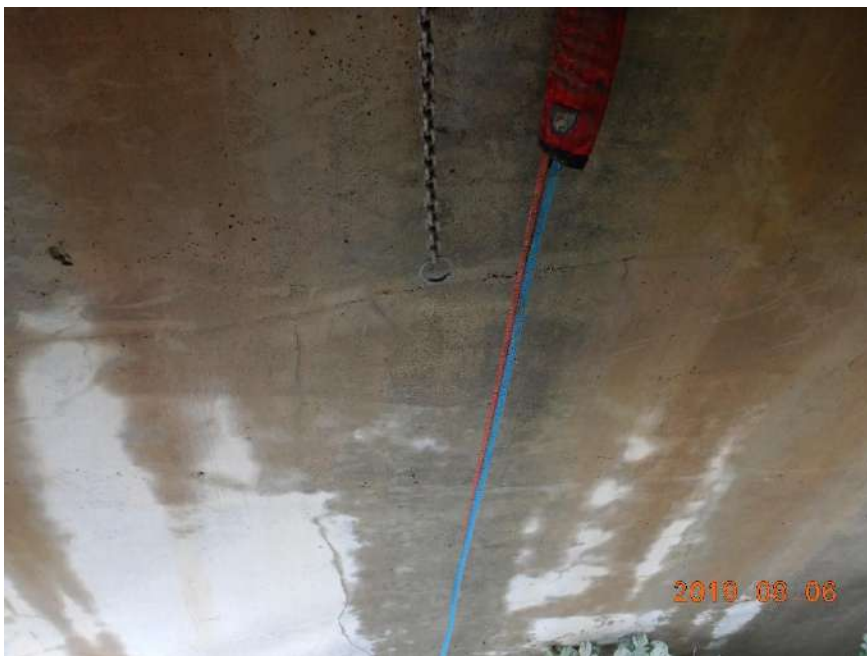
Figure 18 : Cold joint and narrow cracks on the West front wall

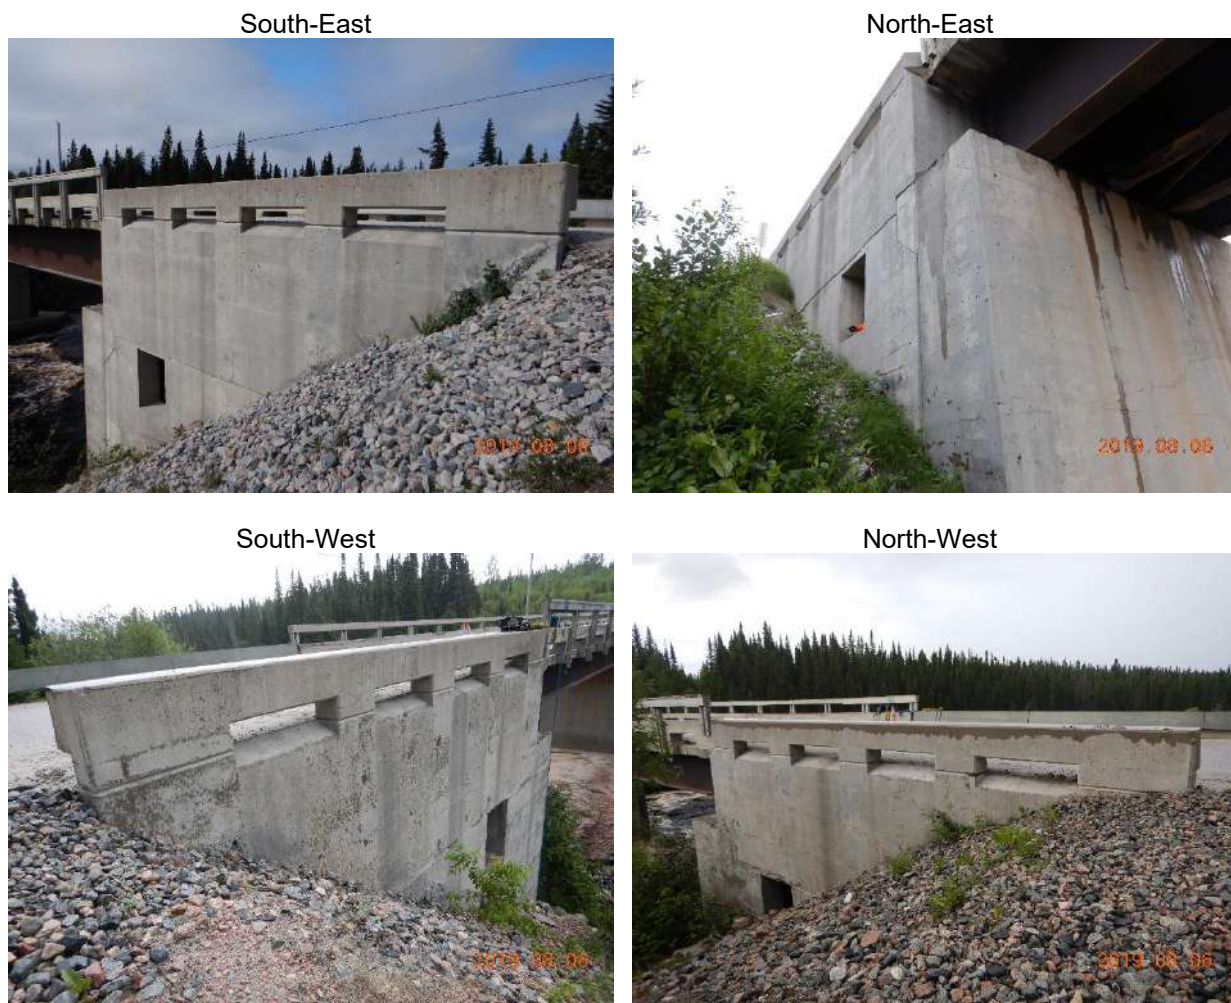
Figure 19 : Sidewalls

No concrete deficiencies were found on the side walls, except for narrow cracks in concrete (width opening < 0,8 mm). Sidewalls are in good condition.

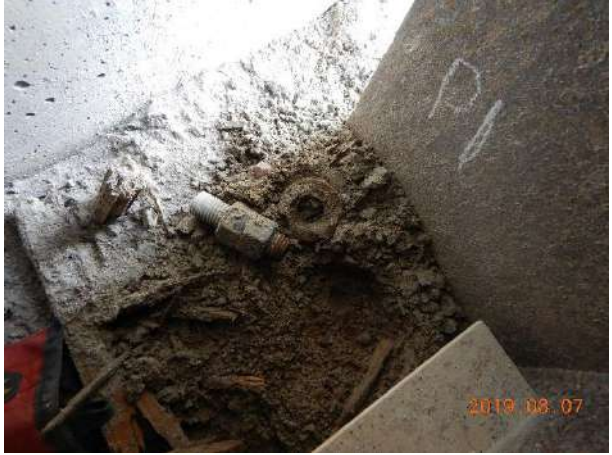
East abutment		
Beam #1	One sectioned bolt

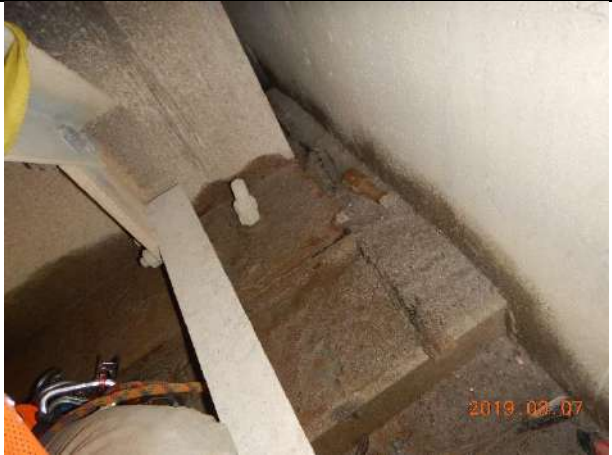
A photograph showing a sectioned bolt in a concrete abutment. The bolt is broken and surrounded by debris and dirt. A date stamp '2019.08.07' is visible in the bottom right corner.
Beam #2	One bent bolt

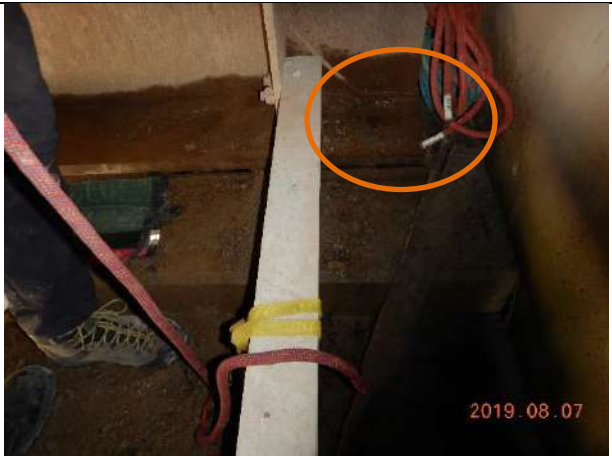
A photograph showing a bent bolt in a concrete abutment. The bolt is curved and surrounded by debris. A date stamp '2019.08.07' is visible in the bottom right corner.
Beam #3	One sectioned bolt

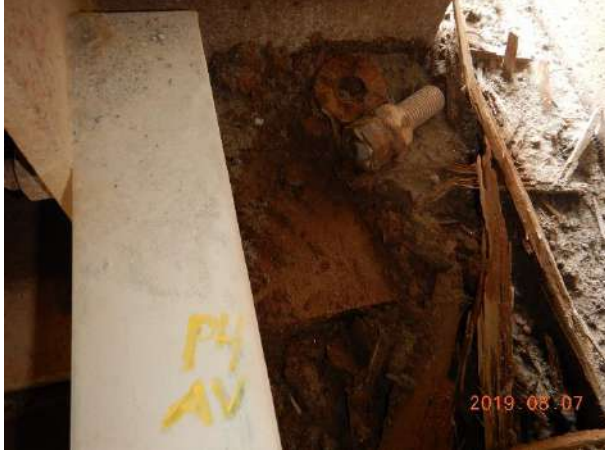
Beam #4	One sectioned bolt (interior face)

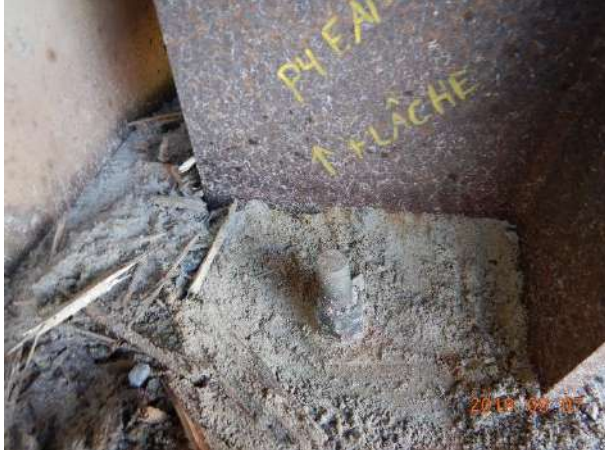
One bent and loose bolt (exterior face)

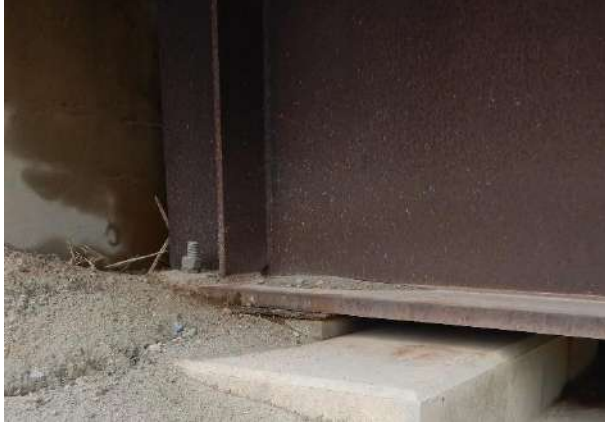
West abutment		
Beam #1	One bent bolt

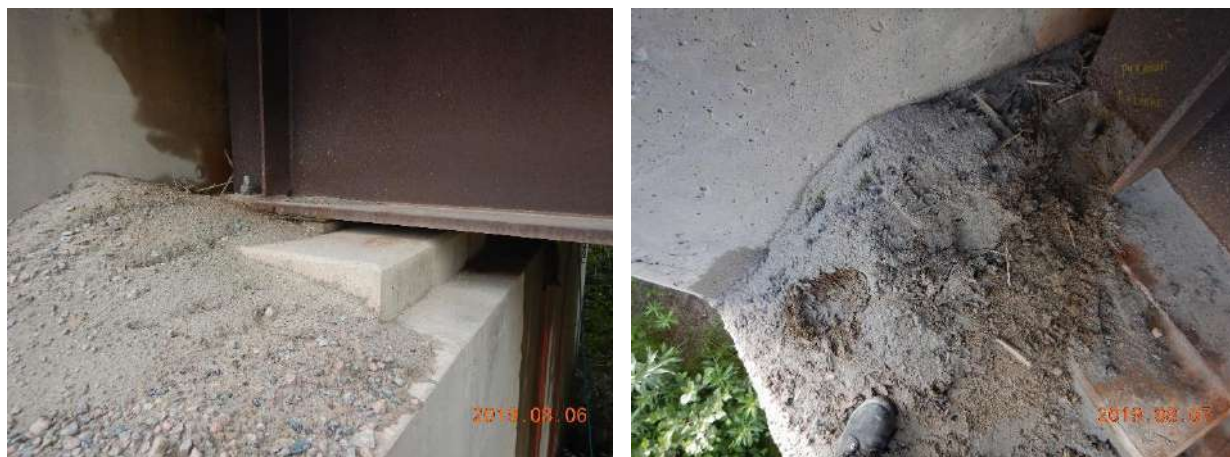
Concrete bearing pedestals are located under each end beam on the bearing seat. Bearing pedestals' dimensions are approximately 950 mm long x 1030 mm width x 150 mm height. No concrete deficiencies such as delamination or spalling was noted on these elements. Debris are covering the most part of the bearing seat and the bearing pedestals of both abutments. Bearing seat and bearings pedestals are in good condition.

Figure 20 : Debris on the bearing pedestals (West and East)

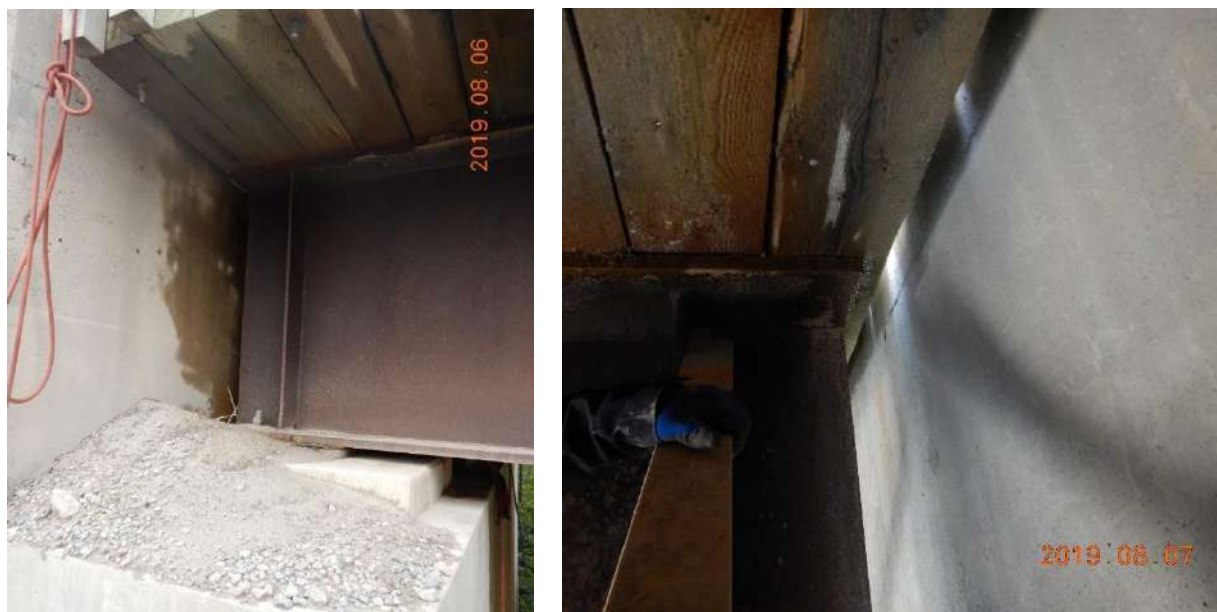
Figure 21 : Ballast walls (Left: West and Right: East)

Ballast walls of west and east abutments are in good condition. No concrete deficiencies were noted on these elements. Narrow cracks were observed (width opening < 0,8 mm).

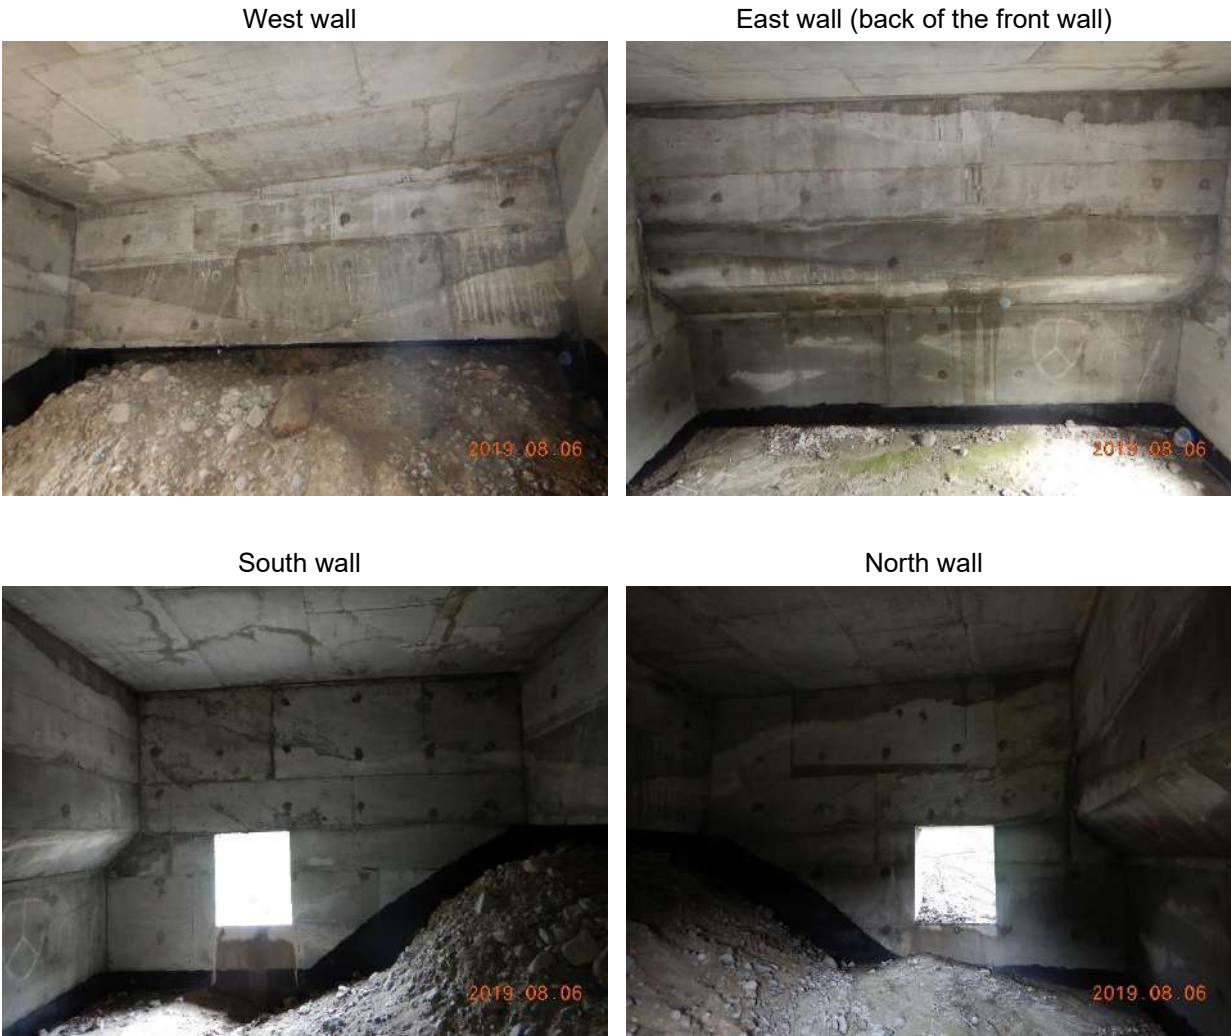
Figure 22 : West abutment's interior

Both abutments' interior are accessible through an opening in the sidewalls. Walls and deck soffits of both abutments are in good condition. Narrow cracks were noted on the concrete (width opening < 0,8 mm).

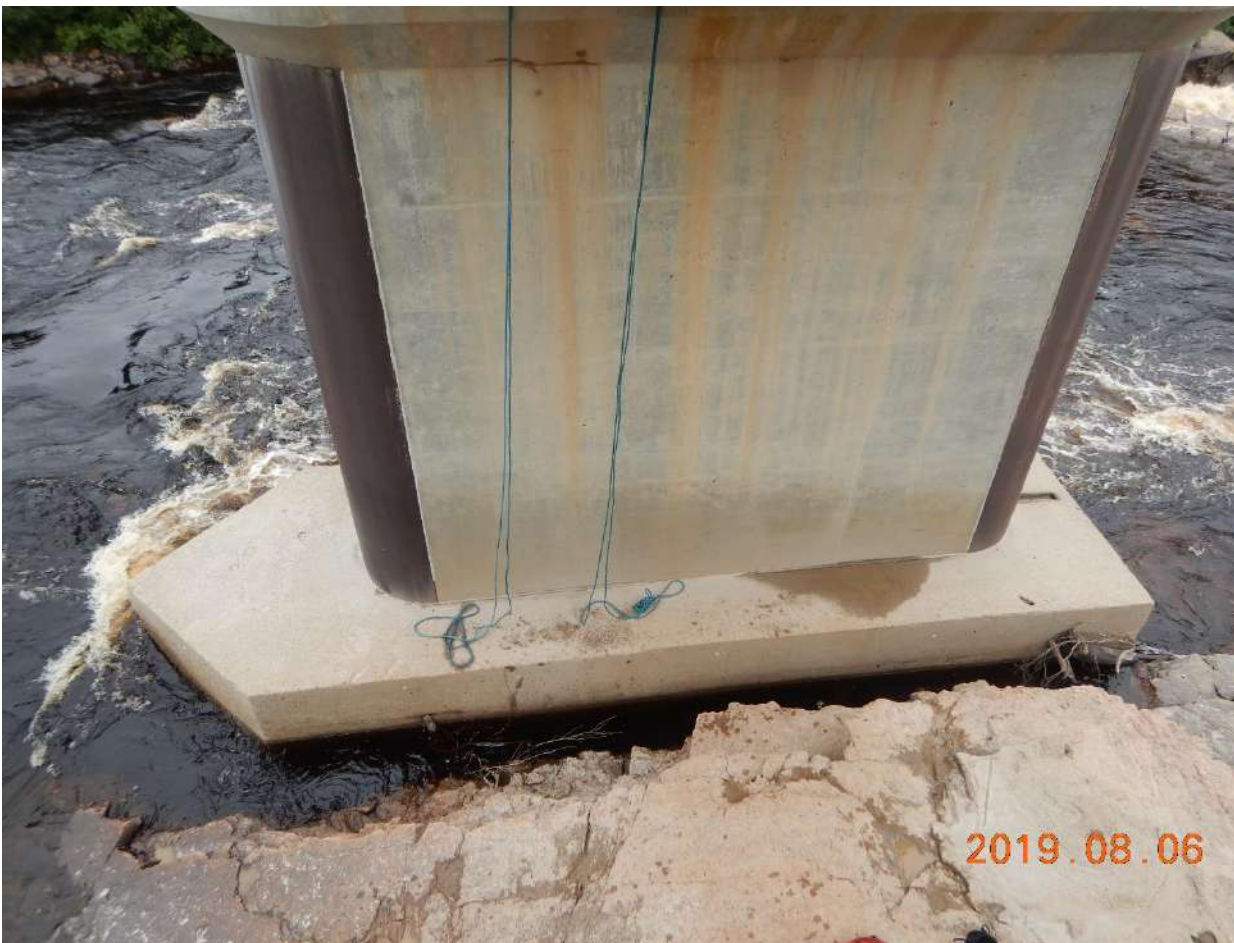
West elevation

The pillar foundation is in good condition. No movement of the structure and no loss of material under the foundation were observed at the time of the damage survey.

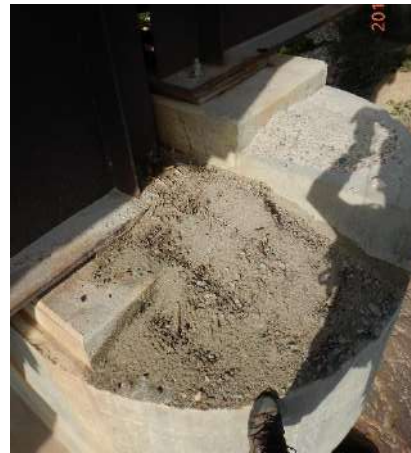
Tels qu'observé durant l'inspection, il y a des déformations permanentes des glissières de sécurité aux approches du pont (voir doc réf [7]). Une fissuration oblique, qui débute du coin extérieur de l'assise du côté sud du chevêtre, a également été notée sur le pilier. La fissure a une largeur inférieure à 0,8 mm (voir doc ref [7] p.25).

Vertical crack width < 0.8 mm

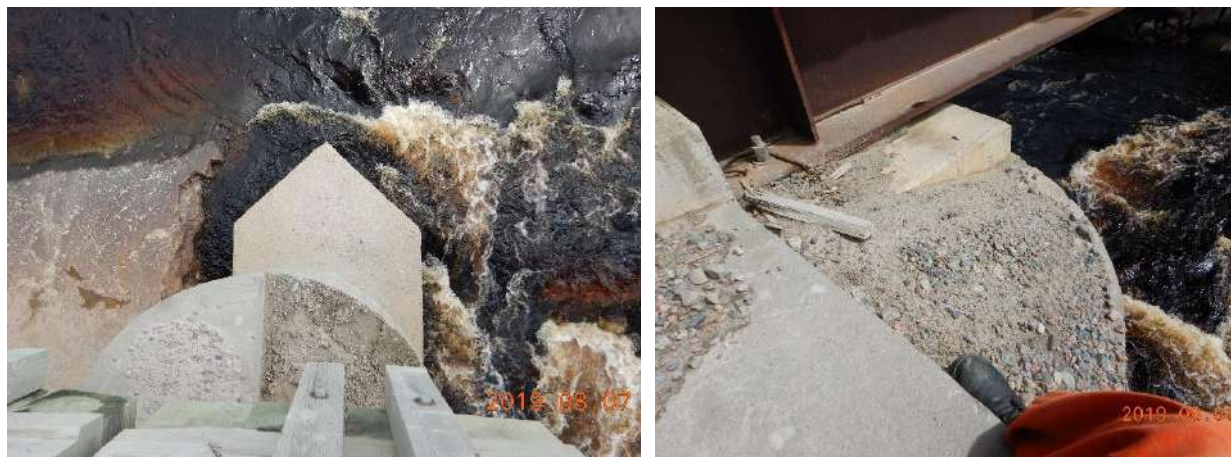
Figure 27 : Pile's bearing seat

The bearing seat is located at the top of the pier cap. Debris are covering some parts of the pier's bearings' seat. Bearing seats are in good condition.

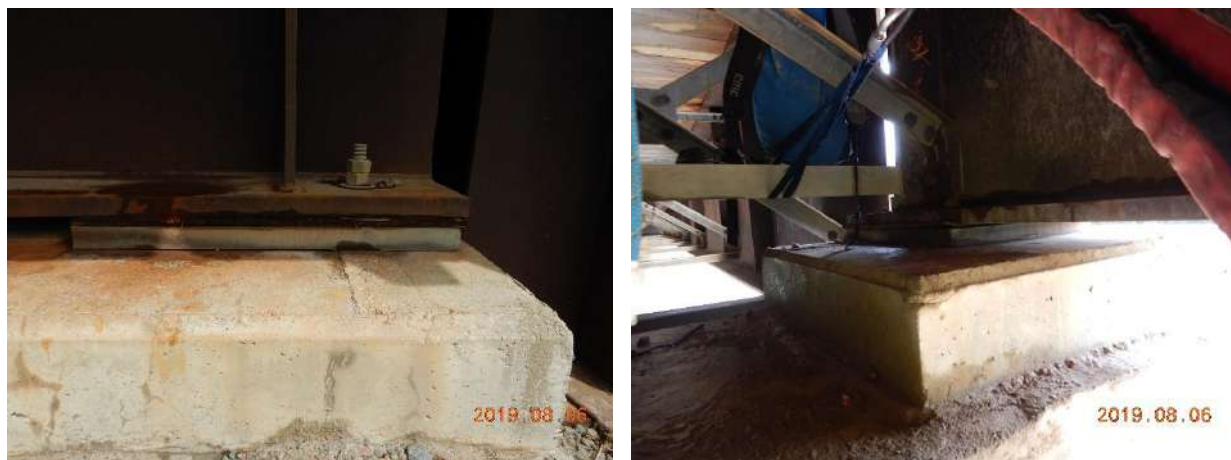
Figure 28 : Pile's bearings and pedestals

Concrete bearings (steel plates and elastomeric plates) and pedestals are located under each beam. The bearings are in good condition. Bearing pedestals are in good condition and no defects were identified.

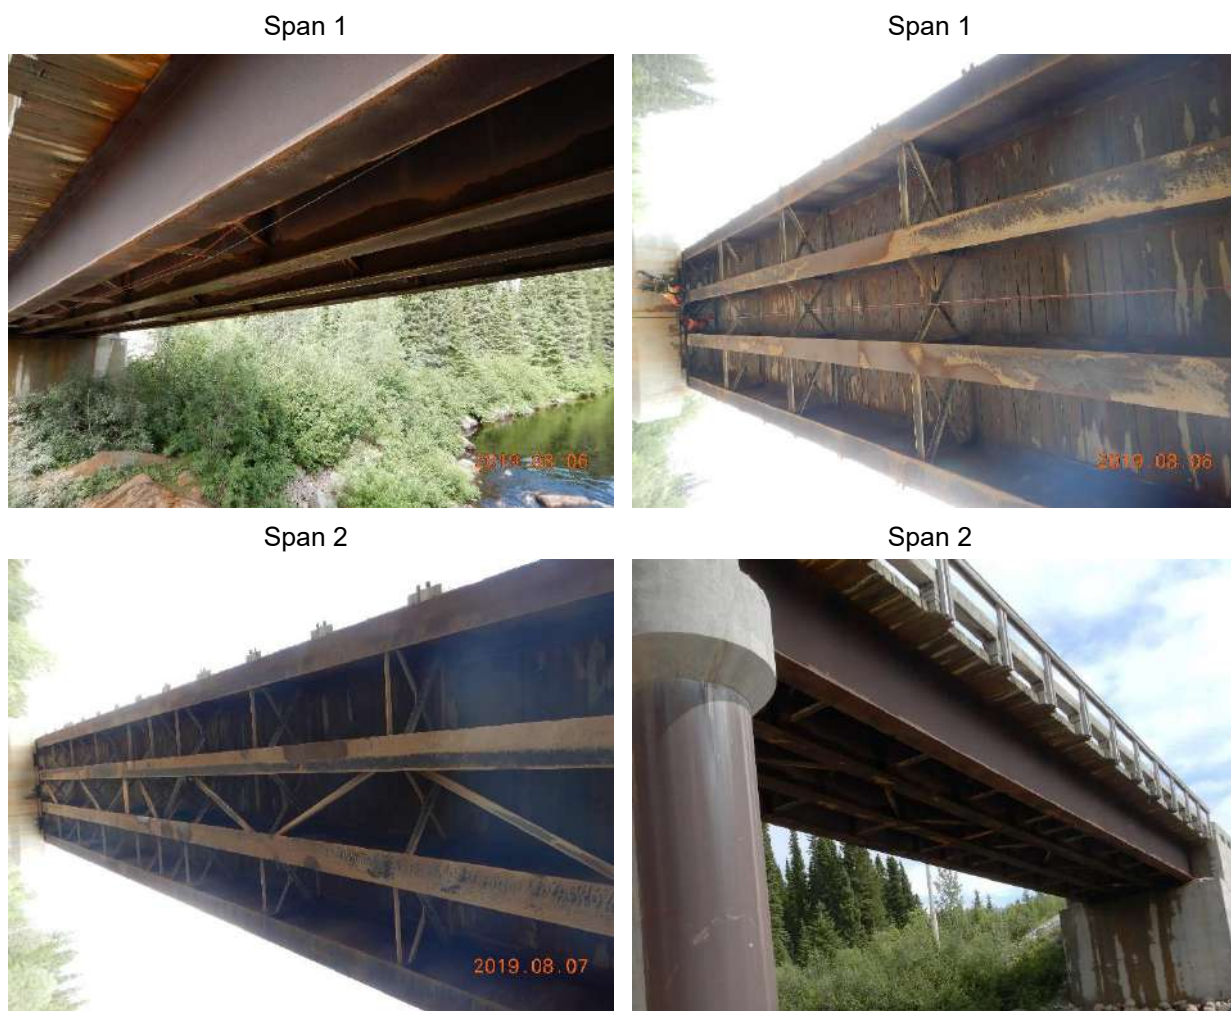
Figure 29 : Beams general views

Nous n'observons pas de détérioration notable liée à la corrosion des poutres en acier. Cependant, nous recommandons de repeindre les semelles supérieures de la structure lors de l'installation du nouveau platelage en bois pour assurer sa protection et sa durabilité.

Beams are in good condition. No important steel section loss was noted in the damage survey.

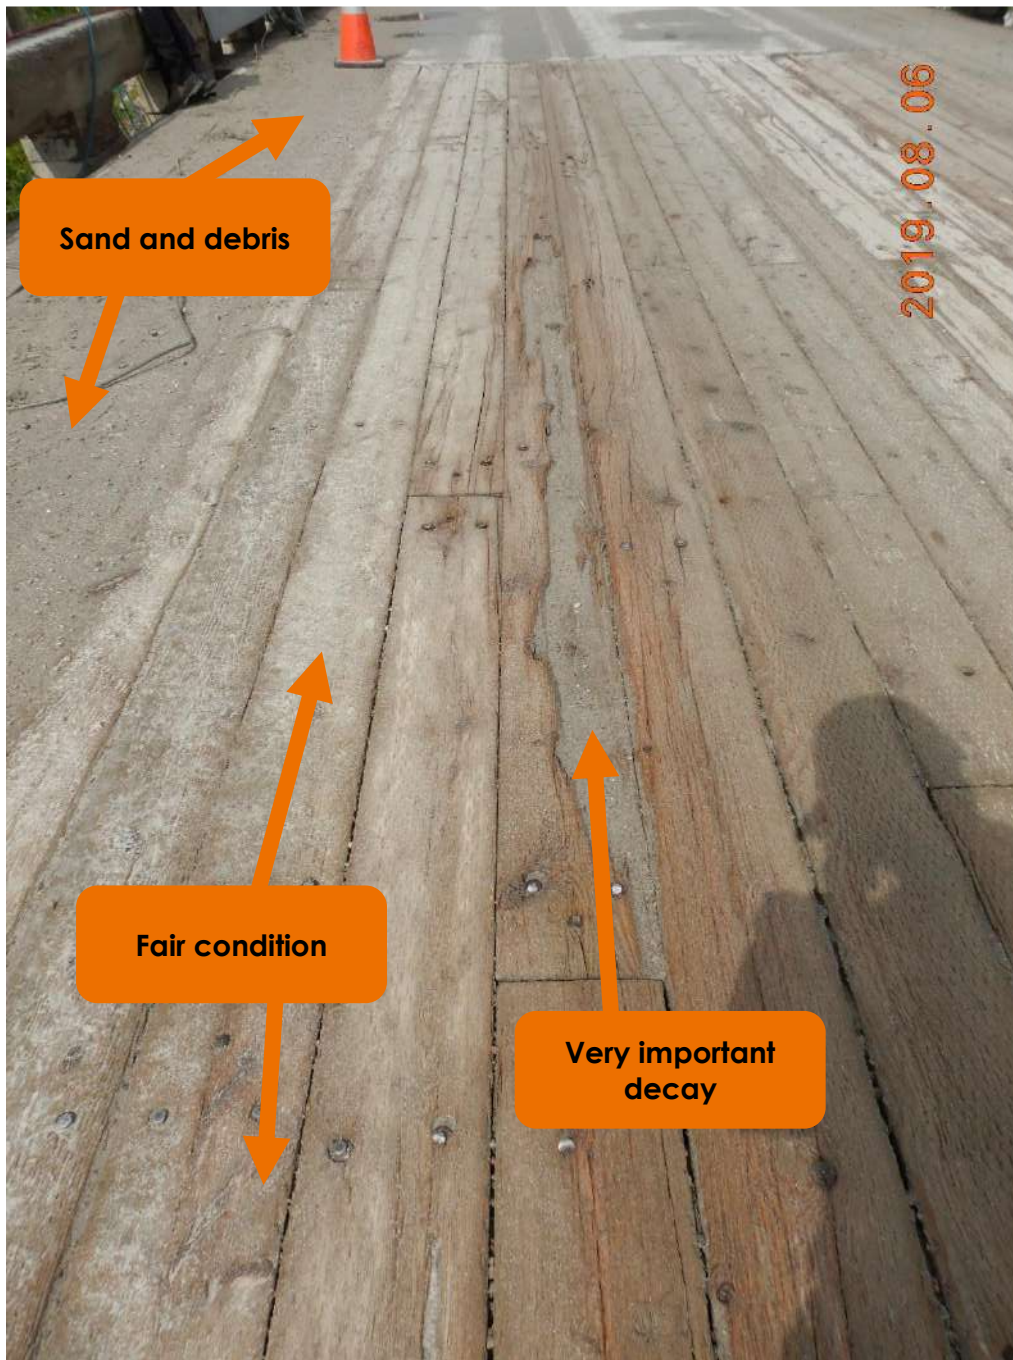
Figure 32 : Wooden Plank Surface

The wearing surface is made of wooden planks. The roadside (25% of the surface) is covered of sand and debris, which makes it not possible to inspect. The visible part of the surface (the clean part) has 5% of its wooden planks with important decay. Another 5% has very important decay. A few bolts were scattered on the surface. There is no joint on the wearing surface above the pile. The wearing surface is in a fair condition.

However, the few defects and problems identified during the inspection show that maintenance has to be done on specific elements to ensure the sustainability of the structure. The wooden wearing surface is partially decayed and should be scheduled to be replaced in the next 5 to 10 years. In the eventuality where the structure enlargement project goes forward, it should be considered to use the same contract to replace the wooden wearing surface on the existing bridge. Estimation cost for the replacement of the wood surface is \$45,000.

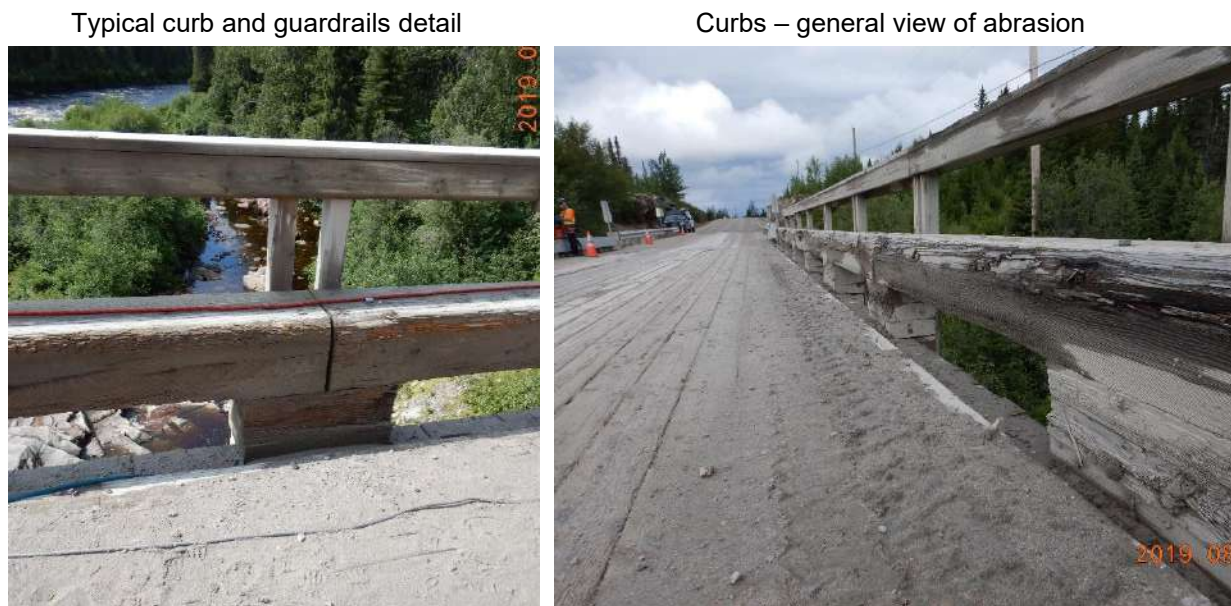
Figure 33 : Road curb

The curbs are in good condition. In both spans, they present medium abrasion on its corner.

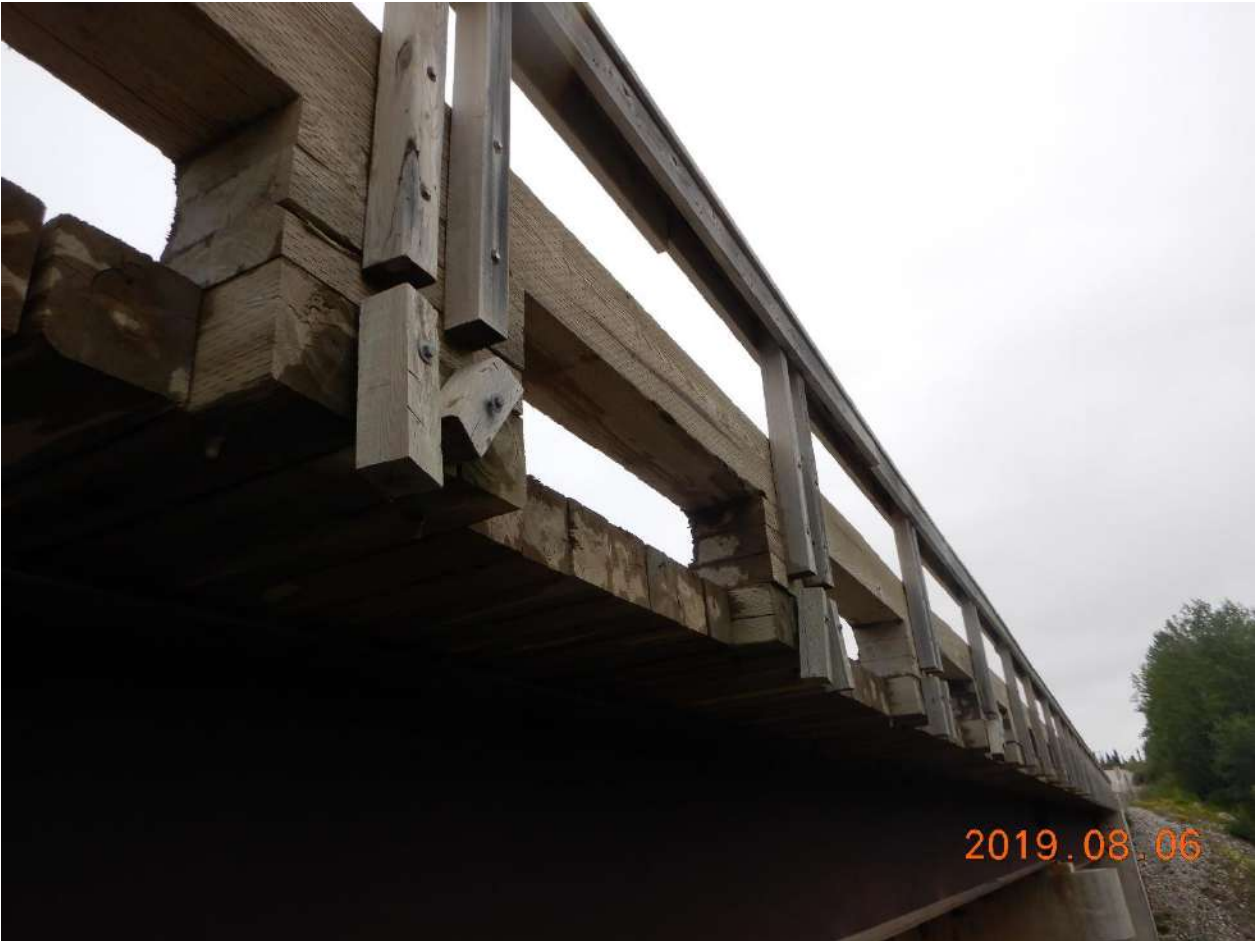
Figure 34 : Wood guardrails – span 1

Both sides of the bridge are protected by wood guardrails. In some places, the posts of the guardrails are not fixed to the timbers, where they should be. Instead, they are fixed to the curbs or the anchor of the curbs. At some places, posts are cut. Therefore, the condition of the guardrails is judged to be poor.

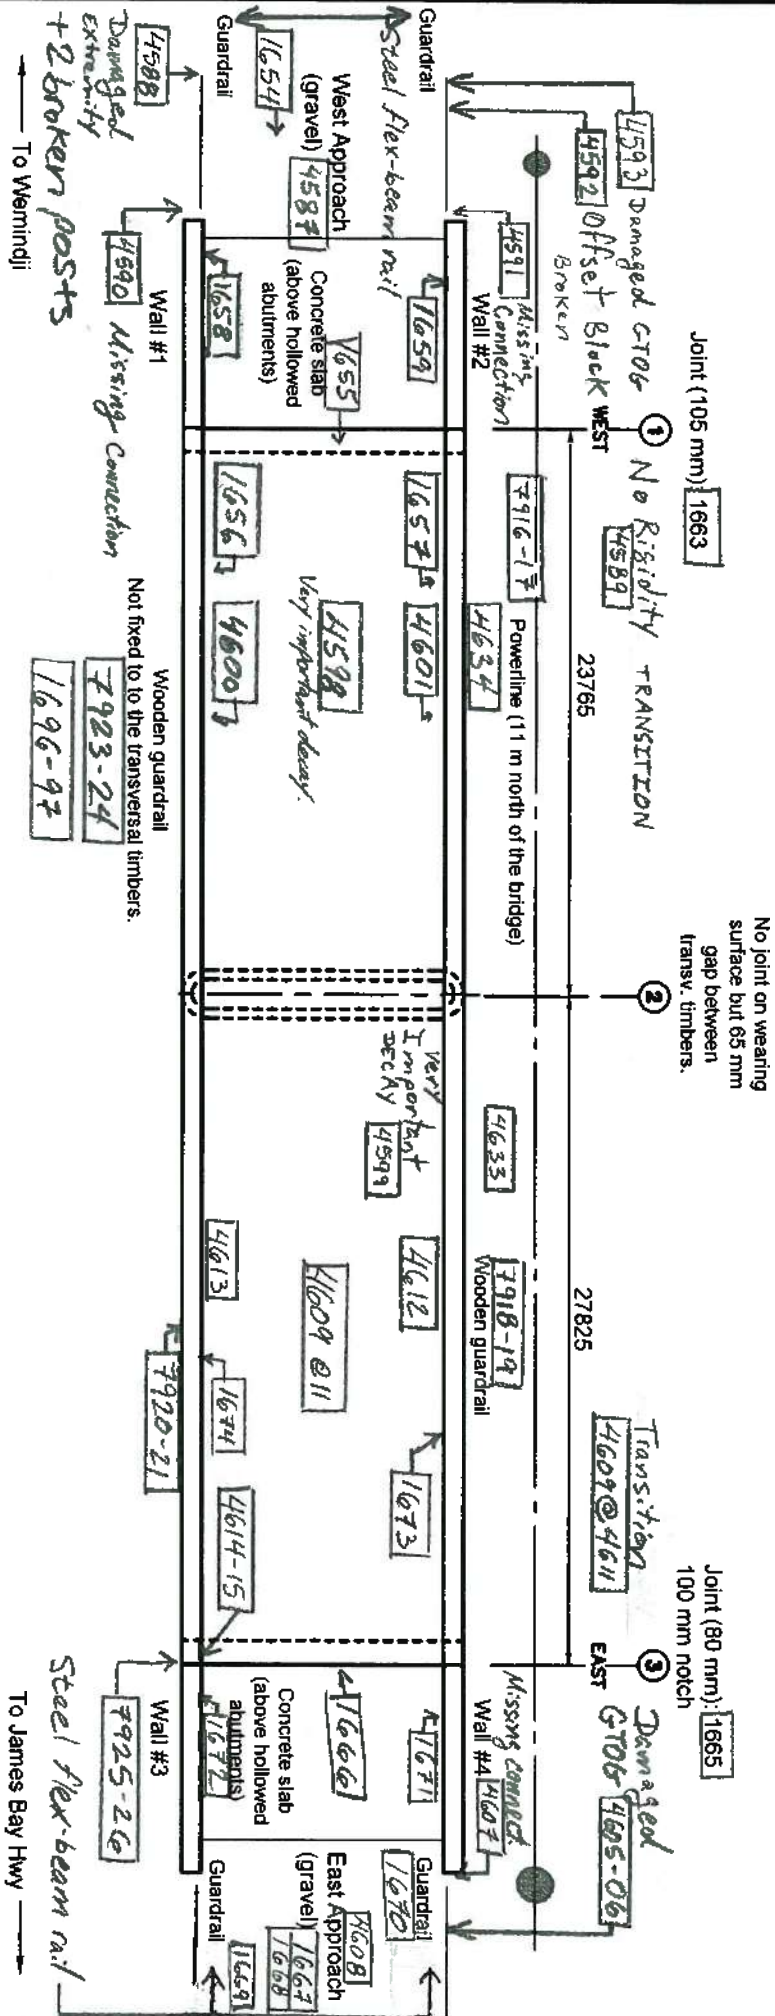
GENERAL PLAN VIEW

Guardrails' Typical Defects
 No connexion between the concrete guardrails.
 Damaged approach extremity of the guardrails.
 Guardrail markers are loose and not installed properly.
Rigidity Transition is missing (all)
