VOLUME 6 - APPENDIX SECTION 6.9 – GREVET-CHAPAIS RAILWAY BRIDGE INSPECTION

Consultant Reference: LGA-1-GN-F-FRN-RT-0006_00_Appendix6.9
2023-04-14

91.0 Chapais O'Sullivan River
LAT. N 49.24208 Long. W 76.27592
Type 3 DPG (Length 186 feet height 22 feet)

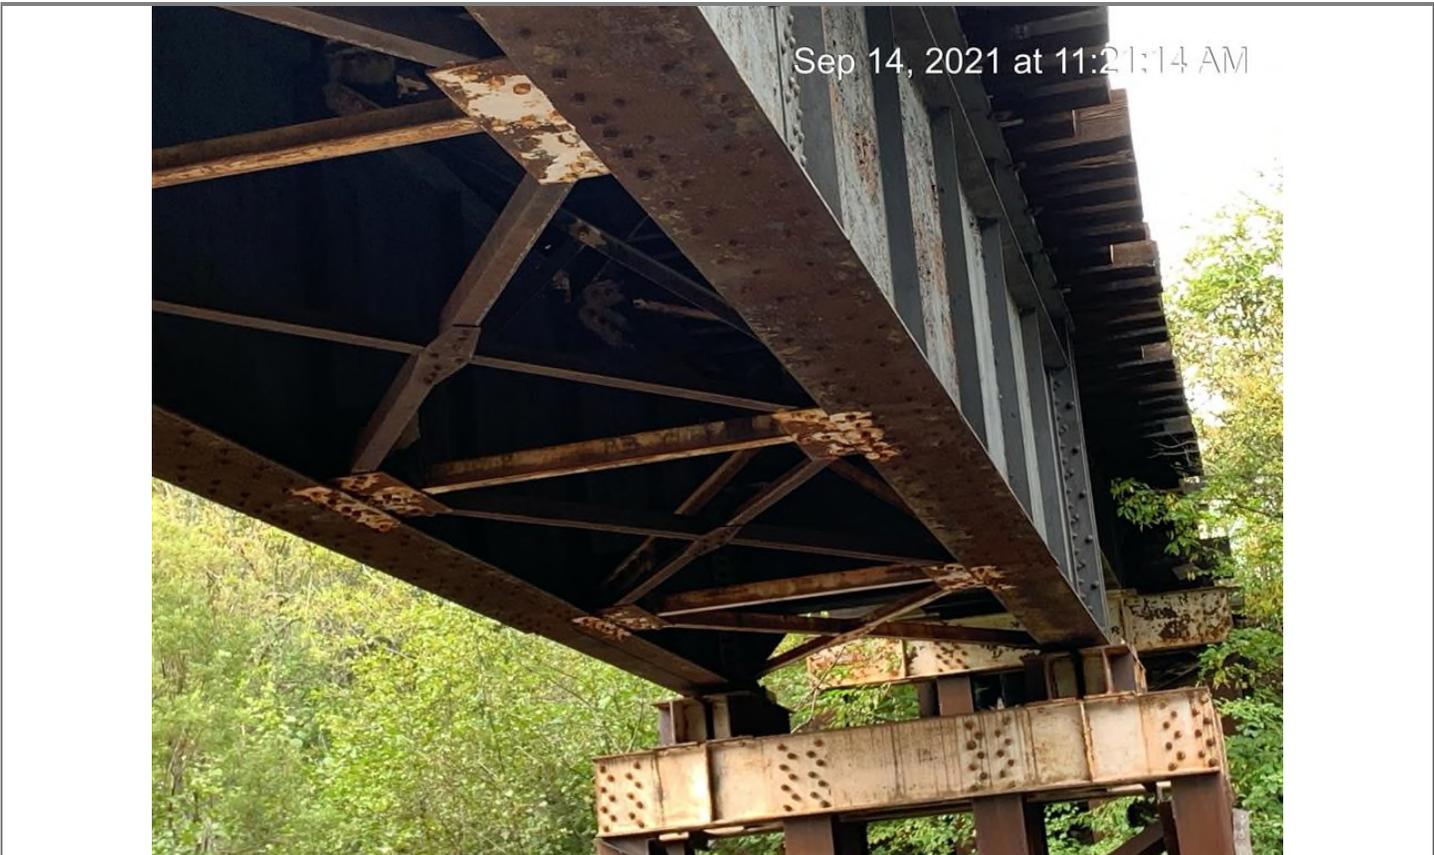
Number	P-158100425-14/09/21-681-YR	Date (AAAA-MM-JJ)	14/09/2021
Location	101.8 Chapais span 4 & 5		
Remark	View of connection between span 4 & 5

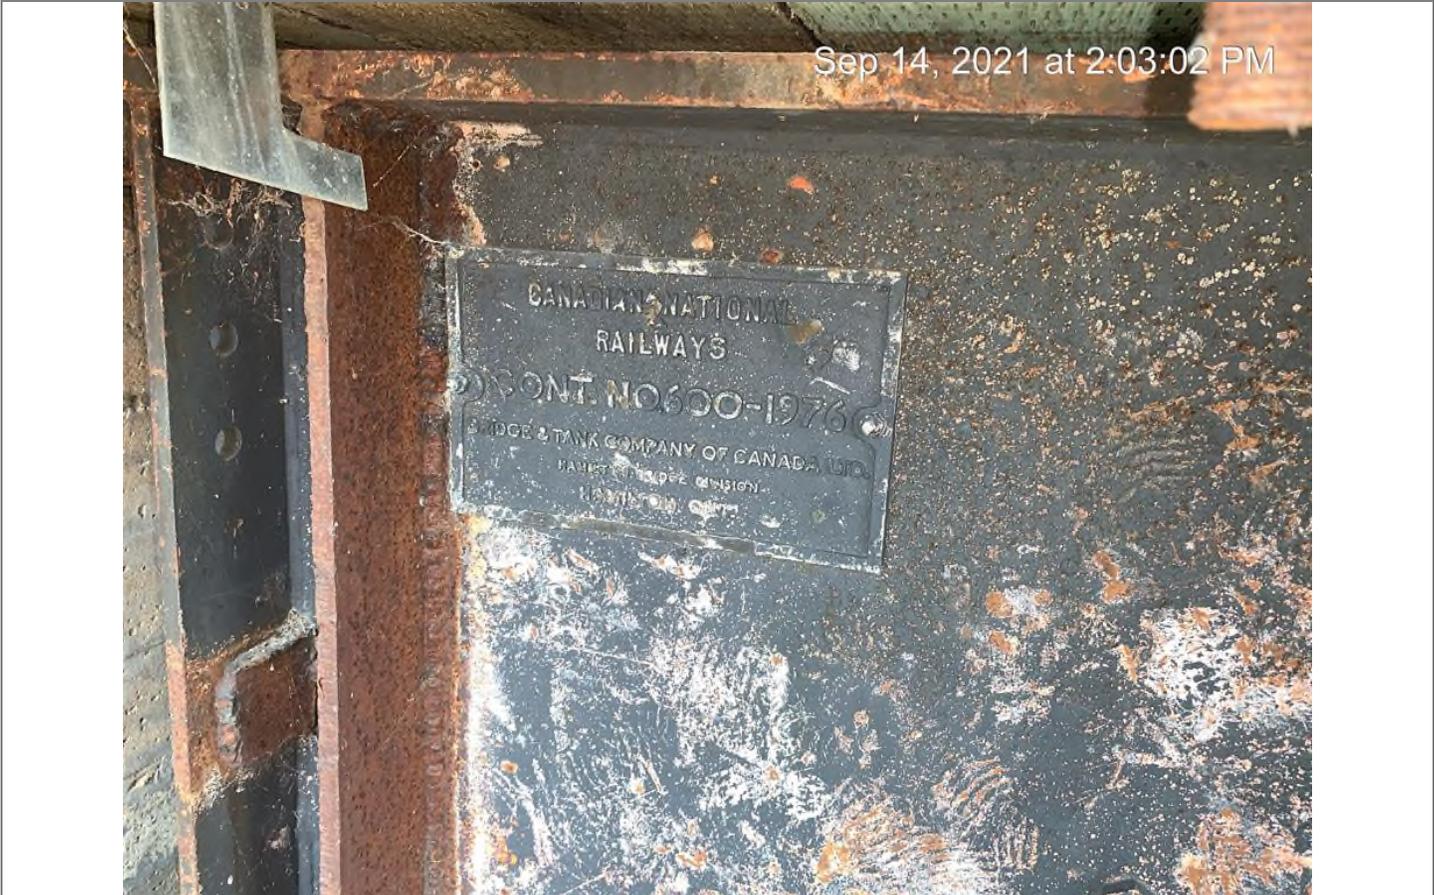
Number	P-158100425-14/09/21-713-YR	Date (AAAA-MM-JJ)	14/09/2021
Location	118.8 Chapais		
Remark	North end West side name plate on bridge.
