ENGINEERING CONSULTING SERVICES
VOLUME 6 - APPENDIX
SECTION 6.25 – WEMINDJI ACCESS ROAD
Feasibility Study Final Report Phase I

Feasibility study of
Maquatua River crossing
bridge - Wemindji.

**DAMAGE SURVEY OF THE ACCESS ROAD
BRIDGE OVER MAQUATUA RIVER IN
WEMINDJI**

2019 Damage Survey Report,
Wemindji, QC Canada
Project #152700393

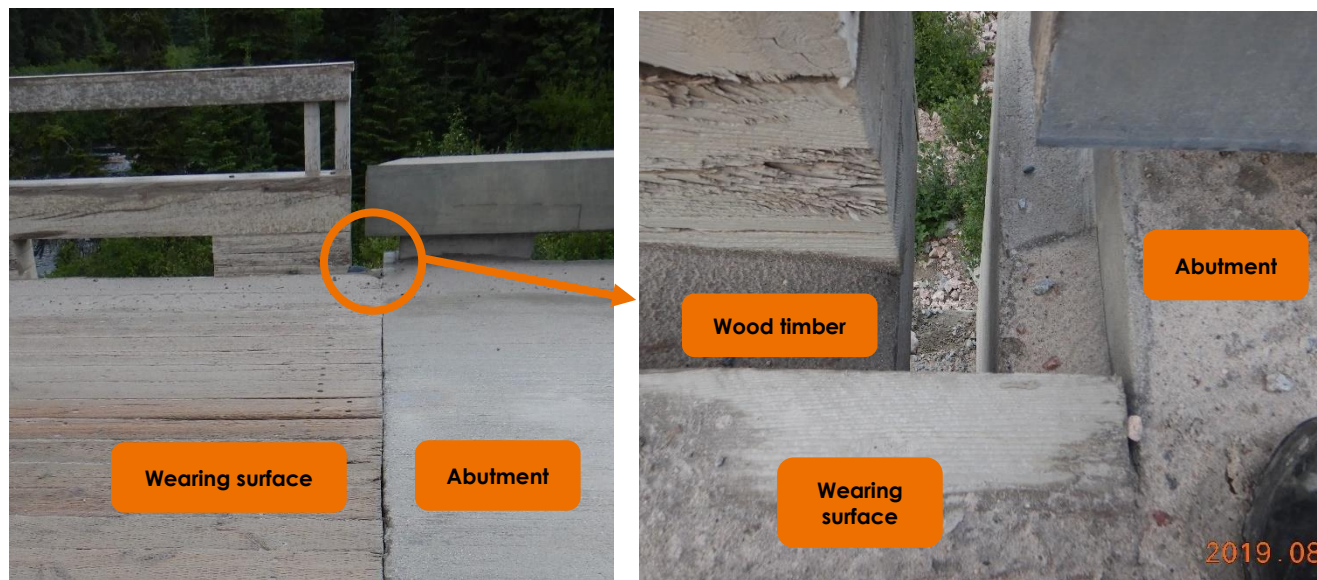
Figure 6 : Deck detail

The deck of Wemindji access road bridge is made of wood timbers and the wearing surface is also made of wood planking surface. The wood planking surface is slightly longer than the deck length (wood timbers) because it sits on a ledge at the top of the abutment walls. An open joint (space) is present between the ballast wall and the first wood timber of the deck. The structural detail is shown in the picture below.

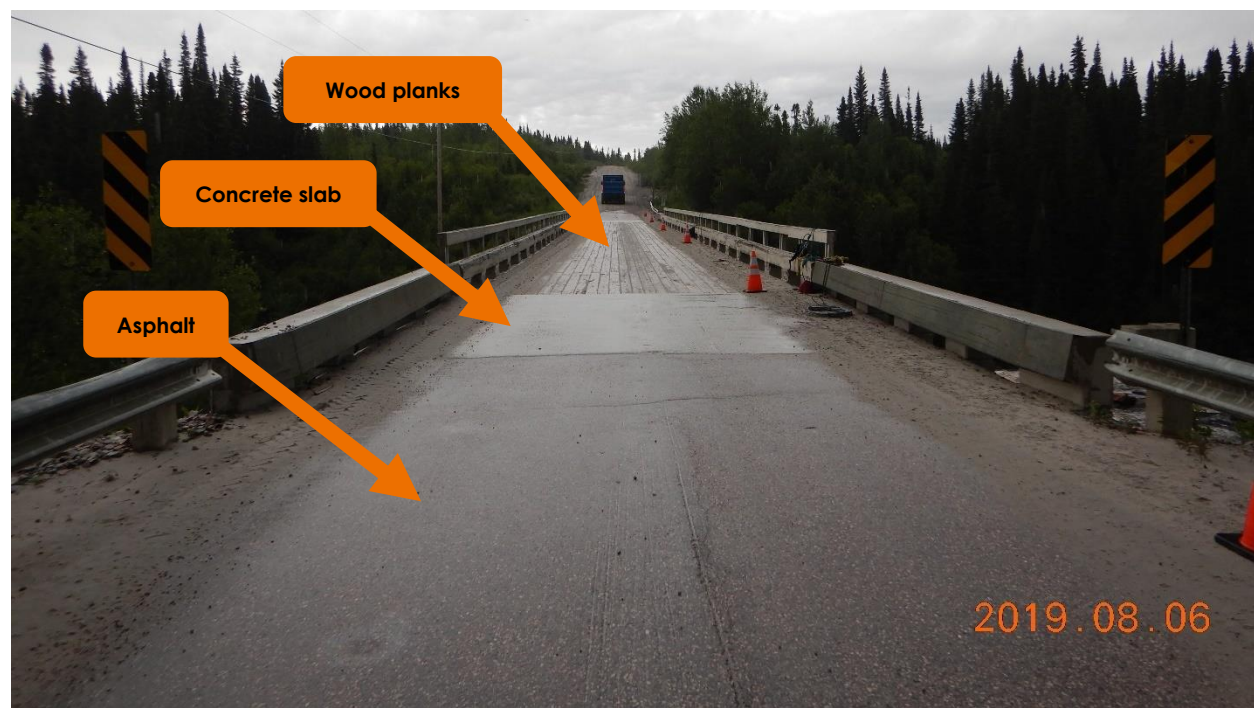
Figure 8 : Western approach

The approaches' asphalt pavement is making the transition between the gravel and the concrete surface (concrete deck of the hollowed abutments). It is damaged by cracks and potholes that allows the water to infiltrate the infrastructure under the pavement and possibly accelerate its deterioration. A concrete slab serves as pavement transition between the asphalt approaches and the wooden planks. No expansion joint is separating the different materials.

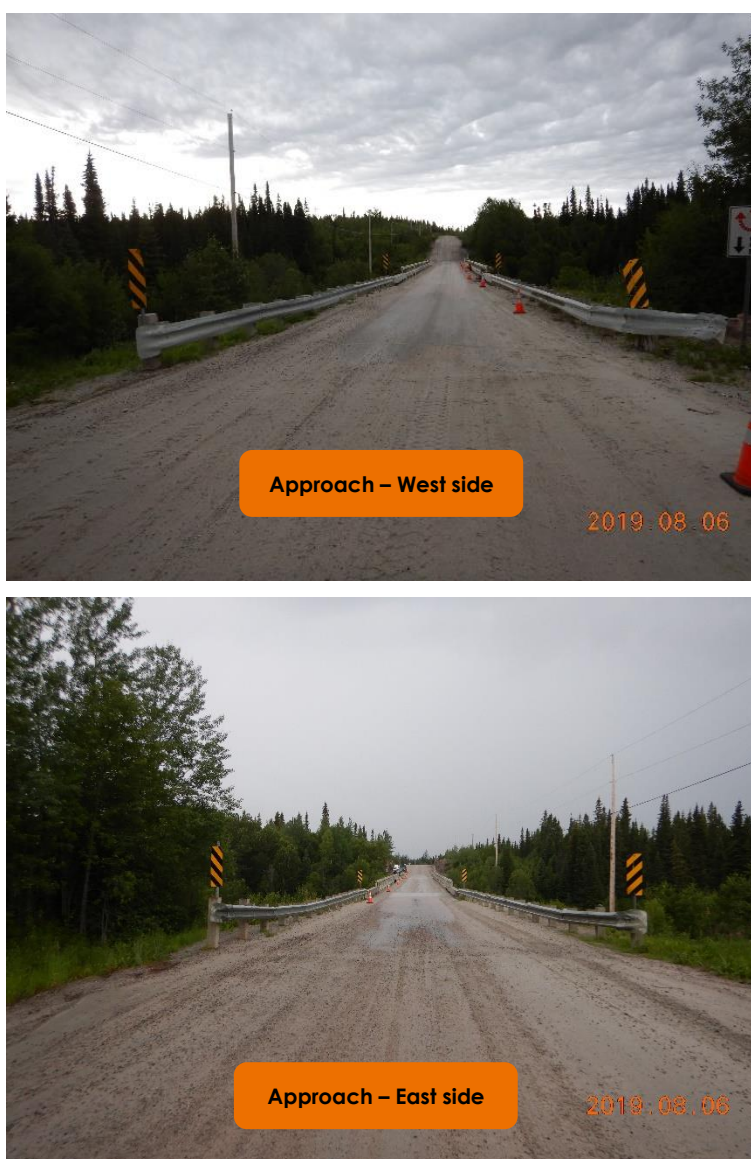
Figure 14 : Wood and galvanized steel *Guardrails*

At first, guardrails are the first protection device while approaching the bridge. A guardrail is a semi-rigid structure made of galvanized steel and wood. Its purpose is to slide the vehicle that might leave the road. Wood and galvanized steel guardrails are installed on both approaches. Wooden posts are in bad condition (some are broken, and some are decayed) and the galvanized steel railings are deformed by impacts. Extremities of galvanized steel railings were possibly hit by cars and are deformed and/or torn up at each end of the structure. No rigidity transition is in place between the semi-rigid wood and steel railing and concrete rigid guardrails.

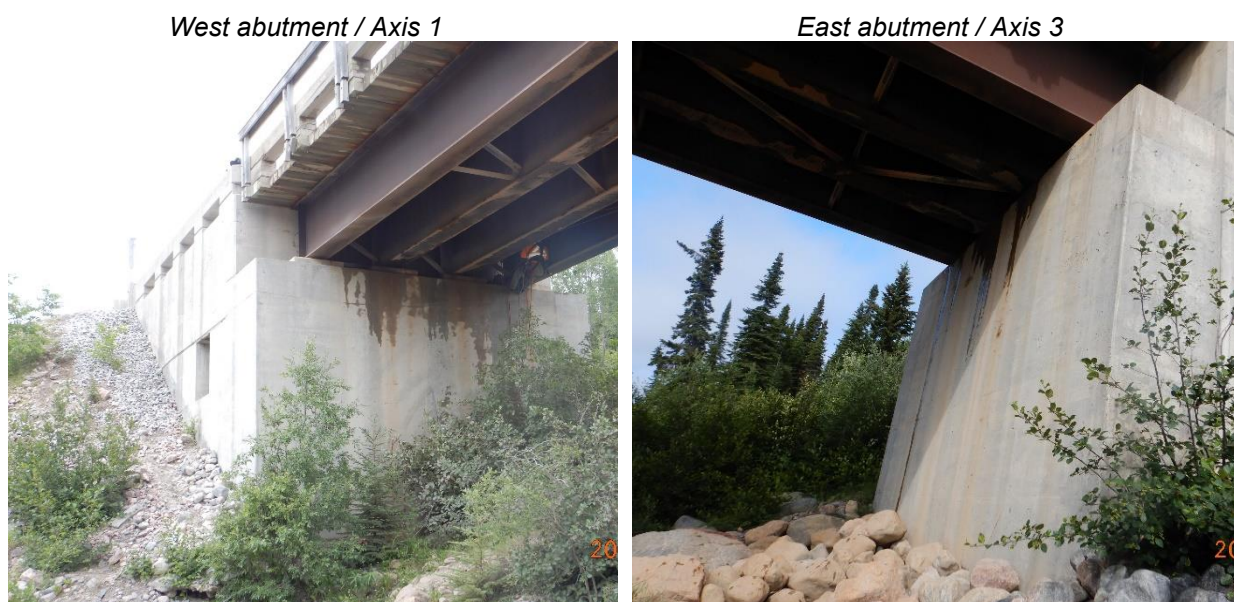
Figure 16 : Front Walls general views

The front walls of the abutment are perpendicular to the bridge alignment. Both abutment walls are in good condition. Narrow cracks (width opening < 0,8 mm) and cold joints in concrete were identified on each front wall. General views of each front walls and typical cracks are shown in the figures below.

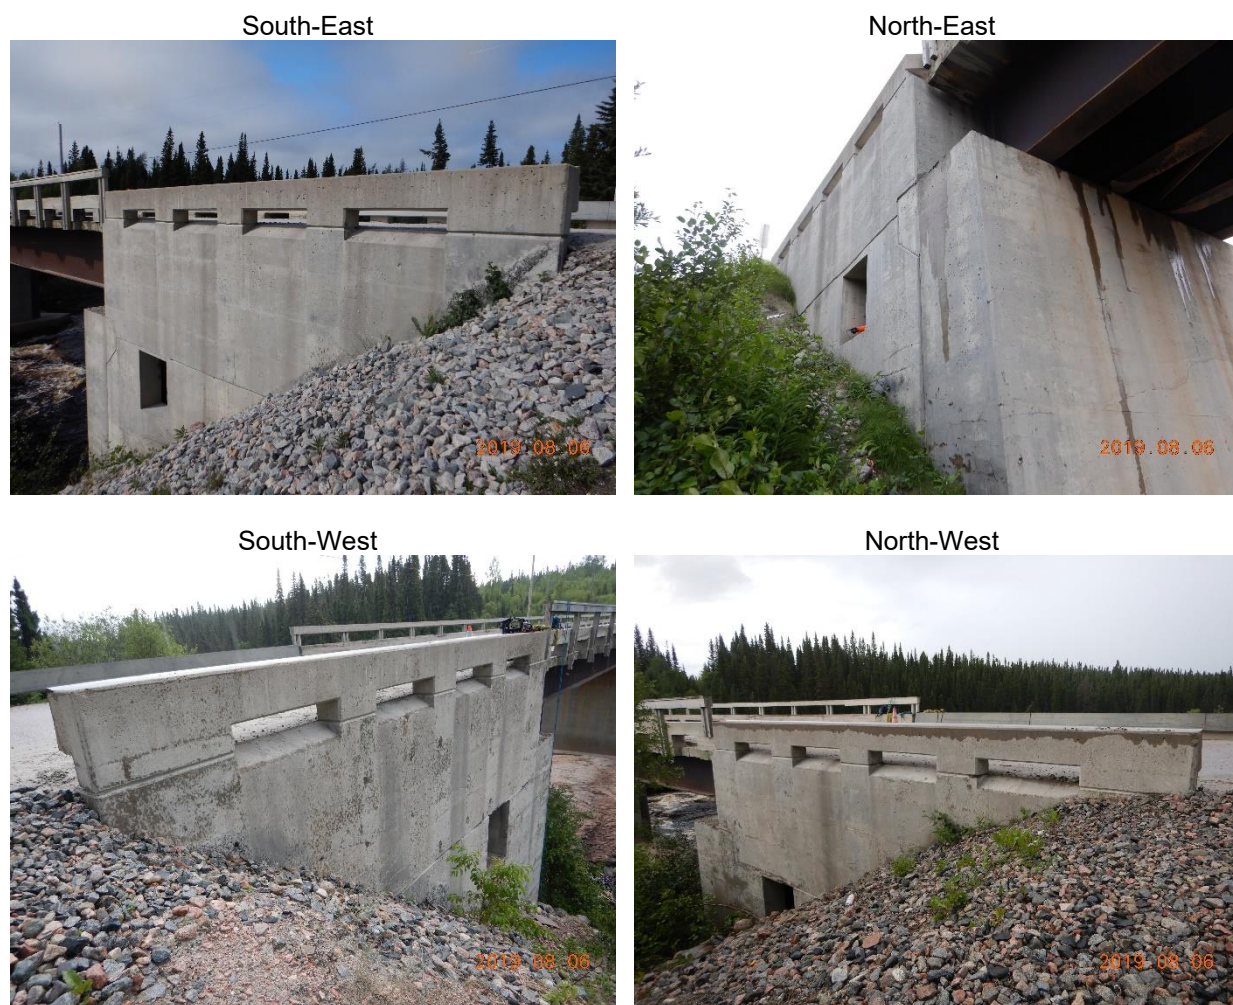
Figure 19 : Sidewalls

No concrete deficiencies were found on the side walls, except for narrow cracks in concrete (width opening < 0,8 mm). Sidewalls are in good condition.

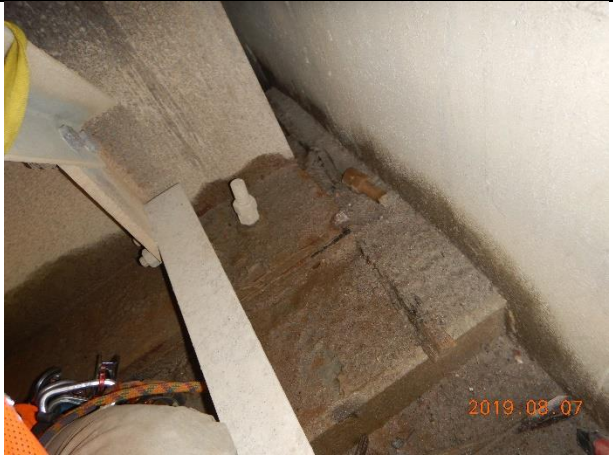
Beam #2	One bent bolt

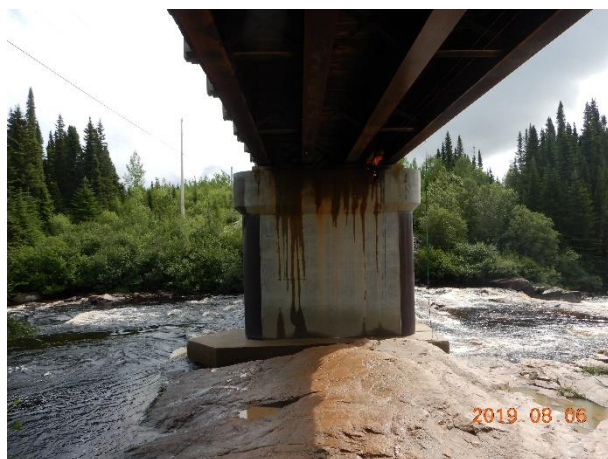
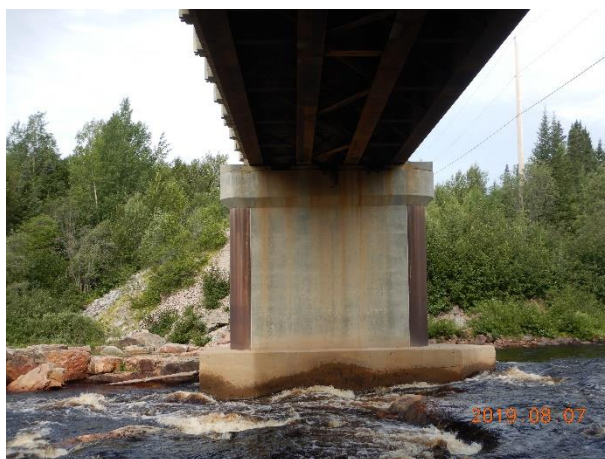
Figure 25 : Pier faces

The pier-wall is the concrete element that transfers the load from the pier cap to the foundation. Both ends are shielded by a steel plate. The wall is in good condition, both concrete and steel plates. Narrow cracks were observed in the concrete (width opening < 0,8 mm).

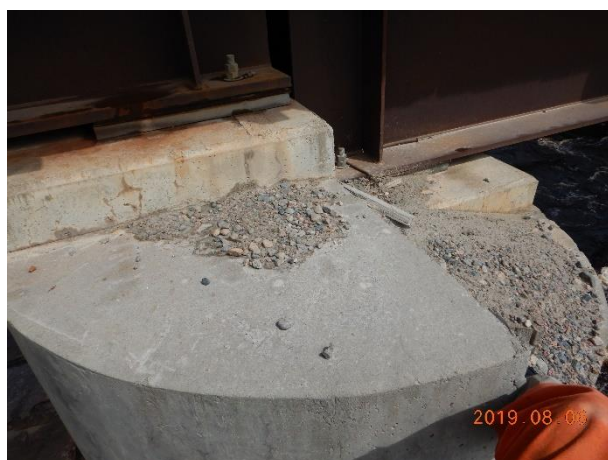
Figure 26 : Pier cap

The pier cap is in good condition. Narrow cracks were observed on the concrete surfaces.

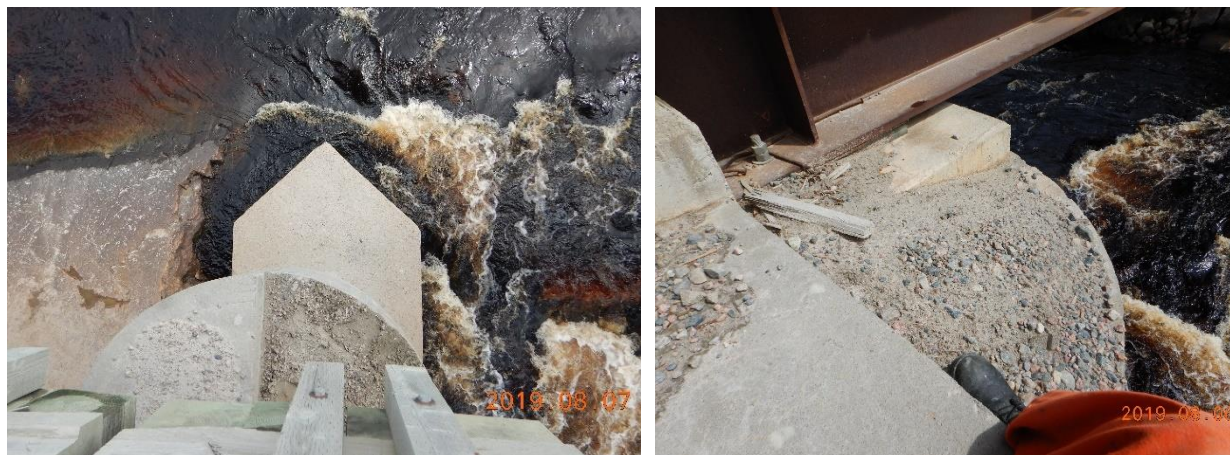
Figure 27 : *Pile's bearing seat*

The bearing seat is located at the top of the pier cap. Debris are covering some parts of the pier's bearings' seat. Bearing seats are in good condition.

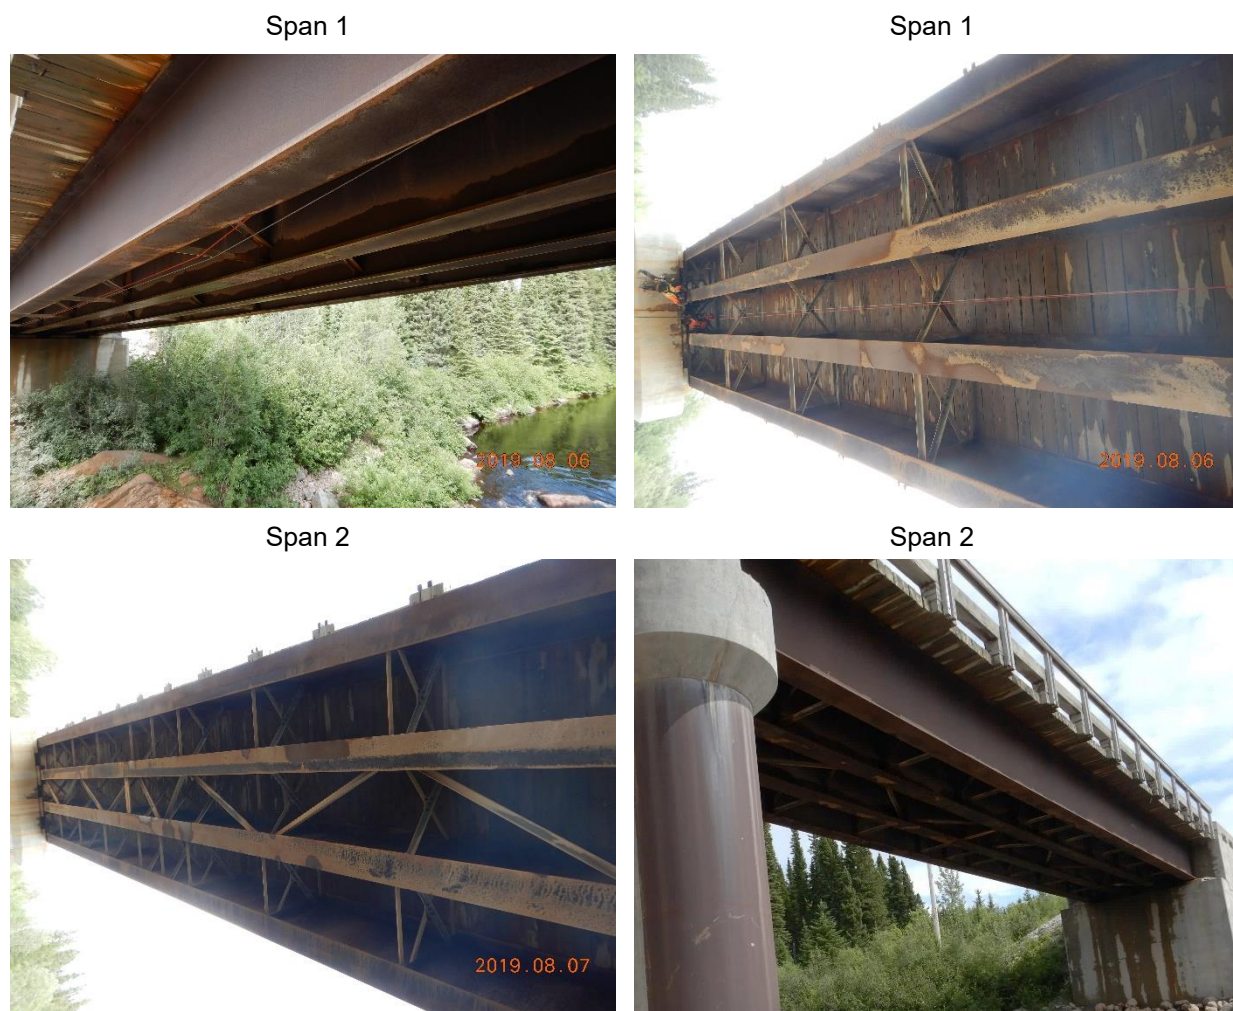
Figure 29 : Beams general views

Beams are in good condition. No important steel section loss was noted in the damage survey.

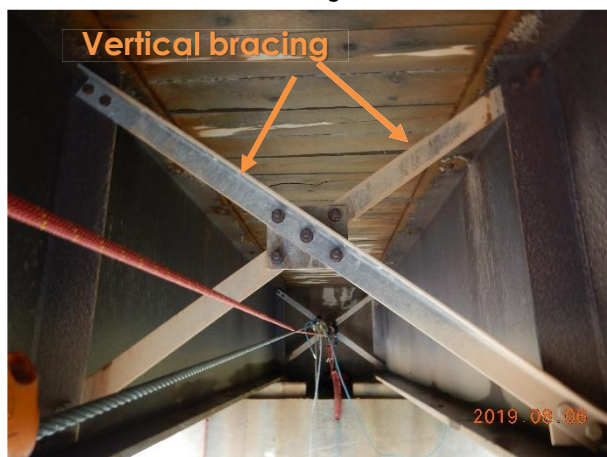
Span 1 – Intermediate vertical transverse bracings

Span 1 has four intermediate vertical transverse bracings and one end vertical transverse bracing at each end. No horizontal bracings are present between beams of span 1. All bracings of span 1 are in good condition.

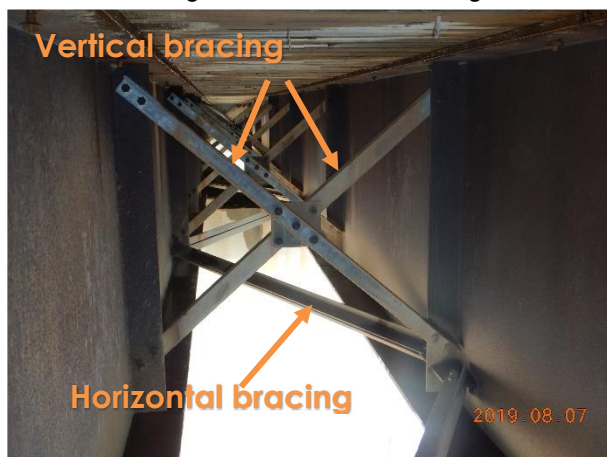
Span 2 – Intermediate vertical transverse bracings and horizontal bracings

Span 2 has nine intermediate vertical transverse bracings and one end vertical transverse bracing at each end. Span 2 also has ten horizontal bracings between beams 2 and 3. All bracings of span 2 are in good condition.

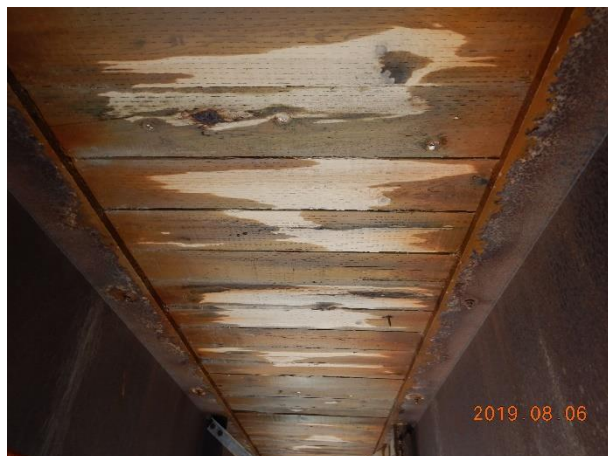
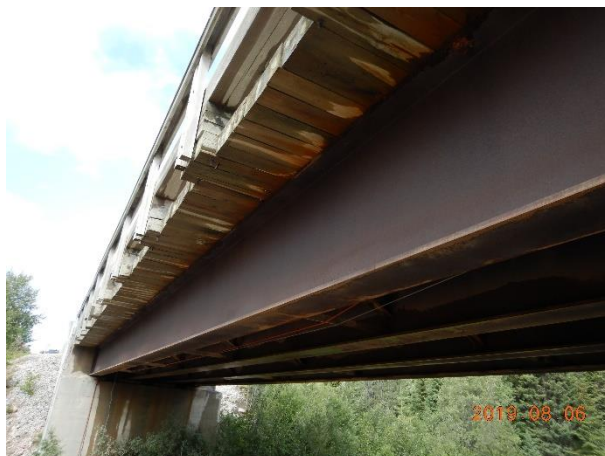
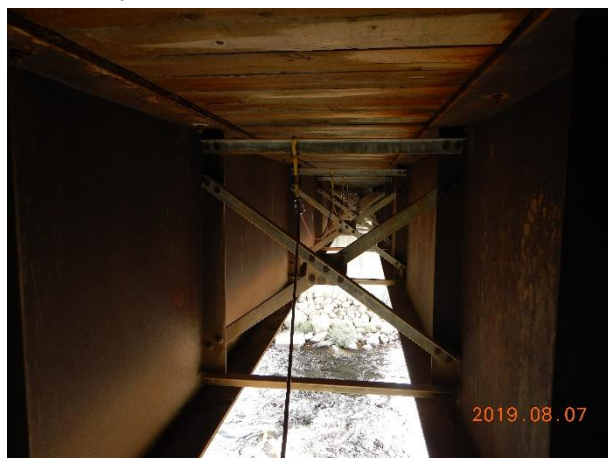
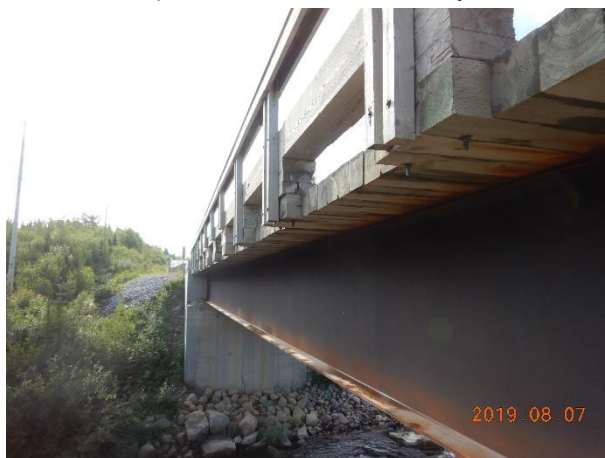
Figure 31 : Bridge deck – wood timbers

Wood timbers are in good condition.

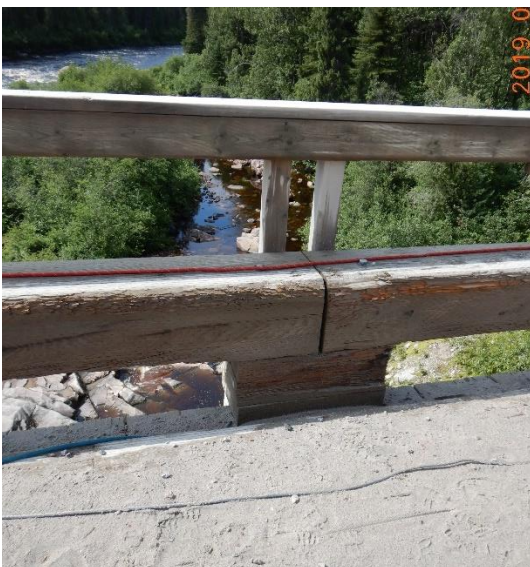
Typical curb and guardrails detail

The curbs are in good condition. In both spans, they present medium abrasion on its corner.
