ENGINEERING CONSULTING SERVICES
VOLUME 6 - APPENDIX
SECTION 6.25 – WEMINDJI ACCESS ROAD
Feasibility Study Final Report Phase I

Feasibility study of Maquatua River crossing bridge - Wemindji.

**DAMAGE SURVEY OF THE ACCESS ROAD
BRIDGE OVER MAQUATUA RIVER IN
WEMINDJI**

2019 Damage Survey Report,
Wemindji, QC Canada
Project #152700393

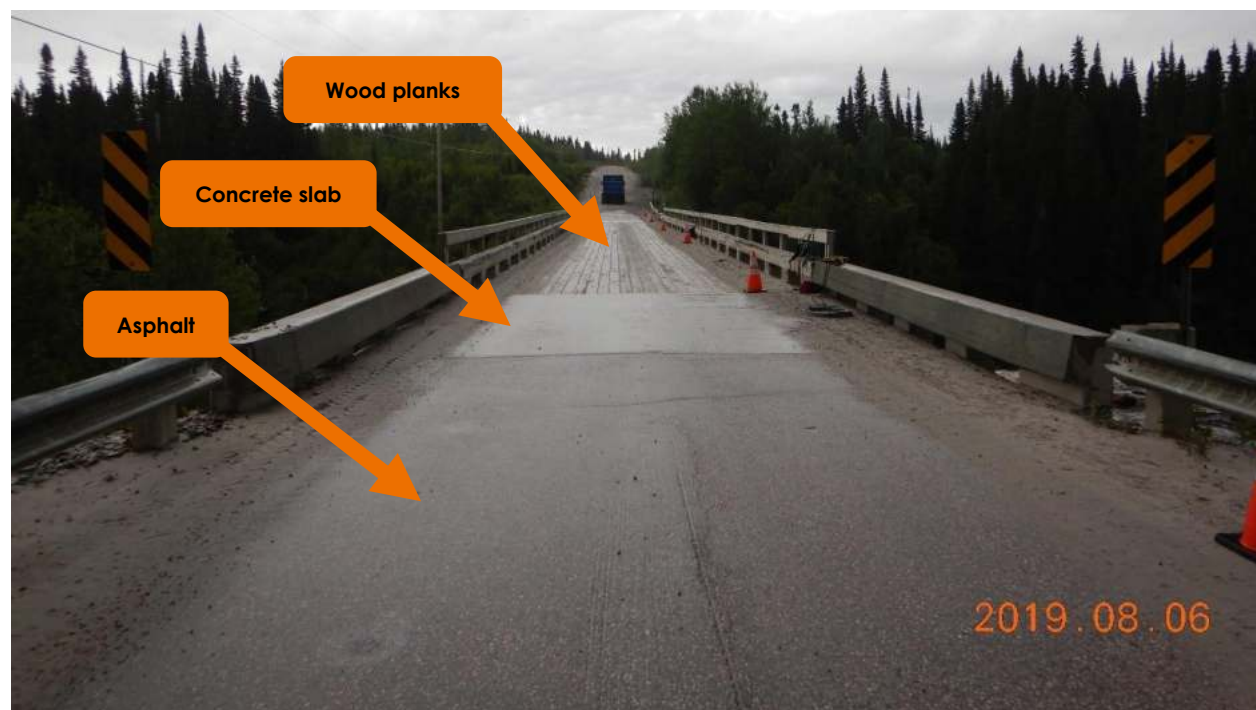
Figure 8 : Western approach

The approaches' asphalt pavement is making the transition between the gravel and the concrete surface (concrete deck of the hollowed abutments). It is damaged by cracks and potholes that allows the water to infiltrate the infrastructure under the pavement and possibly accelerate its deterioration. A concrete slab serves as pavement transition between the asphalt approaches and the wooden planks. No expansion joint is separating the different materials.

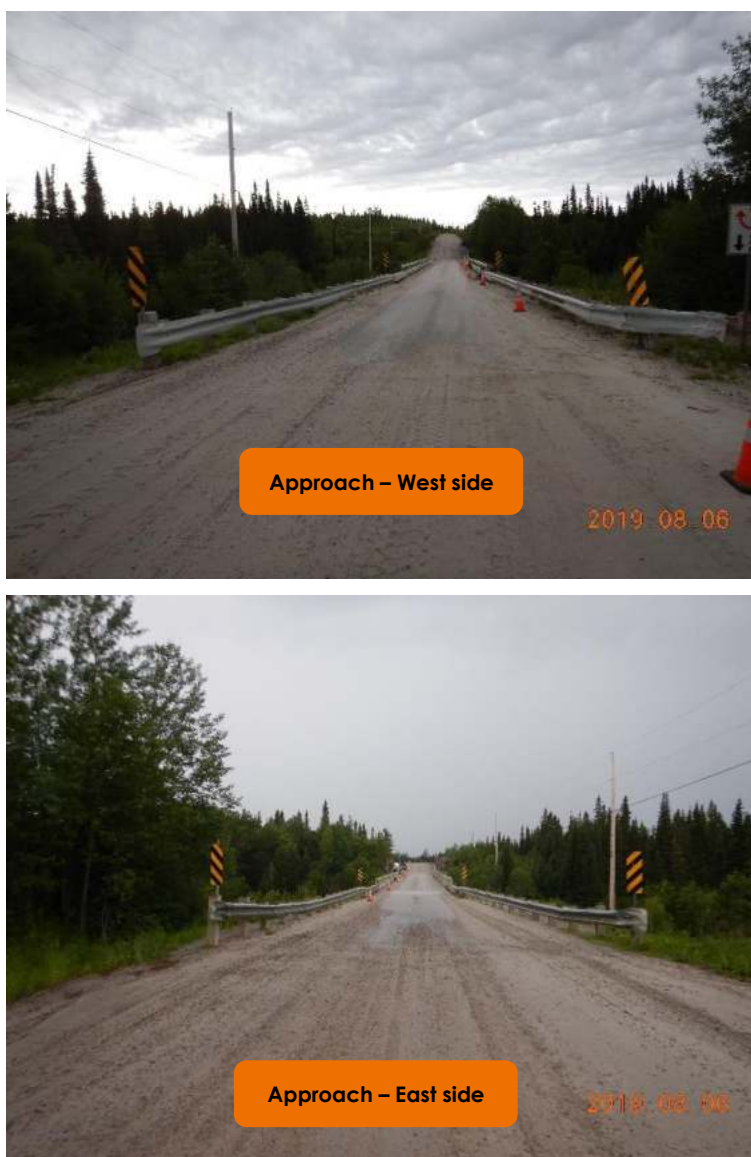
Figure 14 : Wood and galvanized steel *Guardrails*

At first, guardrails are the first protection device while approaching the bridge. A guardrail is a semi-rigid structure made of galvanized steel and wood. Its purpose is to slide the vehicle that might leave the road. Wood and galvanized steel guardrails are installed on both approaches. Wooden posts are in bad condition (some are broken, and some are decayed) and the galvanized steel railings are deformed by impacts. Extremities of galvanized steel railings were possibly hit by cars and are deformed and/or torn up at each end of the structure. No rigidity transition is in place between the semi-rigid wood and steel railing and concrete rigid guardrails.

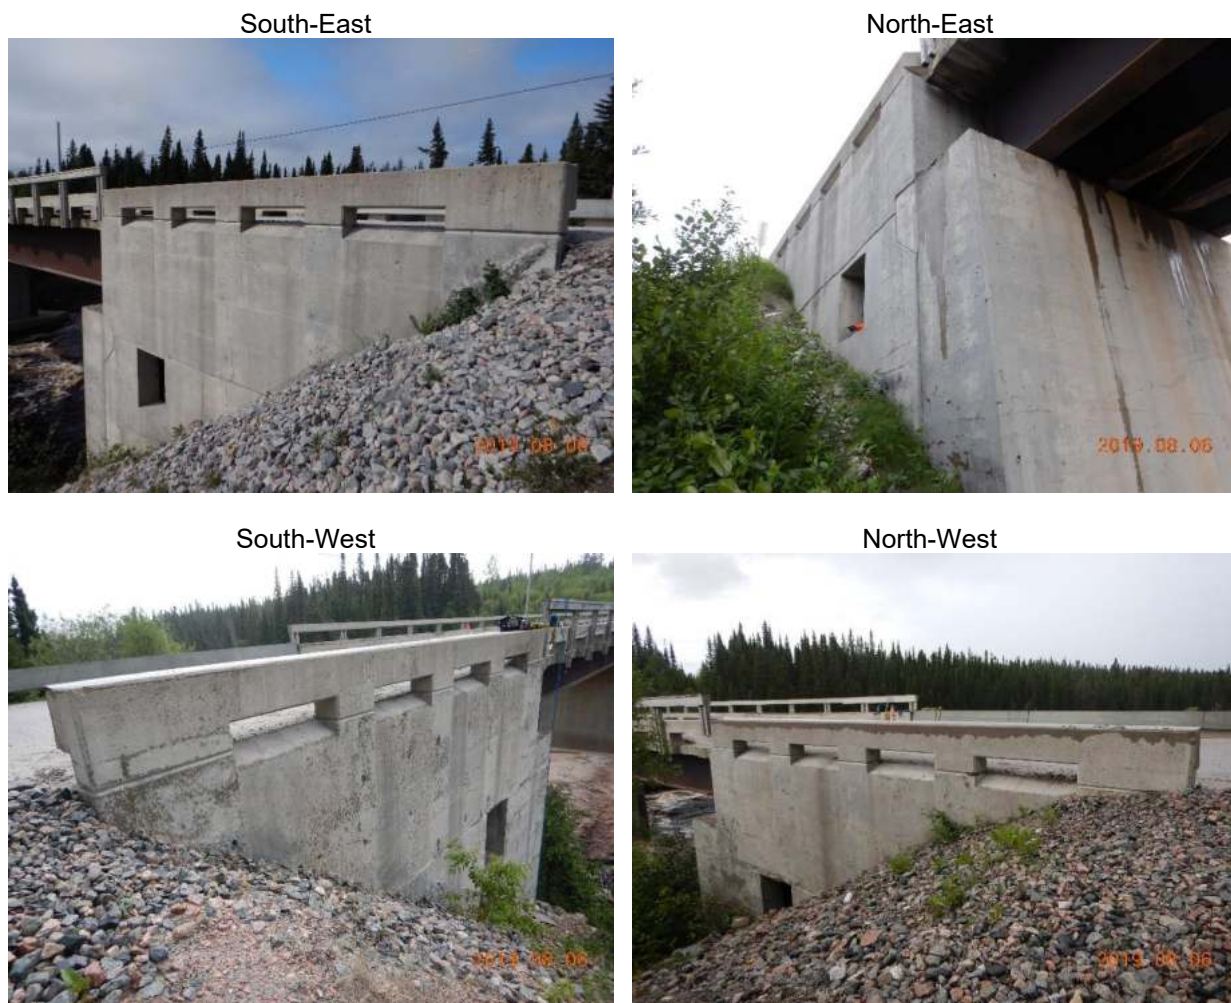
Figure 19 : Sidewalls

No concrete deficiencies were found on the side walls, except for narrow cracks in concrete (width opening < 0,8 mm). Sidewalls are in good condition.

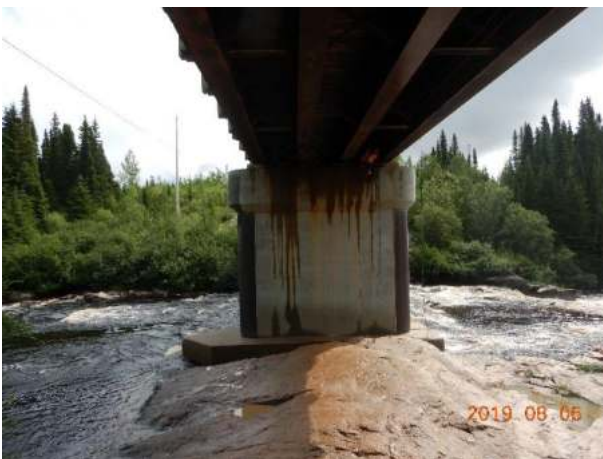
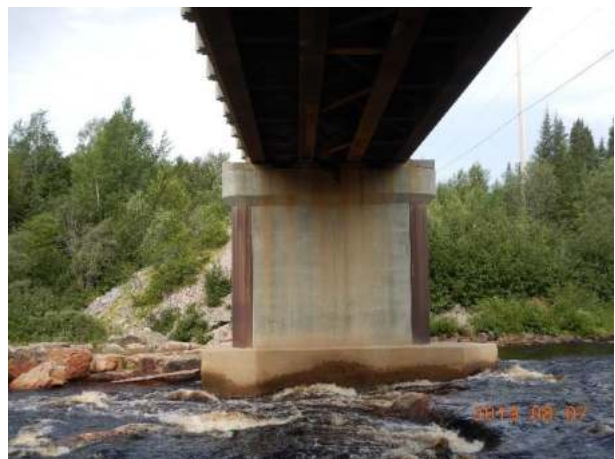
Figure 25 : *Pier faces*

The pier-wall is the concrete element that transfers the load from the pier cap to the foundation. Both ends are shielded by a steel plate. The wall is in good condition, both concrete and steel plates. Narrow cracks were observed in the concrete (width opening < 0,8 mm).

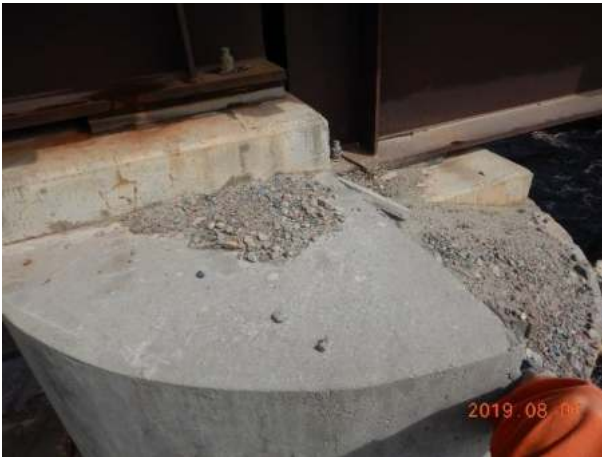
Figure 26 : Pier cap

The pier cap is in good condition. Narrow cracks were observed on the concrete surfaces.

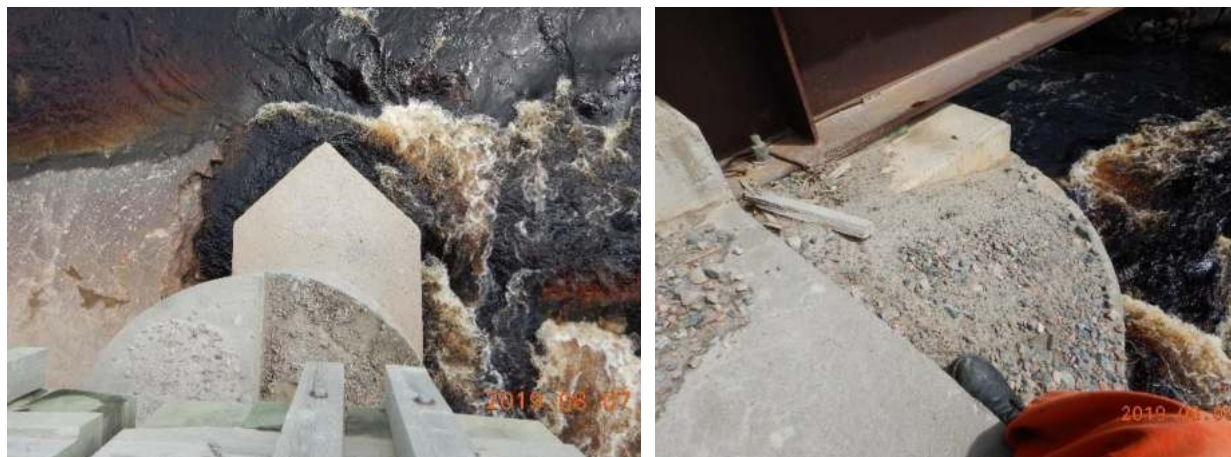
Figure 27 : Pile's bearing seat

The bearing seat is located at the top of the pier cap. Debris are covering some parts of the pier's bearings' seat. Bearing seats are in good condition.

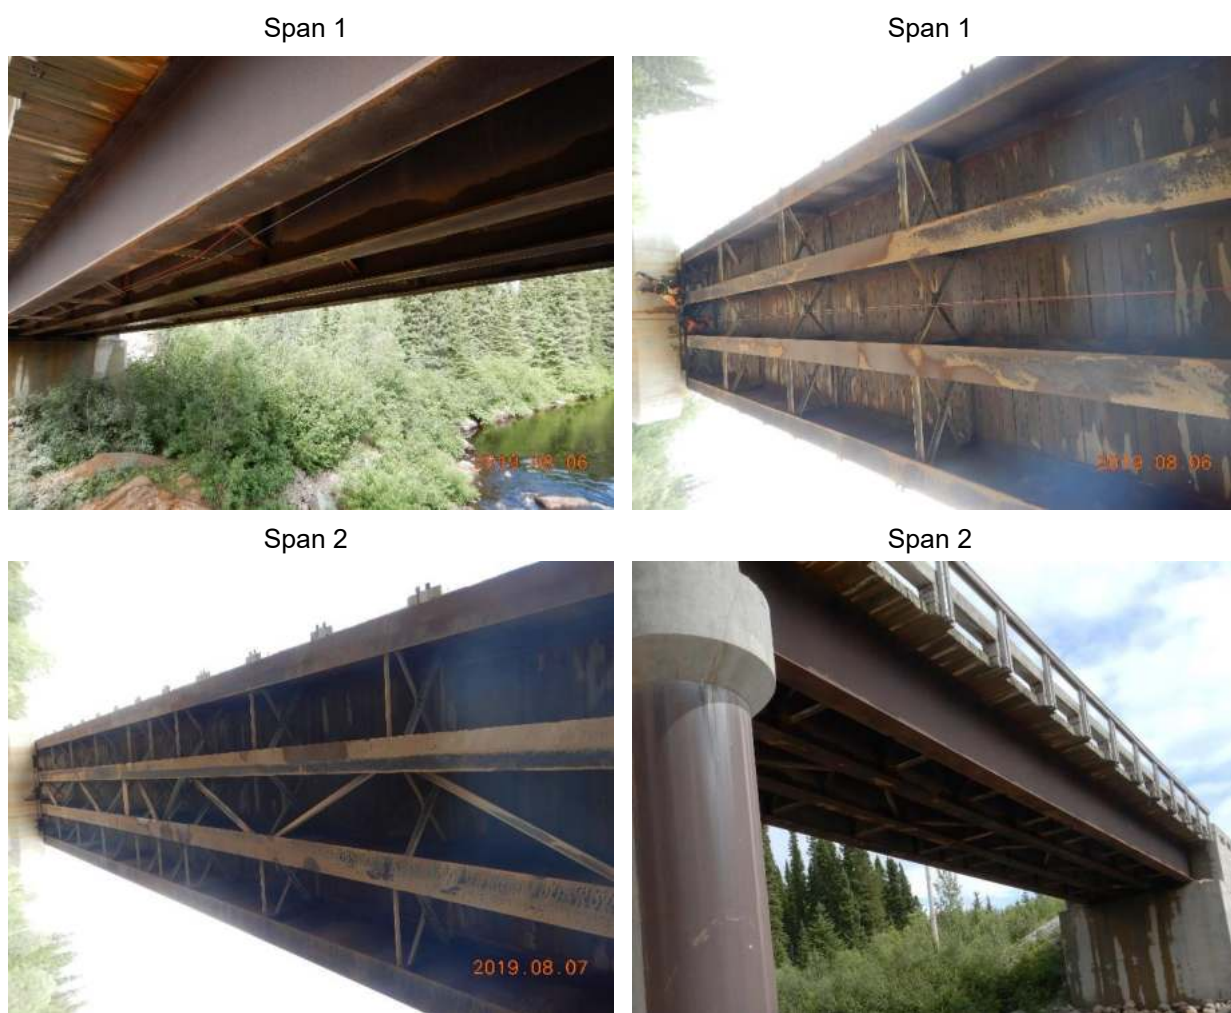
Figure 29 : Beams general views

Beams are in good condition. No important steel section loss was noted in the damage survey.

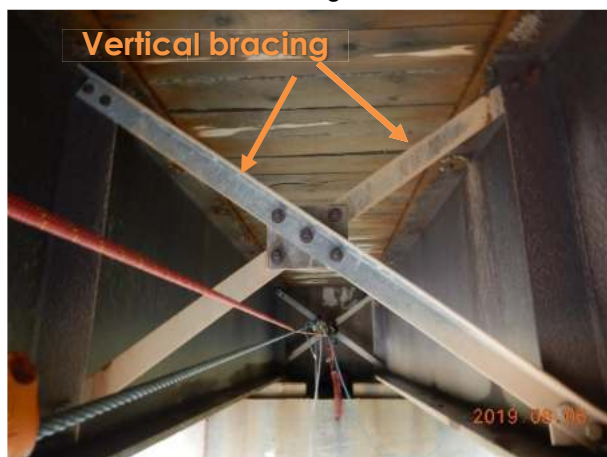
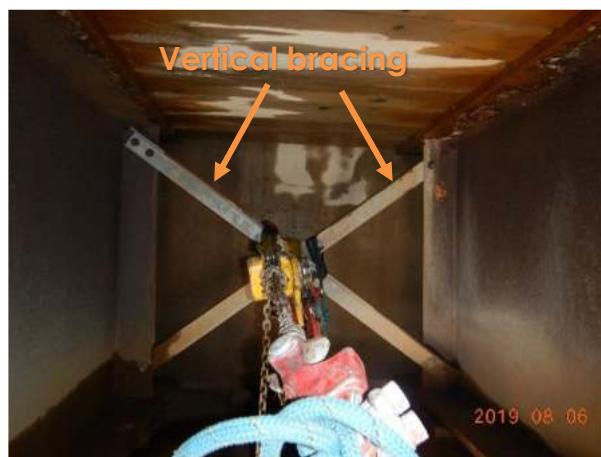
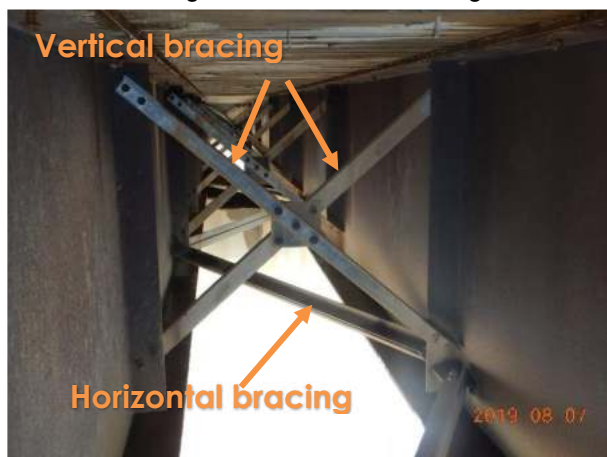
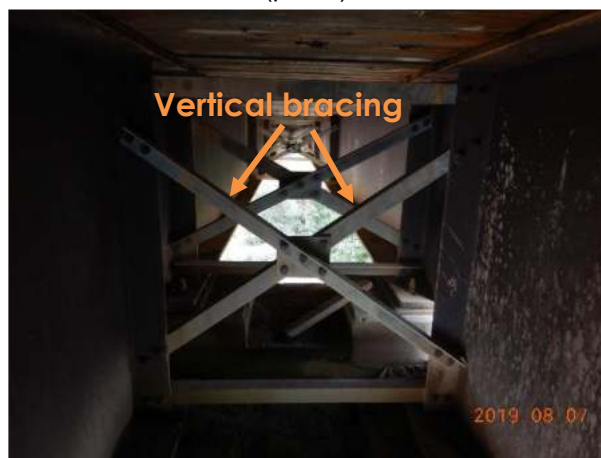
Figure 30 : Bracings

Span 1 has four intermediate vertical transverse bracings and one end vertical transverse bracing at each end. No horizontal bracings are present between beams of span 1. All bracings of span 1 are in good condition.

Span 2 has nine intermediate vertical transverse bracings and one end vertical transverse bracing at each end. Span 2 also has ten horizontal bracings between beams 2 and 3. All bracings of span 2 are in good condition.

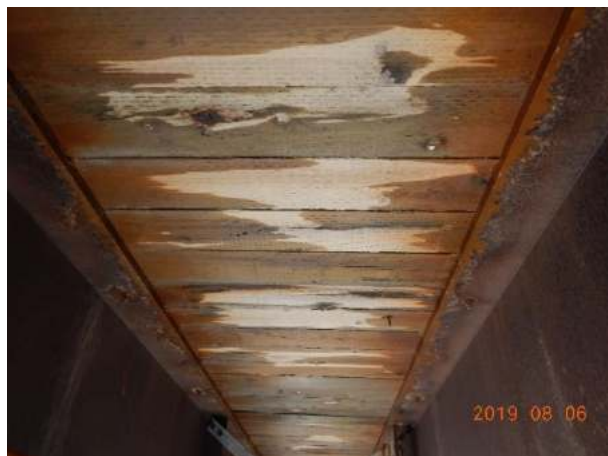
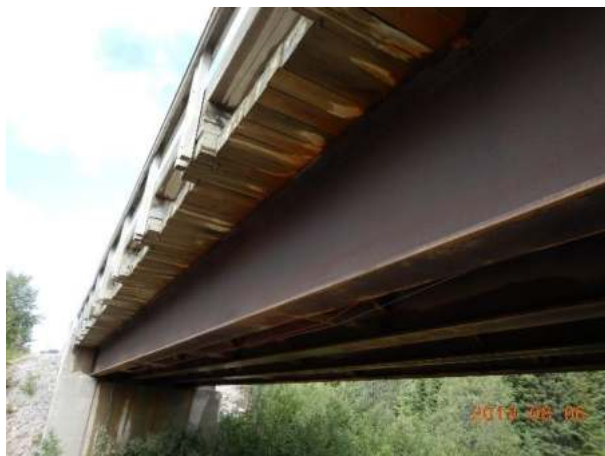
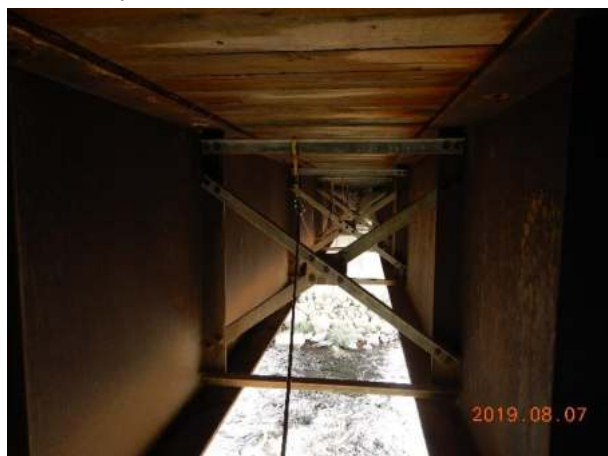
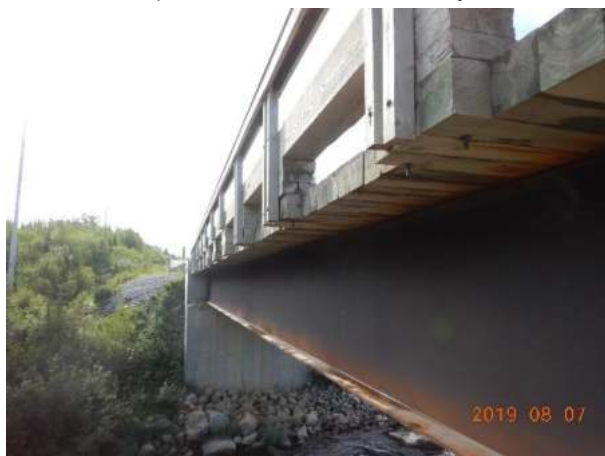
Figure 31 : Bridge deck – wood timbers

Wood timbers are in good condition.

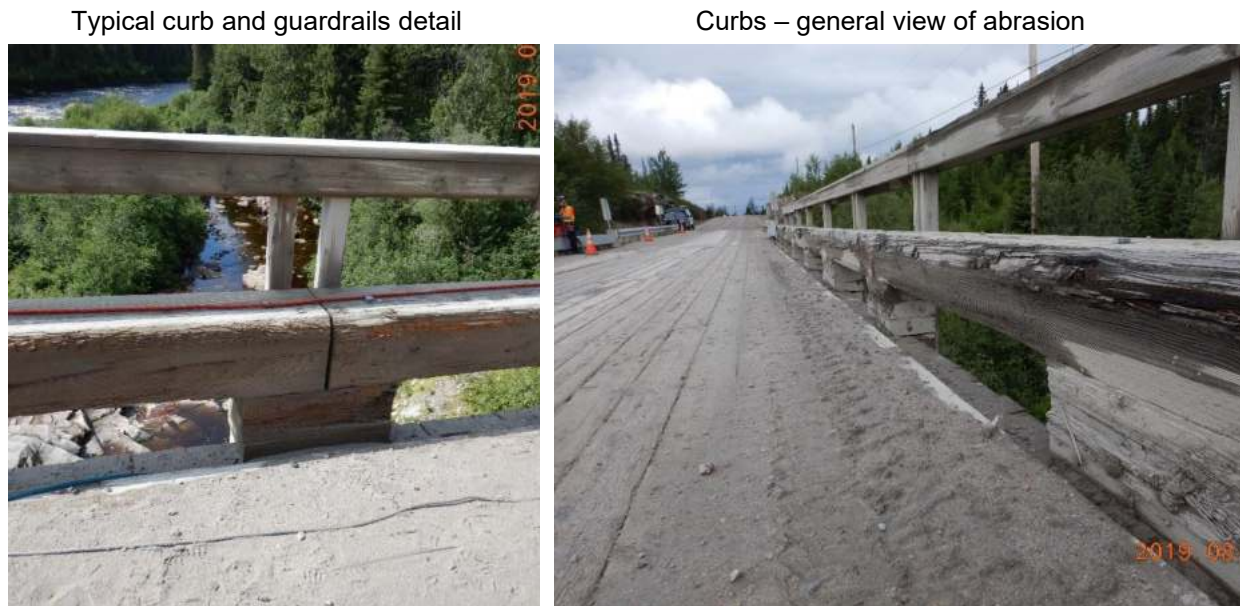
Figure 33 : Road curb

The curbs are in good condition. In both spans, they present medium abrasion on its corner.
