VOLUME 6 - ANNEXES
SECTION 6.25 – ROUTE D'ACCÈS WEMINDJI
Rapport final de l'étude de faisabilité Phase I

La Grande Alliance Étude
de faisabilité Phase I

Rapport Technique -Route
d'accès Wemindji

Damage Survey of the Access Road Bridge Over Maquatua River in Wemindji

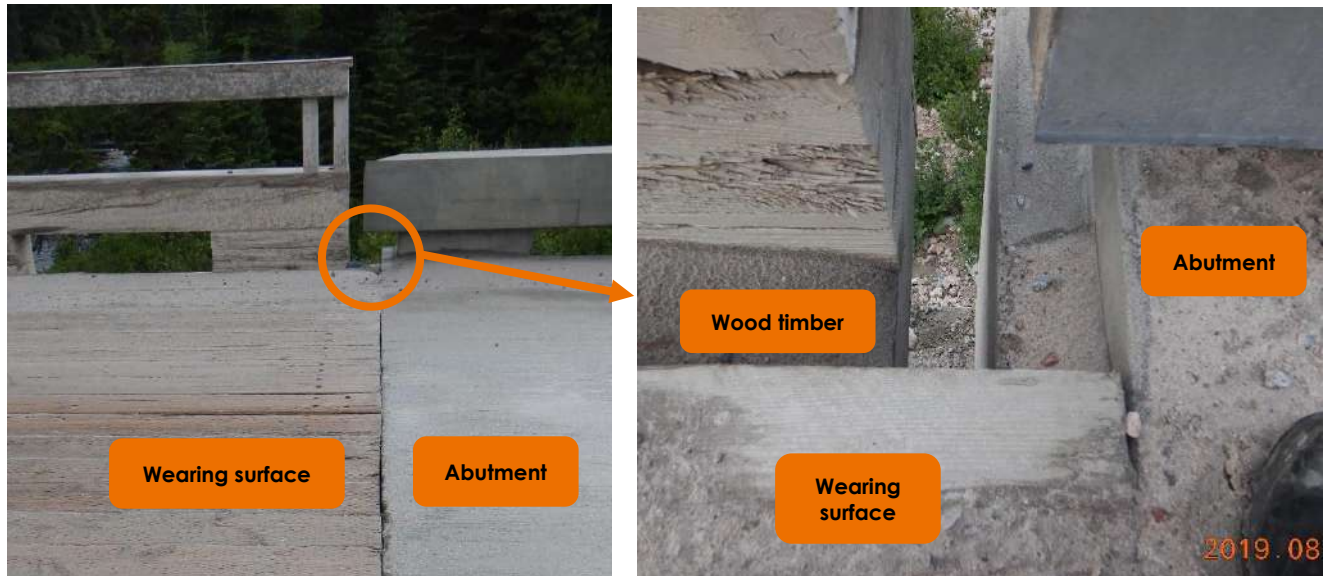
Figure 6 : Deck detail

The deck of Wemindji access road bridge is made of wood timbers and the wearing surface is also made of wood planking surface. The wood planking surface is slightly longer than the deck length (wood timbers) because it sits on a ledge at the top of the abutment walls. An open joint (space) is present between the ballast wall and the first wood timber of the deck. The structural detail is shown in the picture below.

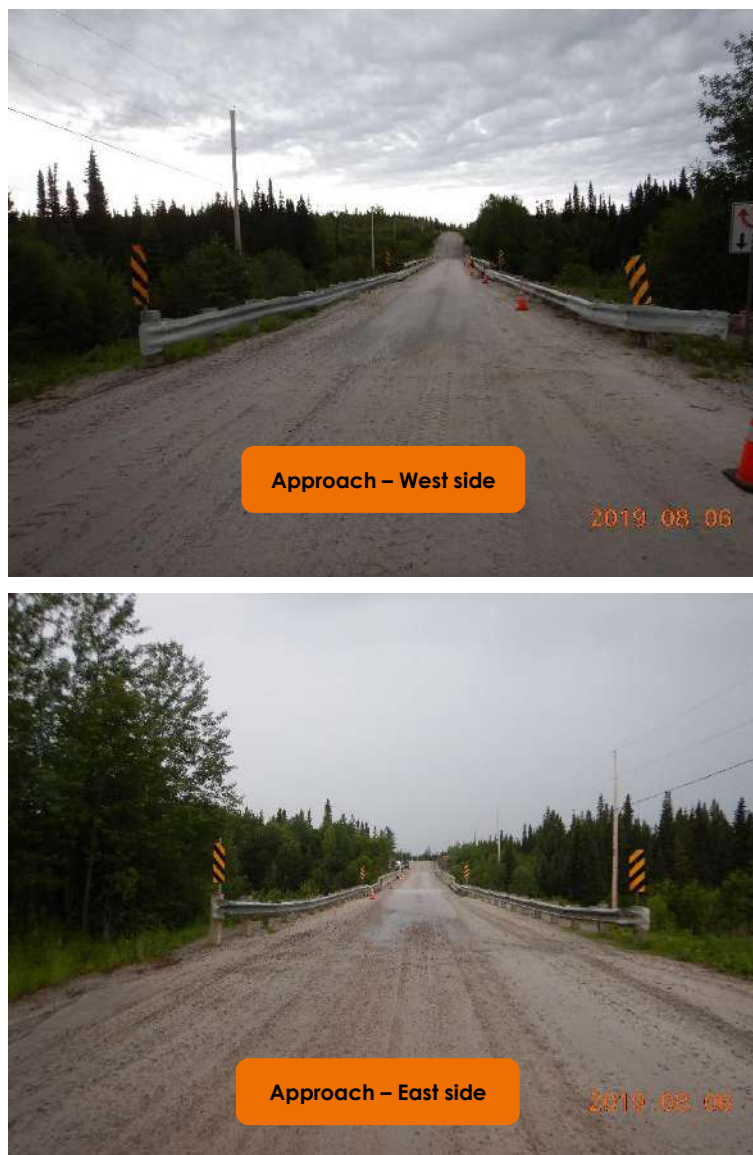
Figure 14 : Wood and galvanized steel *Guardrails*

At first, guardrails are the first protection device while approaching the bridge. A guardrail is a semi-rigid structure made of galvanized steel and wood. Its purpose is to slide the vehicle that might leave the road. Wood and galvanized steel guardrails are installed on both approaches. Wooden posts are in bad condition (some are broken, and some are decayed) and the galvanized steel railings are deformed by impacts. Extremities of galvanized steel railings were possibly hit by cars and are deformed and/or torn up at each end of the structure. No rigidity transition is in place between the semi-rigid wood and steel railing and concrete rigid guardrails.

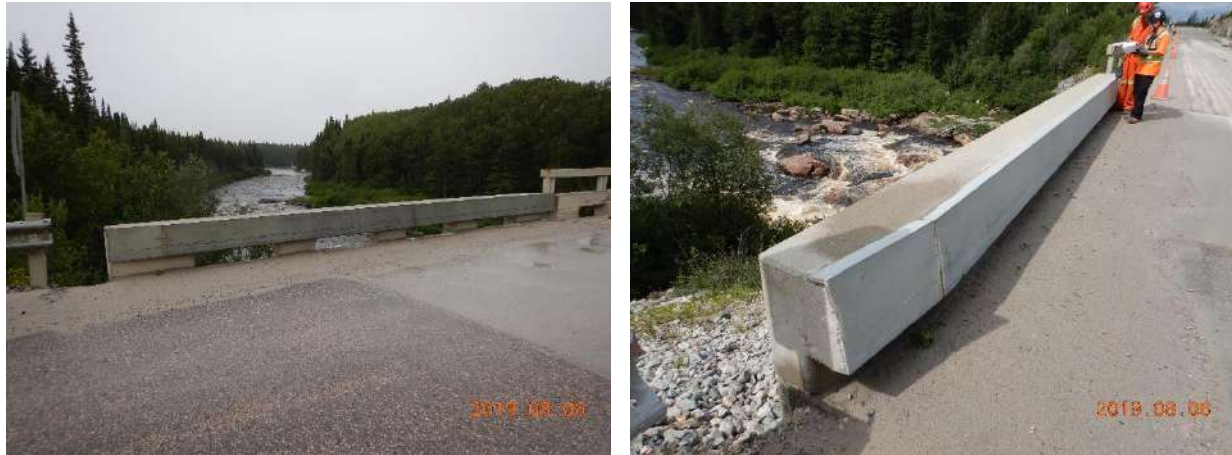
Figure 15 : Concrete guardrails

The second device is made of concrete rails and concrete posts covered with a “C” formed steel channel. Those concrete guardrails are located at the top of the four sidewalls. No material defect was noted on the concrete barriers and their condition is good.

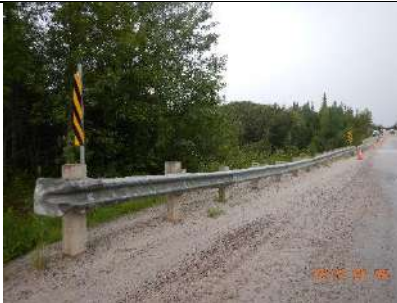
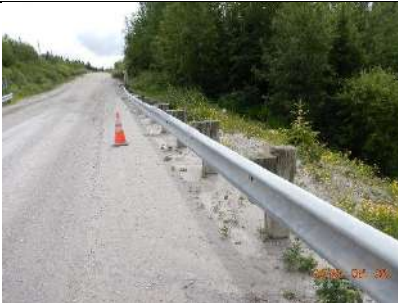
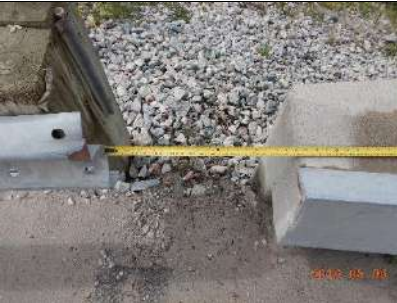
East approach		
South-East corner

Permanent deformation of guardrail and torn guardrail.	Permanent deformation of guardrail.	No connection device between the wood and galvanized steel railing and the concrete barrier

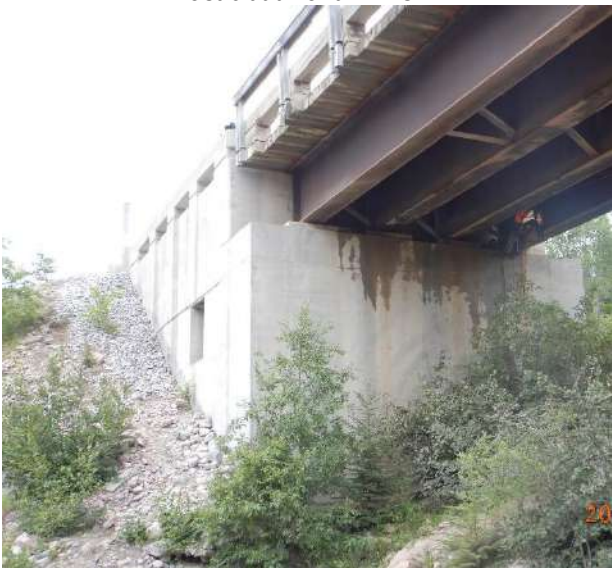
West abutment / Axis 1

The front walls of the abutment are perpendicular to the bridge alignment. Both abutment walls are in good condition. Narrow cracks (width opening < 0,8 mm) and cold joints in concrete were identified on each front wall. General views of each front walls and typical cracks are shown in the figures below.

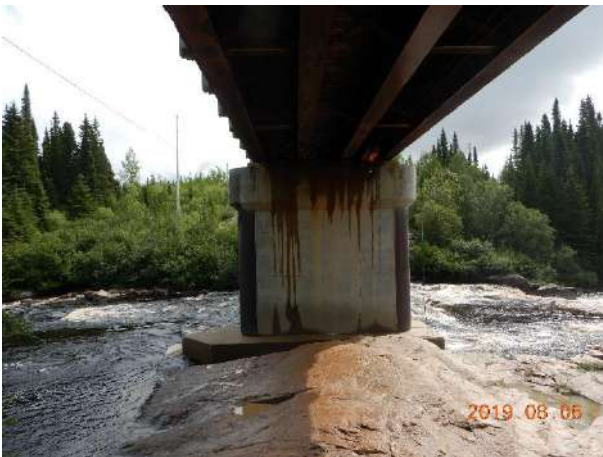
West face

The pier-wall is the concrete element that transfers the load from the pier cap to the foundation. Both ends are shielded by a steel plate. The wall is in good condition, both concrete and steel plates. Narrow cracks were observed in the concrete (width opening < 0,8 mm).

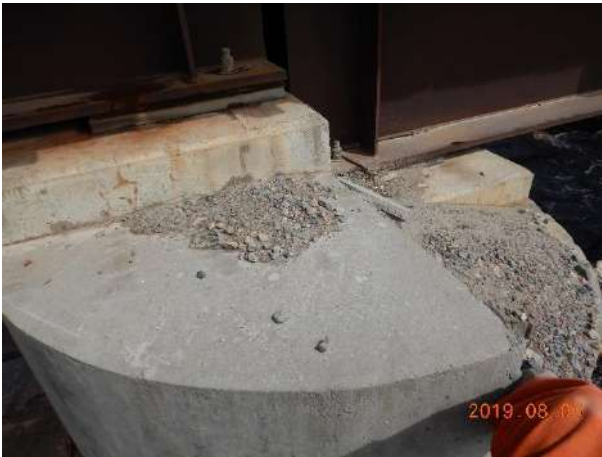
Figure 26 : Pier cap

The pier cap is in good condition. Narrow cracks were observed on the concrete surfaces.

The bearing seat is located at the top of the pier cap. Debris are covering some parts of the pier's bearings' seat. Bearing seats are in good condition.

Vertical crack width < 0.8 mm

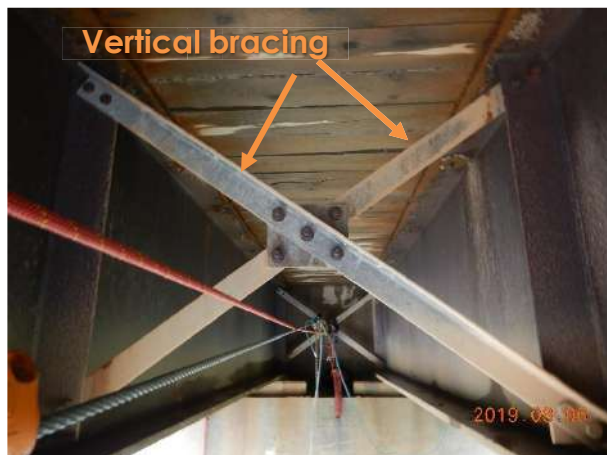
Span 1 – Intermediate vertical transverse bracings

Span 1 has four intermediate vertical transverse bracings and one end vertical transverse bracing at each end. No horizontal bracings are present between beams of span 1. All bracings of span 1 are in good condition.

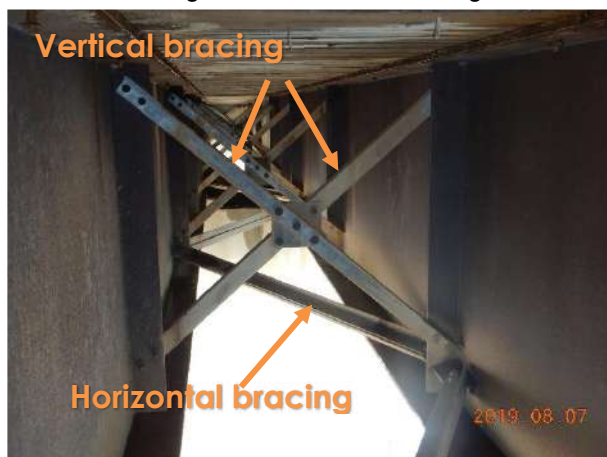
Span 2 – Intermediate vertical transverse bracings and horizontal bracings

Span 2 has nine intermediate vertical transverse bracings and one end vertical transverse bracing at each end. Span 2 also has ten horizontal bracings between beams 2 and 3. All bracings of span 2 are in good condition.

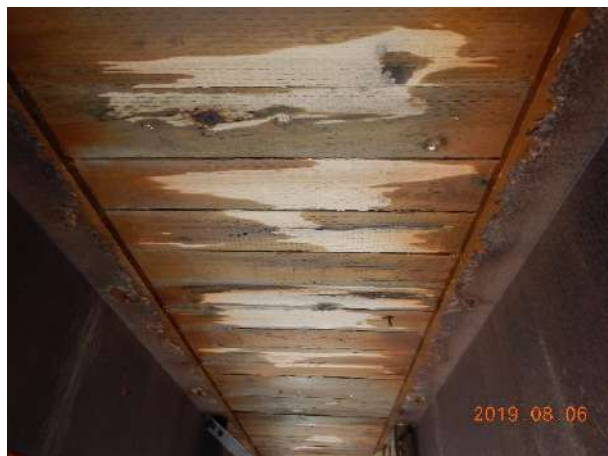
Span 1 – Timbers between beams

Wood timbers are in good condition.
