ENGINEERING CONSULTING SERVICES
VOLUME 6 - APPENDIX
**APPENDIX 6.1.1 – PRELIMINARY
GEOTECHNICAL INVESTIGATION –
EASTMAIN ACCESS ROAD**
FEASIBILITY STUDY FINAL REPORT PHASE I

**LA GRANDE ALLIANCE FEASIBILITY
STUDY – PHASE I**

PRELIMINARY GEOTECHNICAL
INVESTIGATION – EASTMAIN
ACCESS ROAD

February 22, 2023

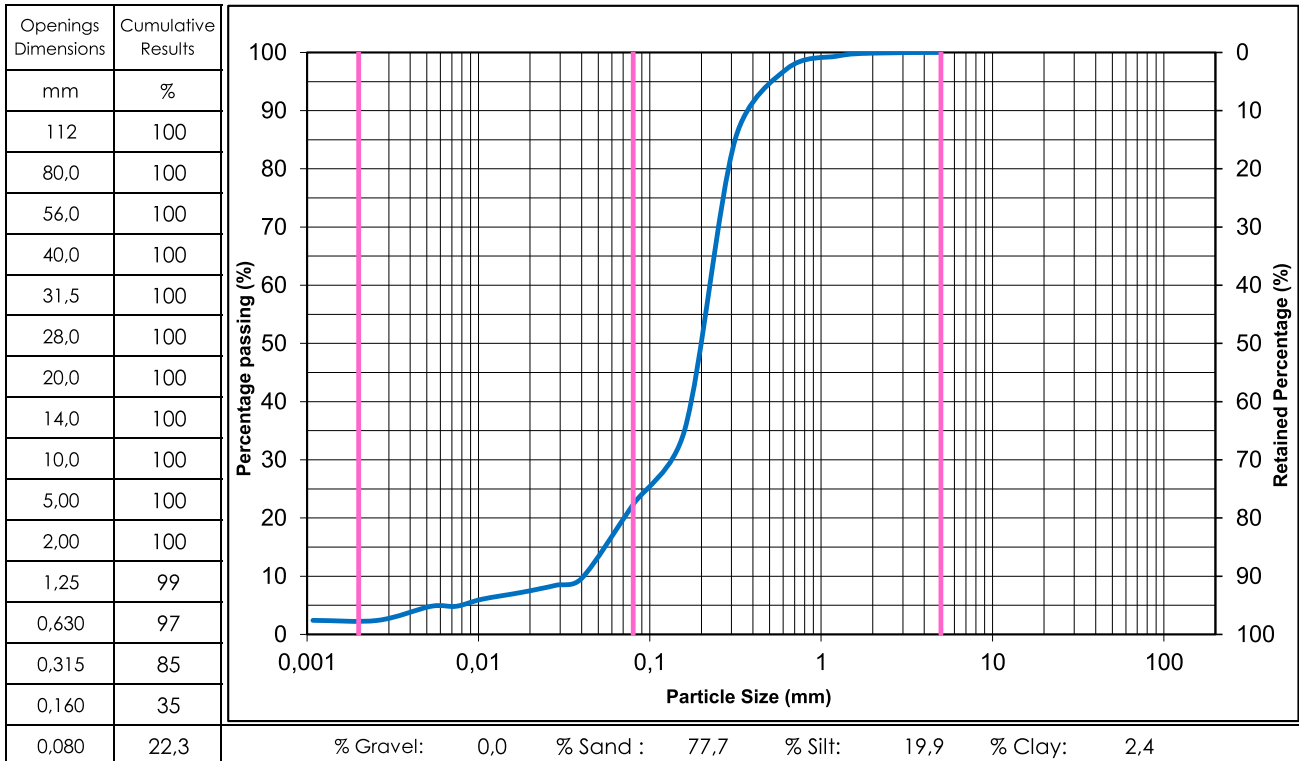
Grain Size Analysis (BNQ 2501-025)

Material Description : Sand, some Silt, traces of Clay

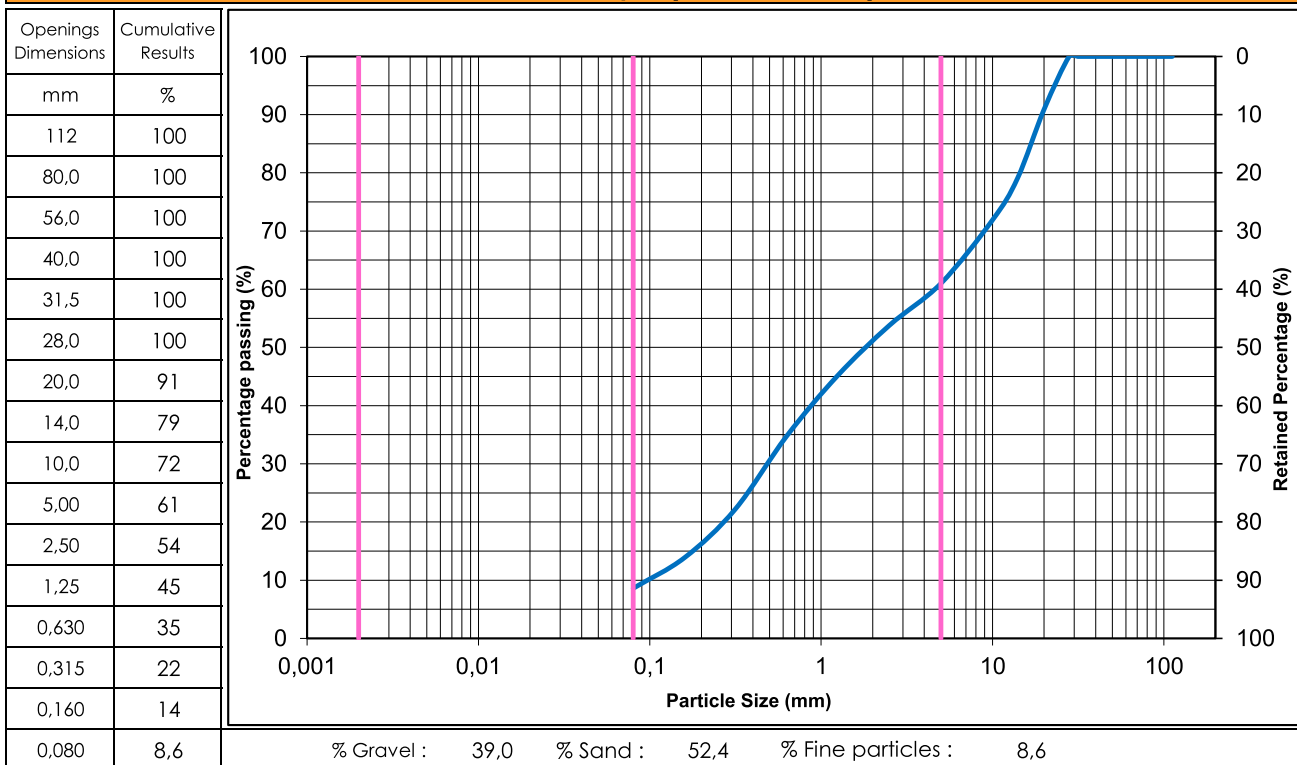
Grain Size Analysis (BNQ 2501-025)

Sampled by : Élie Ferland
 Sampling Date : May 31, 2022
 Material Description : Sand and Gravel, traces of fine particles
